USAARL REPORT NO. 72-07

DYNAMIC AND CRASHWORTHY EVALUATION
OF THE UH-1B, C, D, H, MEDICAL ATTENDANT'S SEAT

January 1972

U. S. ARMY AEROMEDICAL RESEARCH LABORATORY

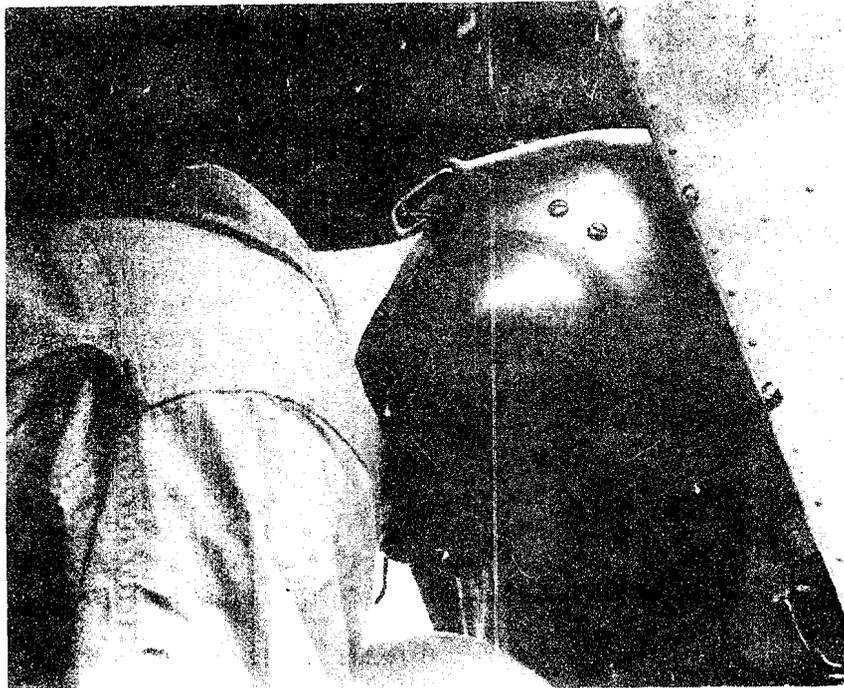
Figure 2. Demonstration of Head - Seat Contact is Allowed by Basic Seat When Used Behind Crew Seat and Without Shoulder Harness.

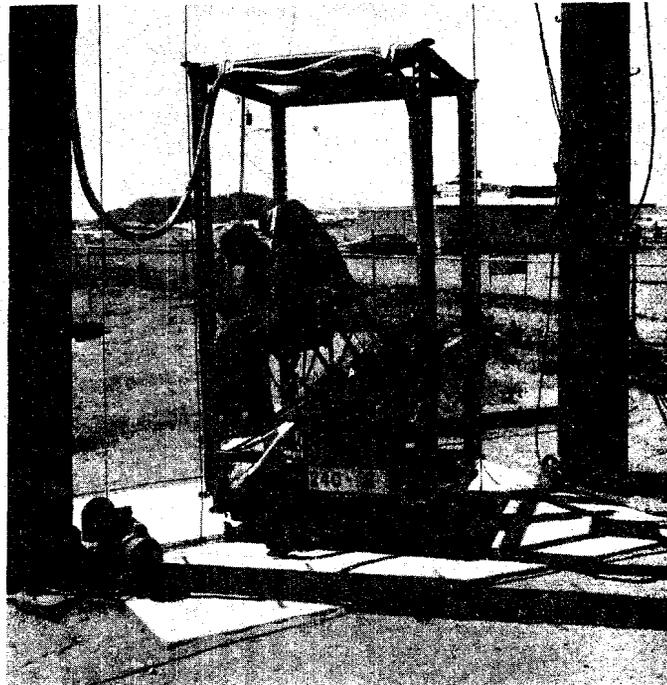
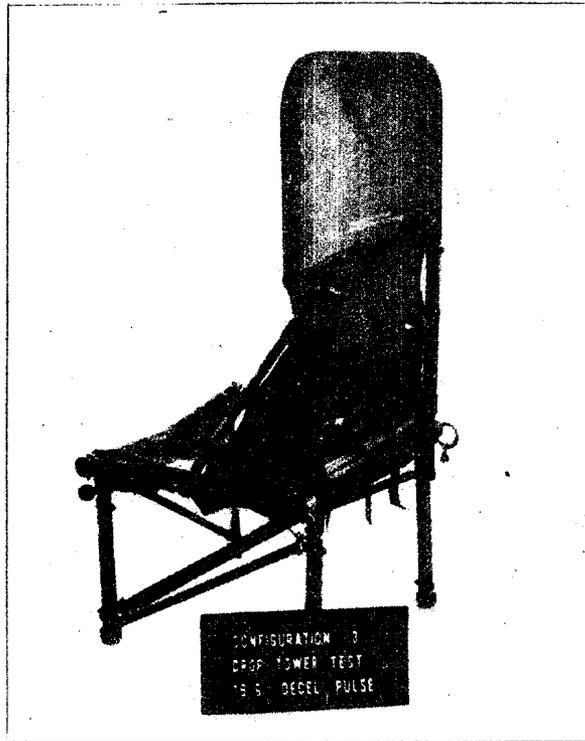
Post-test inspection revealed seat failure in four places. The seat front lateral cross tube failed in the center at a 1/8-inch diameter hole where a screw fastens the seat canvas to the structure, the seat right front corner joint pulled out, the seat back tube failed on the left side at the back brace tube, and the canvas seat also failed. Figure 26 shows a post-test seat side view. Peak dummy chest vertical deceleration was 23.8G. The pelvis experienced a very high vertical deceleration of 40G. (See Figures 24 thru 31.)

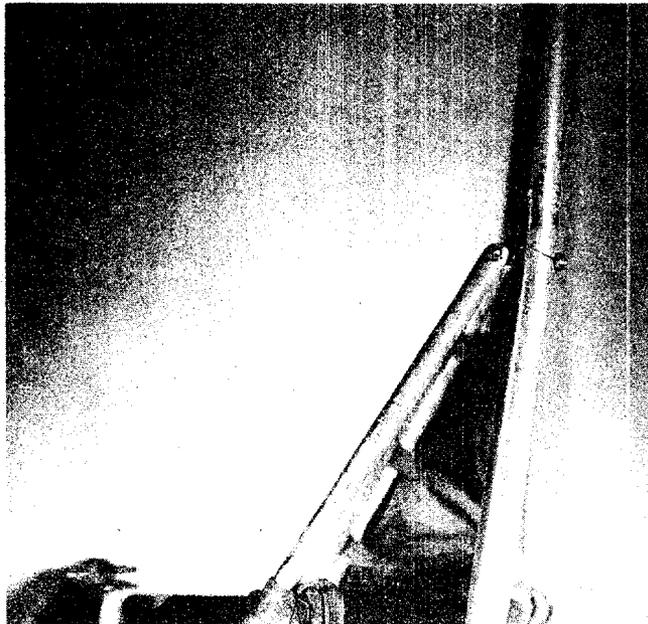
Figure 27. Closeup of Seat Back Failure
Slip-out of Joint in Background.

From the nature of the failure it is obvious that the aluminum seat back is very brittle in nature. The support tube pin served as a pivot about which only 150 + ft-lbs were necessary to fail the notch-sensitive tube.

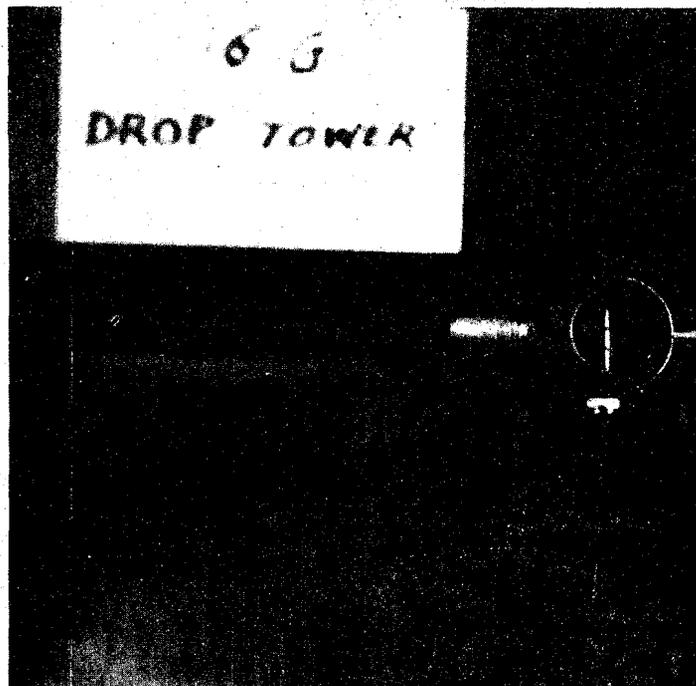
Figure 28. Slipped Joint Right Front

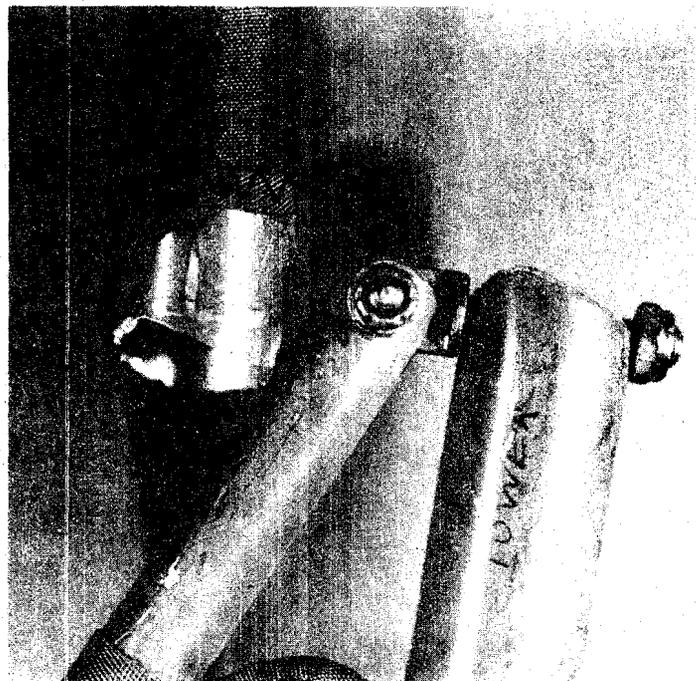
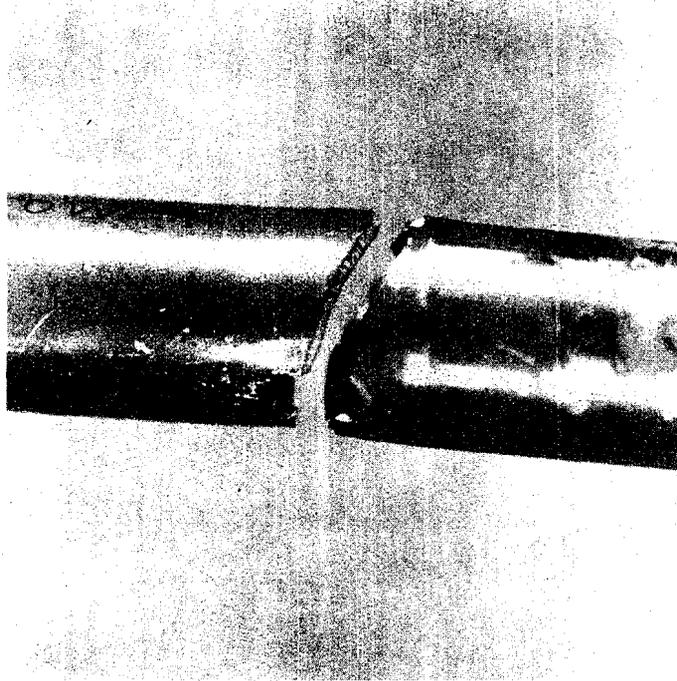
Figure 29. Closeup of Failed Seat Back

Figure 30. Closeup, Seat Back Failure

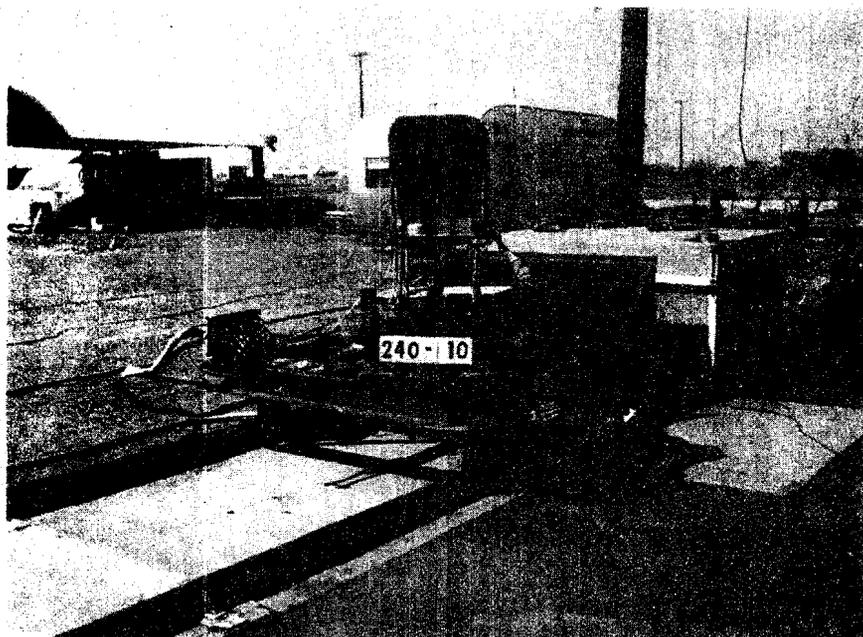
Post-test inspection revealed a broken left side lap belt anchor ring (See Figures 35 and 37). This allowed the dummy to move out of the seat onto the right side of the sled during impact. The dummy and instrumentation were not damaged, however, high decelerations resulted. The highest deceleration measured was a 24.2G lateral chest deceleration.

Figure 36. Post-test Position of Dummy in Test 10.

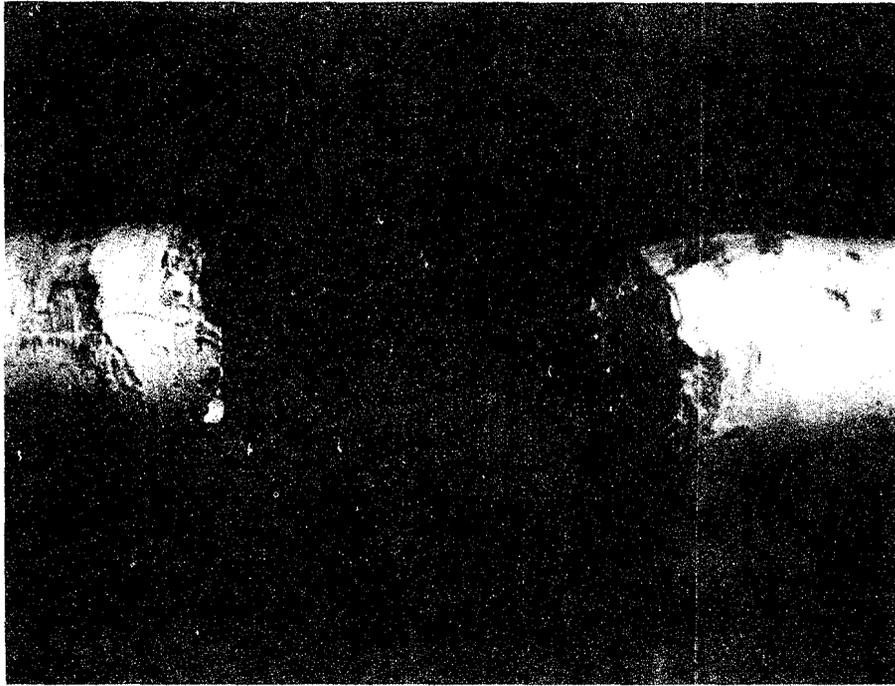
Figure 35. Broken Lap Belt Anchor Ring Sustained in Test 10.

Figure 37. Closeup of Failed Lap Belt Attachments Rings.

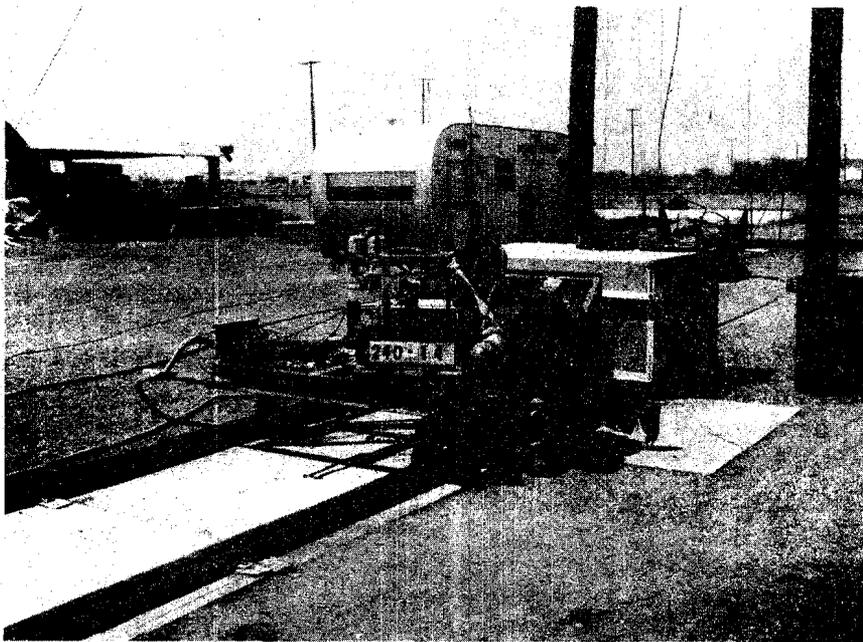
Post-test inspection revealed four failures as shown in Figures 42 thru 44. The seat back tube failed at the back brace tube bolt holes, the left lap belt ring weld failed, the right front seat joint started to pull loose, and the seat canvas failed. The dummy moved out of the seat and onto the left side of the sled; however, the dummy and instrumentation were not damaged. (See Figures 41 thru 44.) The maximum dummy deceleration was measured in the chest and was 13.9G in the vertical direction.

Figure 42. Post-test Position of Dummy After Test 14.

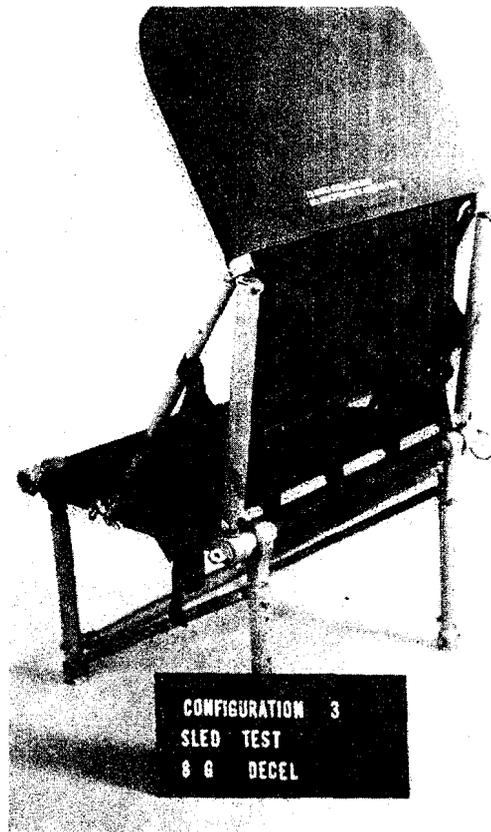
Figure 43. 8G Input, Configuration 3.

Note the absence of the left lap belt attachment ring which broke at 1,340 lbs. Refer to Figure 55 on page 63 for a picture and discussion of this type failure. Note also that the failure of the seat back on both sides occurred at the support tube pin. The torque causing these failures was 530 + lbs-ft total, applied near the center of the two failures.

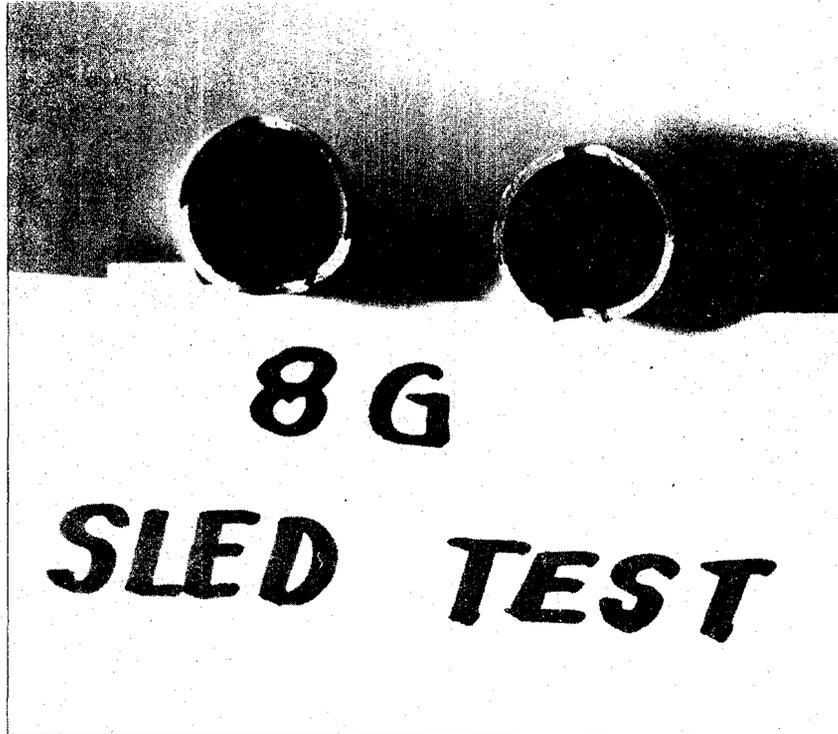
Figure 44. End View of Failed Seat Back Tubes.

The picture in Figure 44 shows an end-to-end view of one of the failures of the seat back tube.

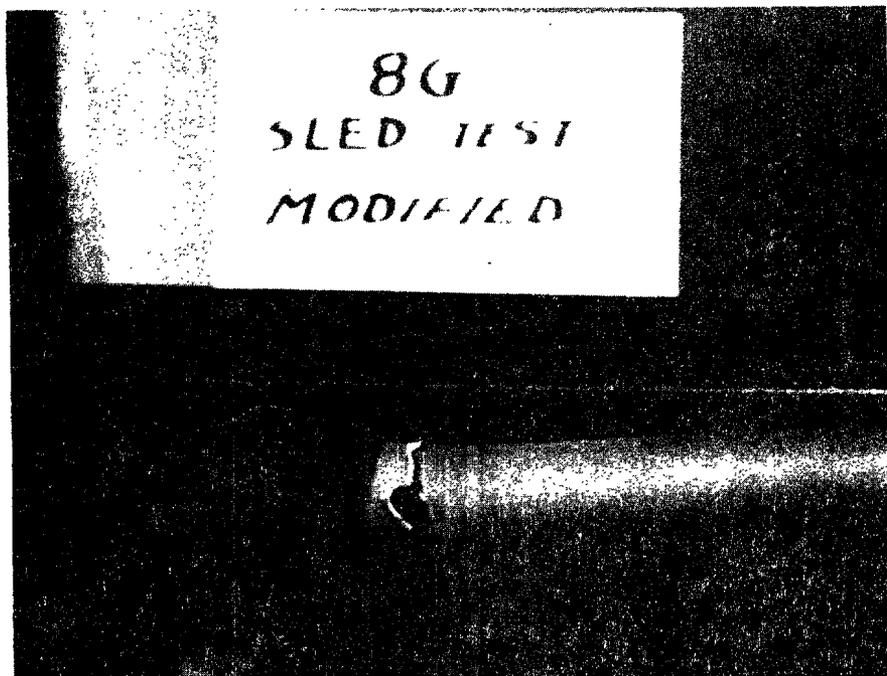
Figure 50. Closeup Longitudinal Frame Failure
