USAARL Report 76-21

REDUCTION OF GLARE FROM THE LANDING LIGHTS OF THE OH-58:
AN EVALUATION OF FOUR POTENTIAL SOLUTIONS

May 1976

US Army Aeromedical Research Laboratory
Fort Rucker, Alabama 36362

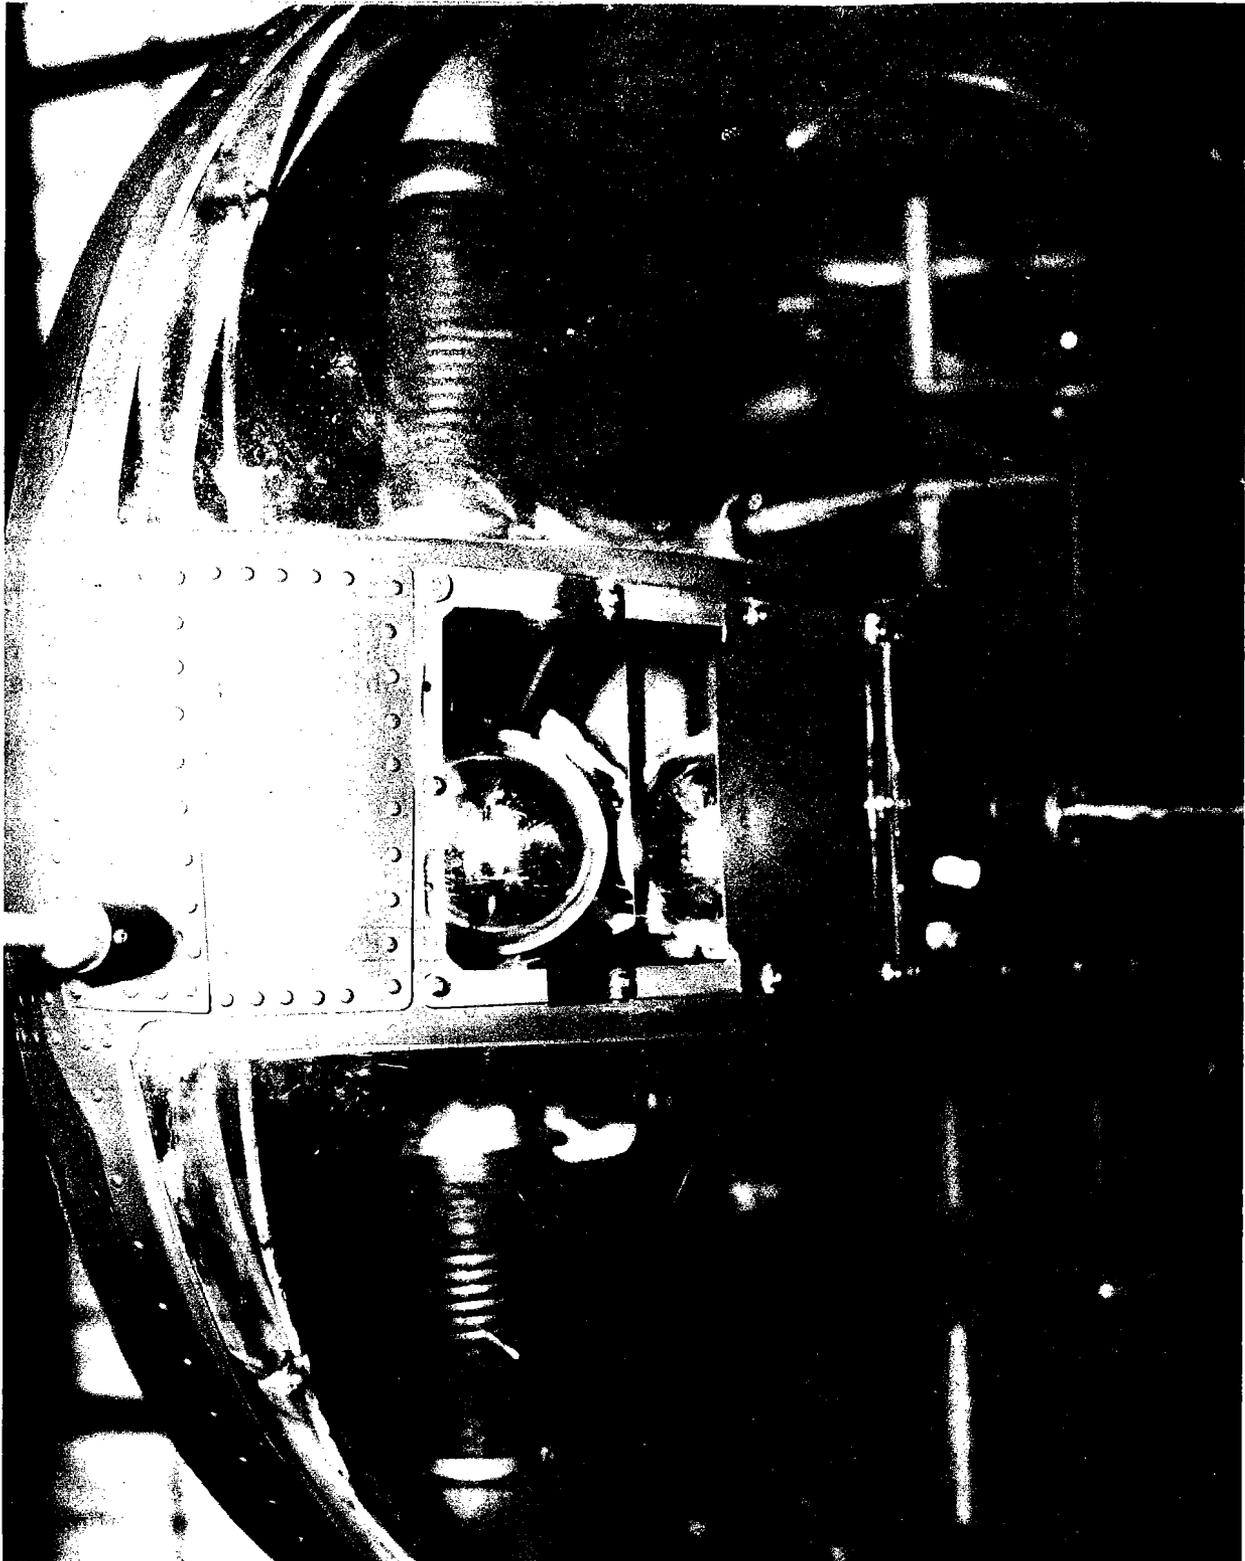
Solutions 1, 2, and 3 were all found to be very effective in reducing glare from the landing lights. The metal shield used in Solution 1, however, became so hot that it burned the protective plexiglass sheet covering the light well. Solution 2 involved a small amount of visibility loss. Solution 3 left a small streak of glare along the lower, outer edge of the ipsilateral windscreen and a large patch of glare in the center of the contralateral windscreen, i.e., the man in the left seat could see a small patch of glare along the lower, outer edge of the left windscreen and a larger glare patch in the center of the right windscreen. The situation was just the reverse for the man in the right seat. Figures 4 through 7 show the glare on the ipsilateral windscreen in the present configuration (no solution applied) and with Solutions 1, 2, and 3 applied. The white rectangles in the background are the runway markers and the windscreen glare is seen superimposed. Tables 1 through 4 show the photometric data for the present configuration and Solutions 1 through 3. It was concluded that if the overheating problem can be solved, Solution 1 together with the rewiring of the switch, is the preferred solution since it involves no visibility loss or additional material inside the cockpit. However, Solution 3 is a very good field-expedient "quick fix."

FIGURE 1. Solution 1 - Metal shield beneath the landing light.

shields beneath the landing lights (Solution 1) since this involved no visibility loss or extra material inside the cockpit. However, the overheating of the plexiglass sheet over the light well caused by these metal shields will have to be overcome before this solution is acceptable. It was also found that the tape over the inside one-half of each chinbubble is a very good field-expedient "quick fix."

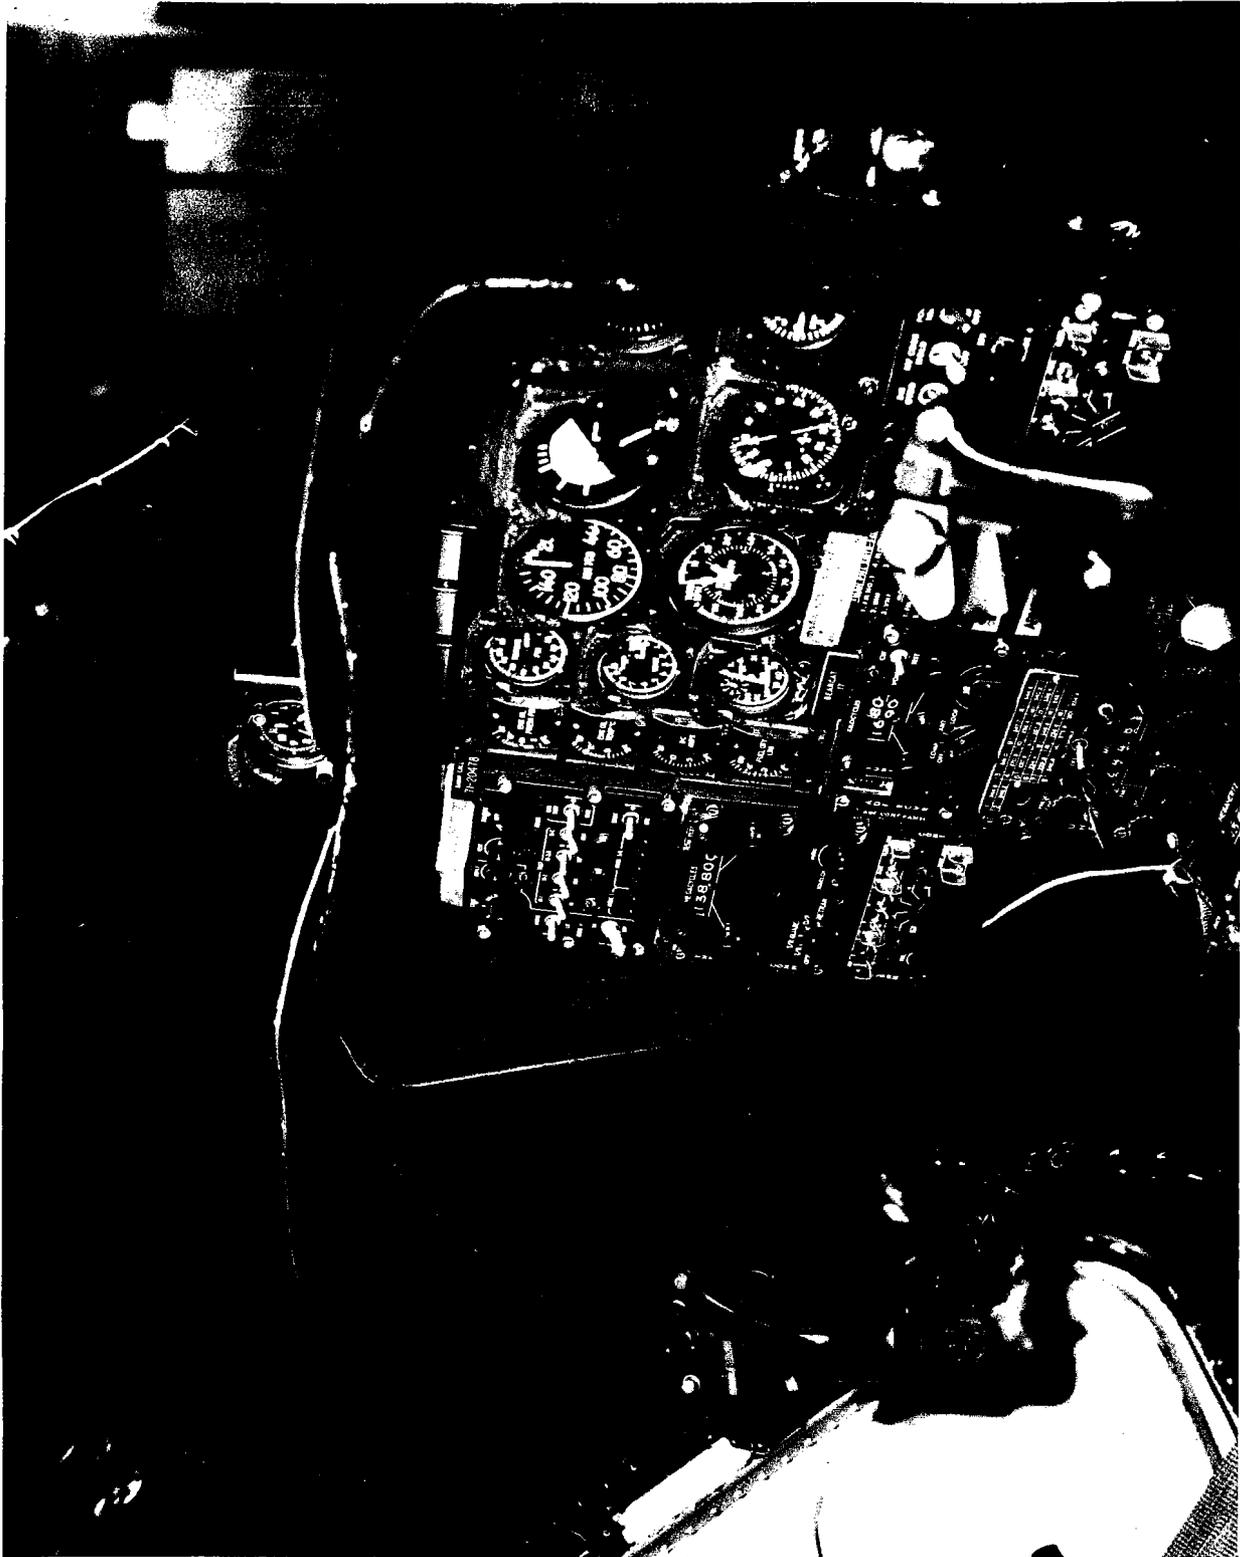
FIGURE 2. Solution 2 - Shields extending out laterally from the top of the instrument panel.

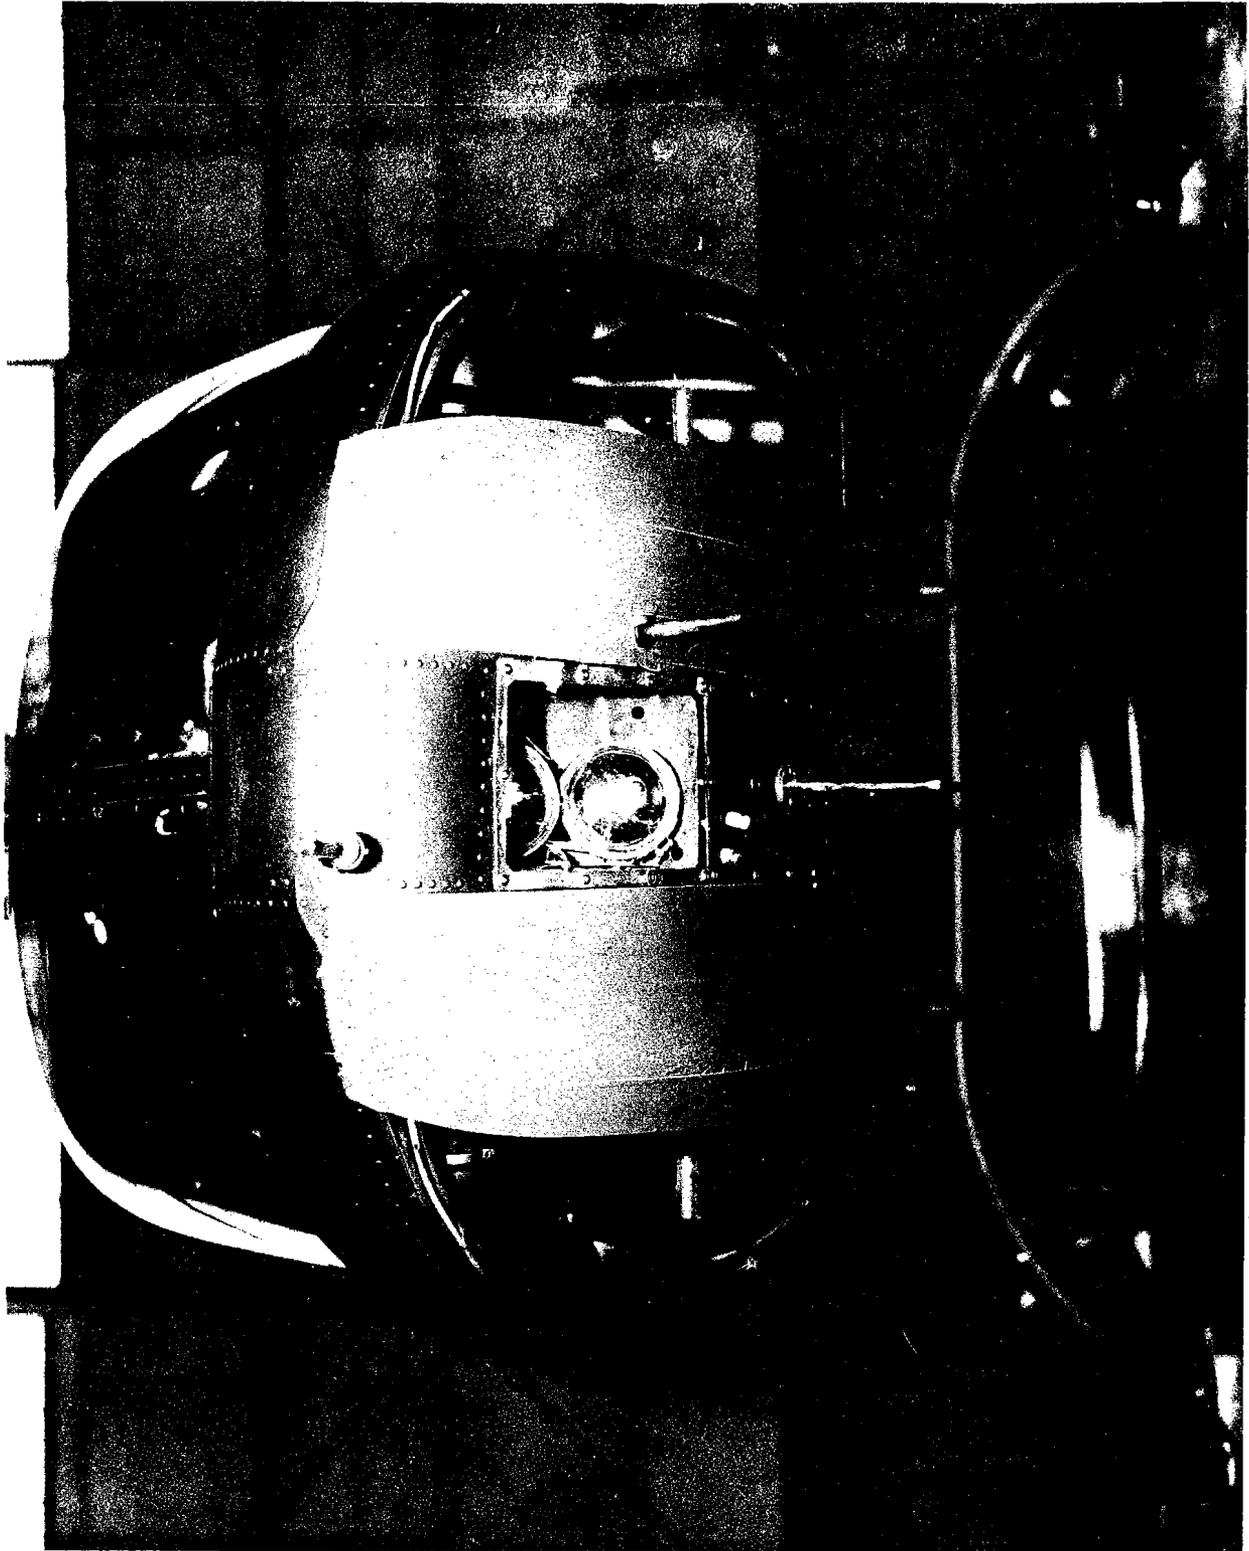
FIGURE 3. Solution 3. - Tape over the inside one-half of the chinbubble.
