USAARL REPORT NO. 77-7

AEROMEDICAL EVALUATION OF UH-1 INTERNAL ADVANCED PERSONNEL RESCUE HOISTS
WESTERN GEAR CORPORATION HOIST MODELS 42277R1 AND 42305R1
BREEZE CORPORATION HOIST ECP-720 MODIFICATION

February 1977

US Army Aeromedical Research Laboratory
Fort Rucker, Alabama 36362

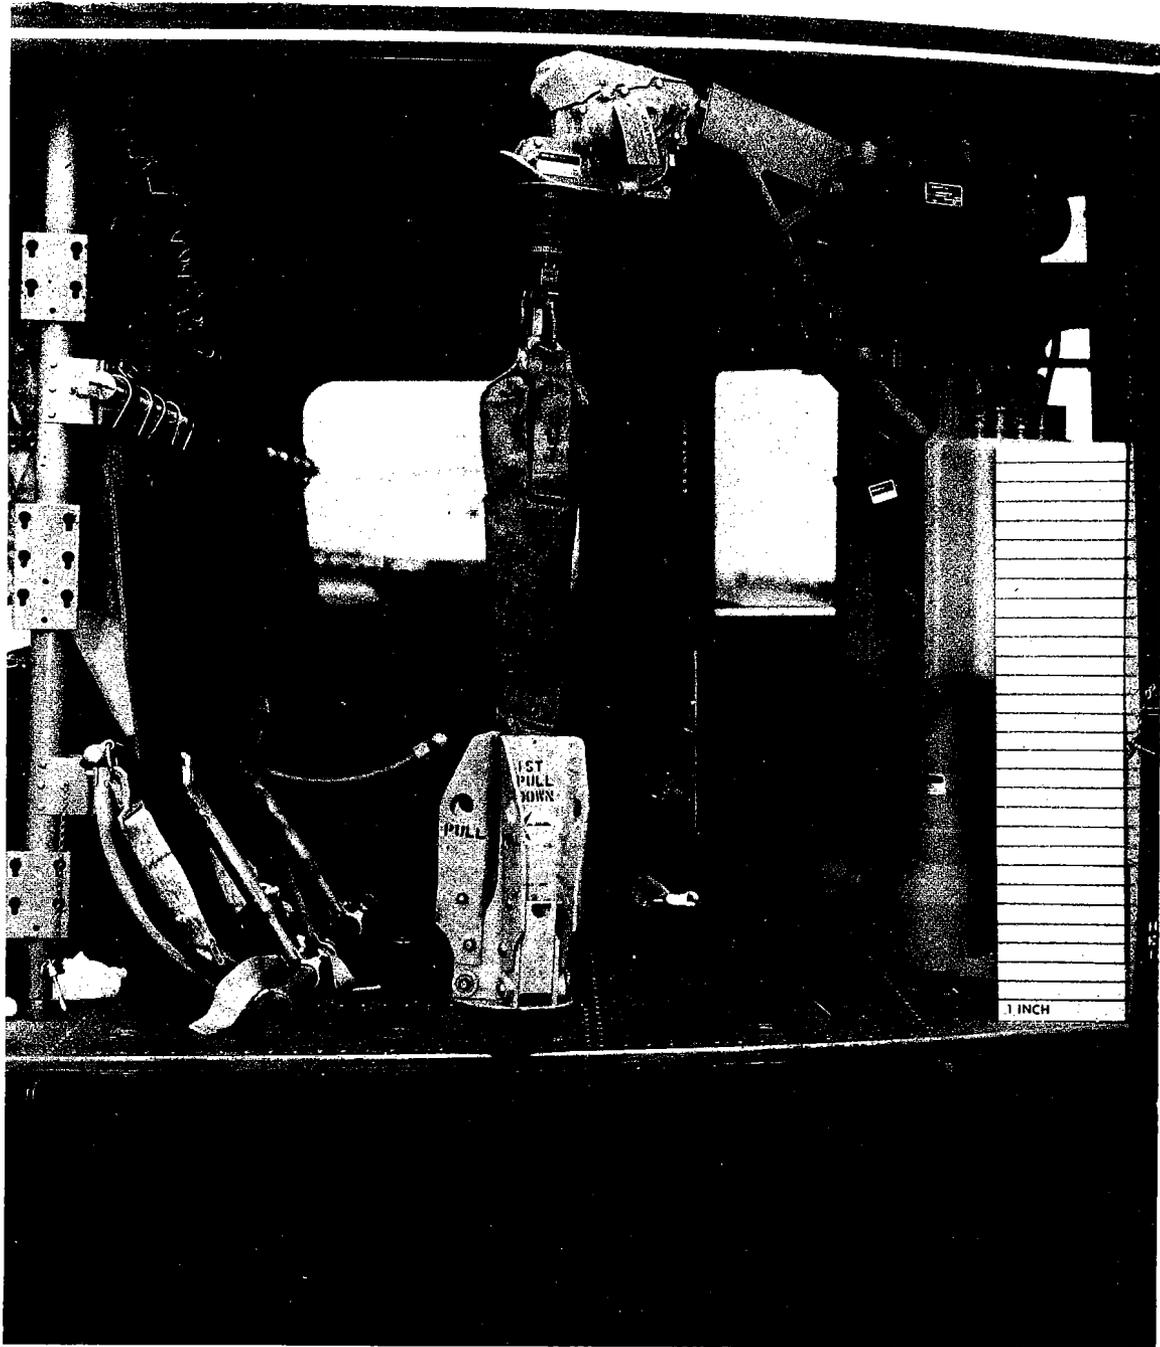
PHOTO A

Photographs A, C, E, and G illustrate the WGH hoist effect on entrance door and cabin space compared to the Breeze ECP-720 hoist photographs B, D, and F. Conservation of entrance door space, as well as absence of actuator base plate, is noted in photographs of WGH.

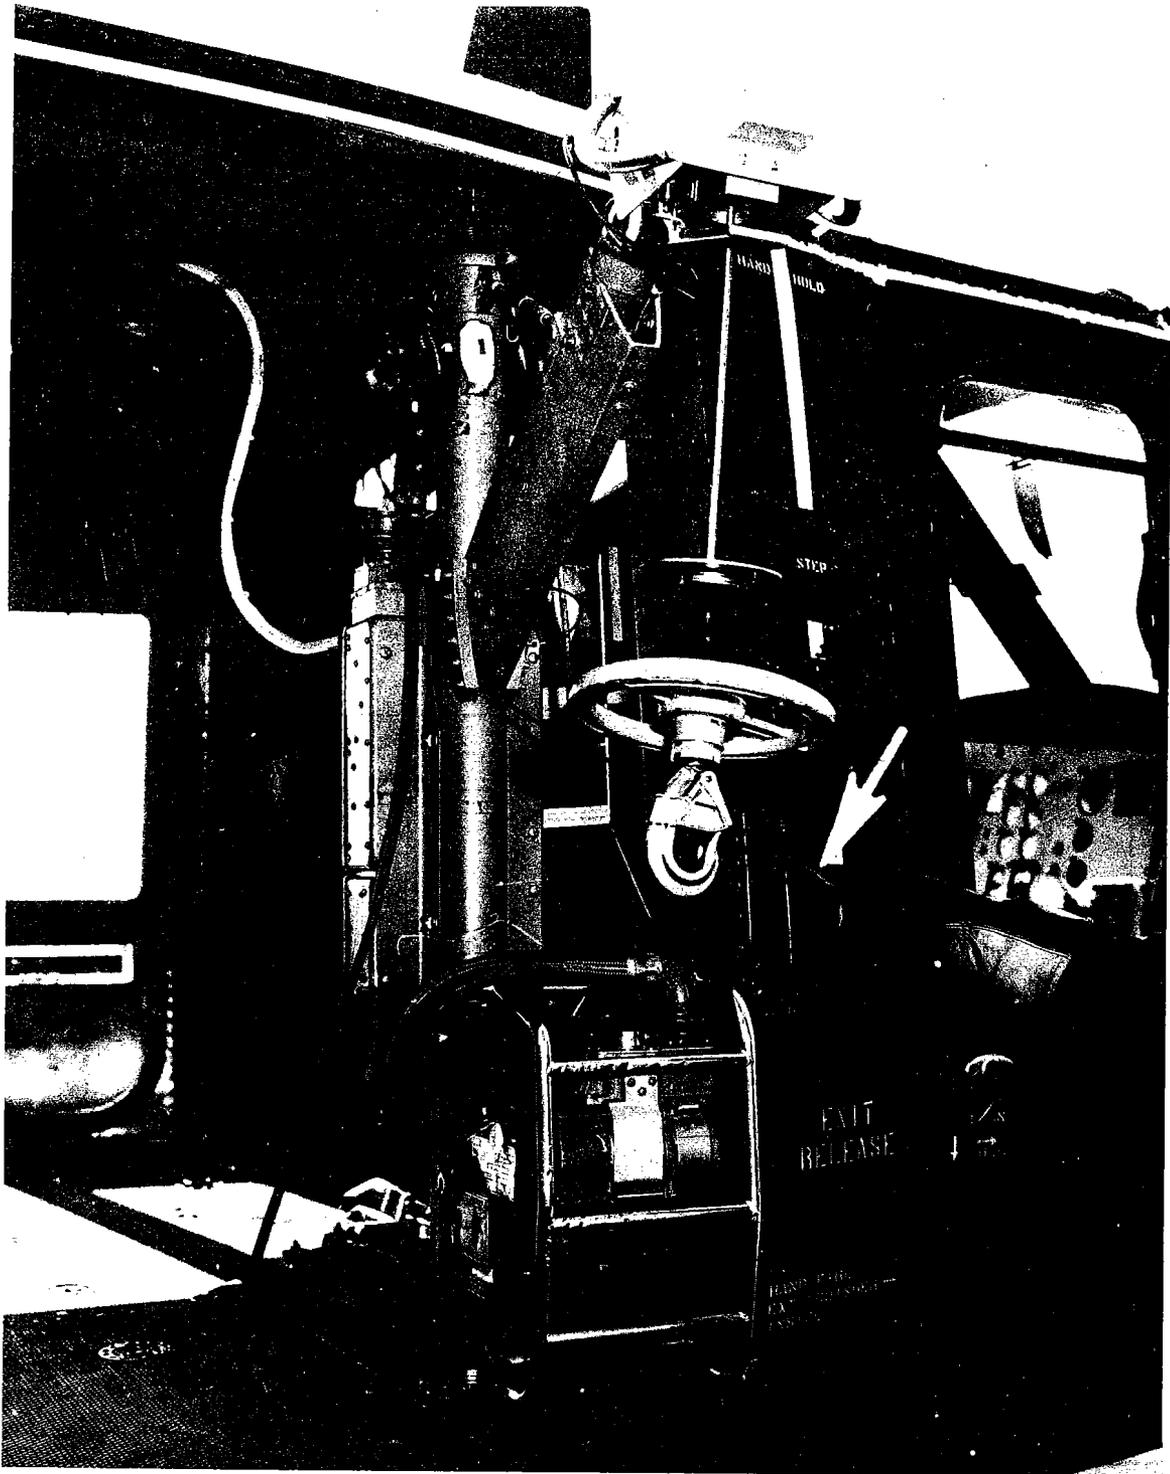
PHOTO I

d. The cable is exposed during the travel parallel to boom. This represents an area of potential damage and/or personnel hazard (Photograph I). Cable is also capable of being fouled on level wind (Photograph J).

1. The open cable travel along boom post continues to provide for inadvertent damage to cable and/or personnel injury. Additionally, any slack in cable or empty hook allows cable to become entangled.

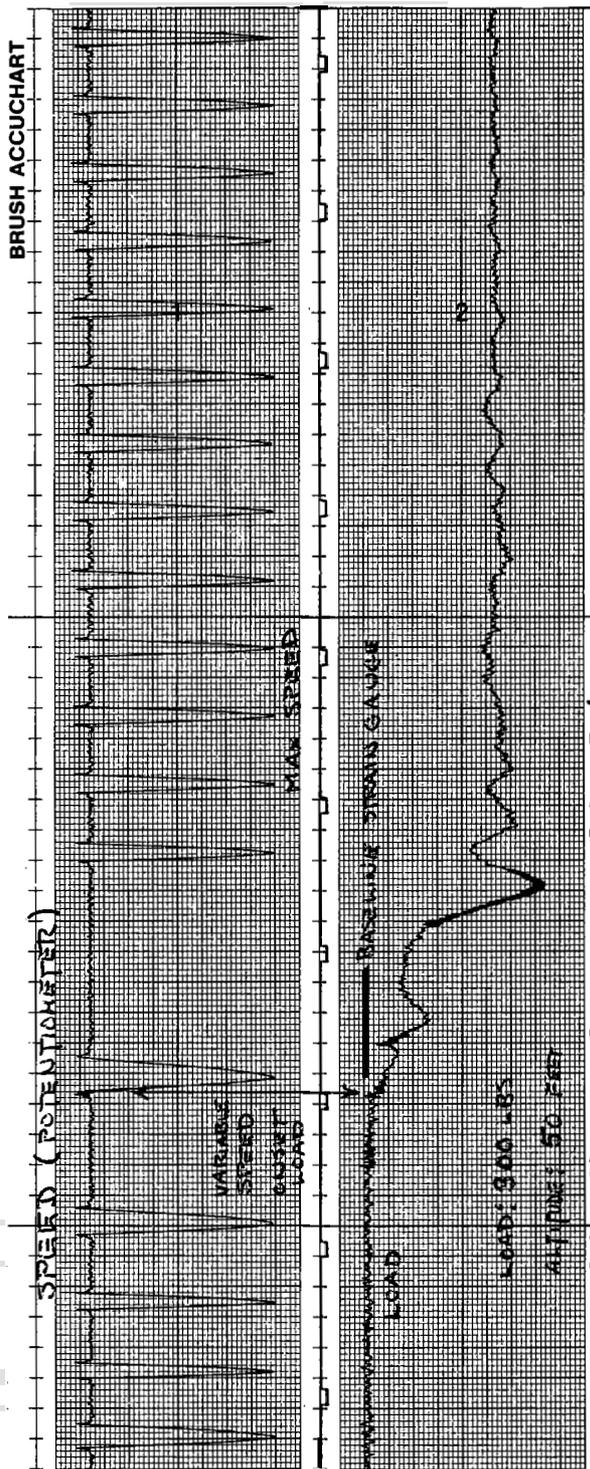
FIGURE 1.

Figures 1 and 2 illustrate data obtained for speed determination.
