USAARL REPORT NO. 84-1

**UH-60 SHOULDER HARNESS LEAD-IN
STRAP FAILURE ANALYSIS**

**By
Ted A. Hundley**

October 1983

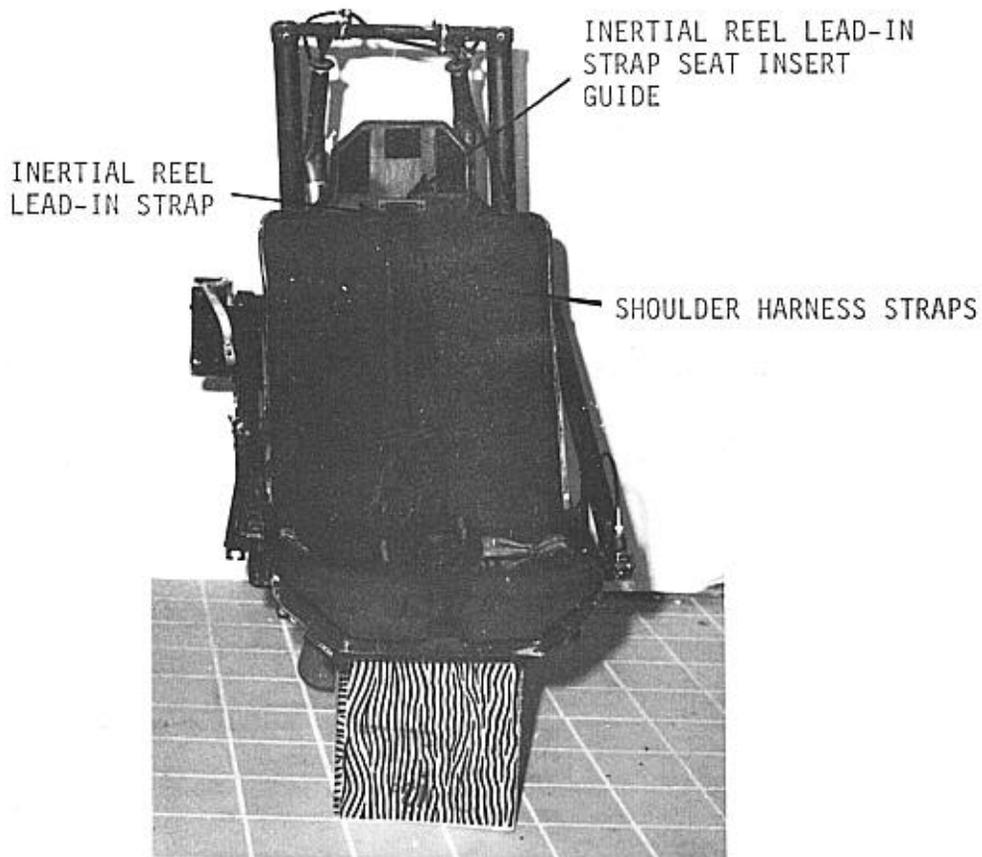
The U.S. Army's newest transport helicopter, the UH-60 Blackhawk, was designed to provide a significant amount of protection for aircraft occupants in case of a crash. However, in two separate crashes the shoulder harness lead-in strap on at least one of the pilot/copilot seats failed. In another crash, a failure of the lead-in strap occurred at the looped end where the shoulder harness straps attach (see Figure 1 for identification of items).

Figure 1. Location of Blackhawk Seat Restraint System Components.

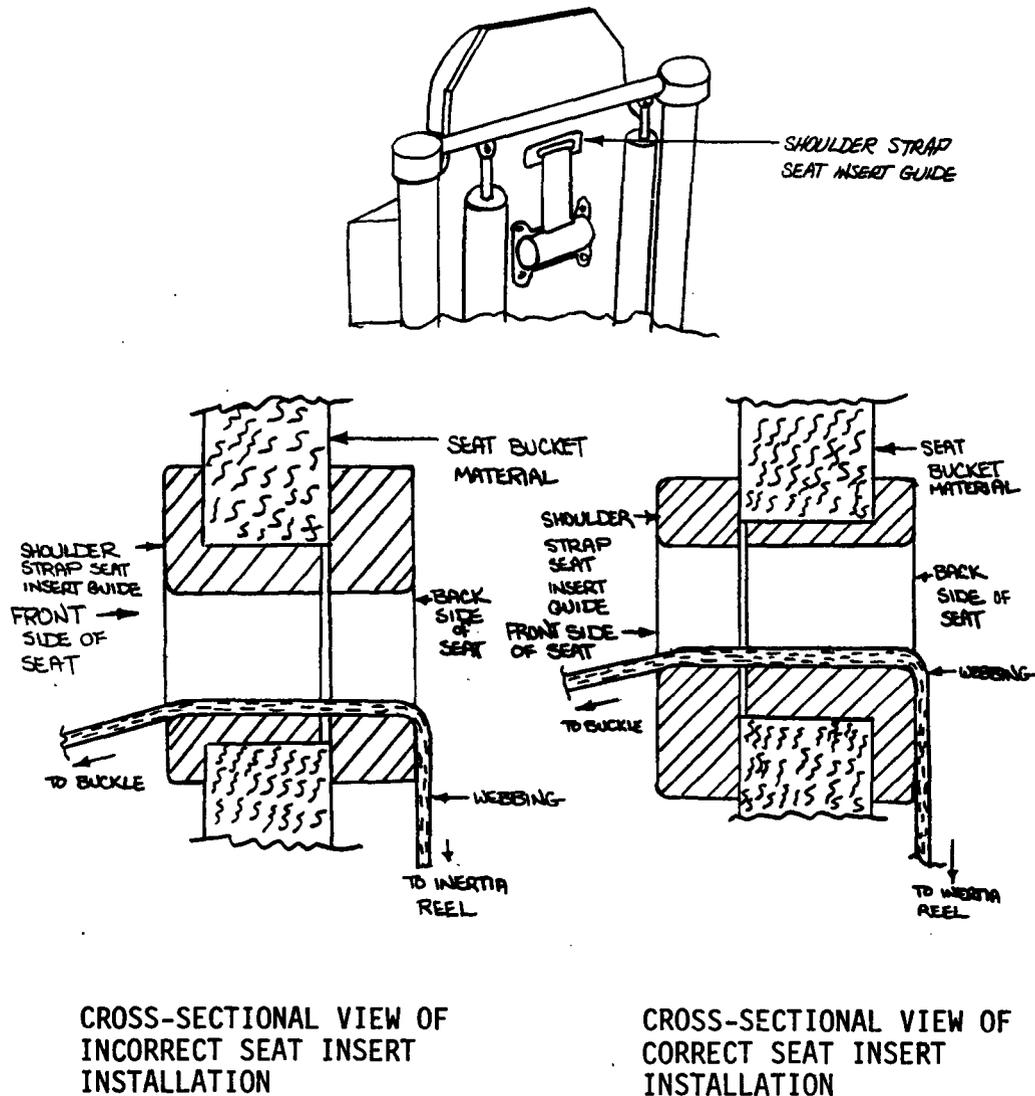
Two potential causes for the failures were identified. The first was improperly installed lead-in strap seat insert guides. In the first two lead-in strap failures, the insert guides were installed reversed and upside down (Figure 2). In this orientation, the lead-in strap loads deformed the lower rear half of the guide and exposed a sharp edge to the strap. This may have caused a stress concentration or may have cut the strap resulting in a failure at a lower-than-designed load. The guides have since been removed and reinstalled correctly.

Figure 2. Illustration of Correct and Incorrect Installation of Seat Insert Guide.

In all cases a significant reduction in tensile strength was shown when the webbing was forced to change directions by bending over the seat insert guide. The greatest reductions in failure loads were caused by the combined lateral-longitudinal loading and by the incorrect installation of the seat insert guide. The seat insert guide installation problem has been corrected, but the combined lateral-longitudinal loading problem remains as a potential threat.

The conclusion of this investigation is that the shoulder harness restraint systems failed at lower than expected loads because of the combination of the incorrect installation of the seat insert guide and the stress concentration caused by the bending of the webbing as it comes up the back of the seat and through the seat insert guide. As a result of the communication of the early findings of this author to the manufacturer, the incorrect installation of the seat insert guides has been corrected. Further research into the effect of bending radius on webbing stress concentration is, however, recommended.

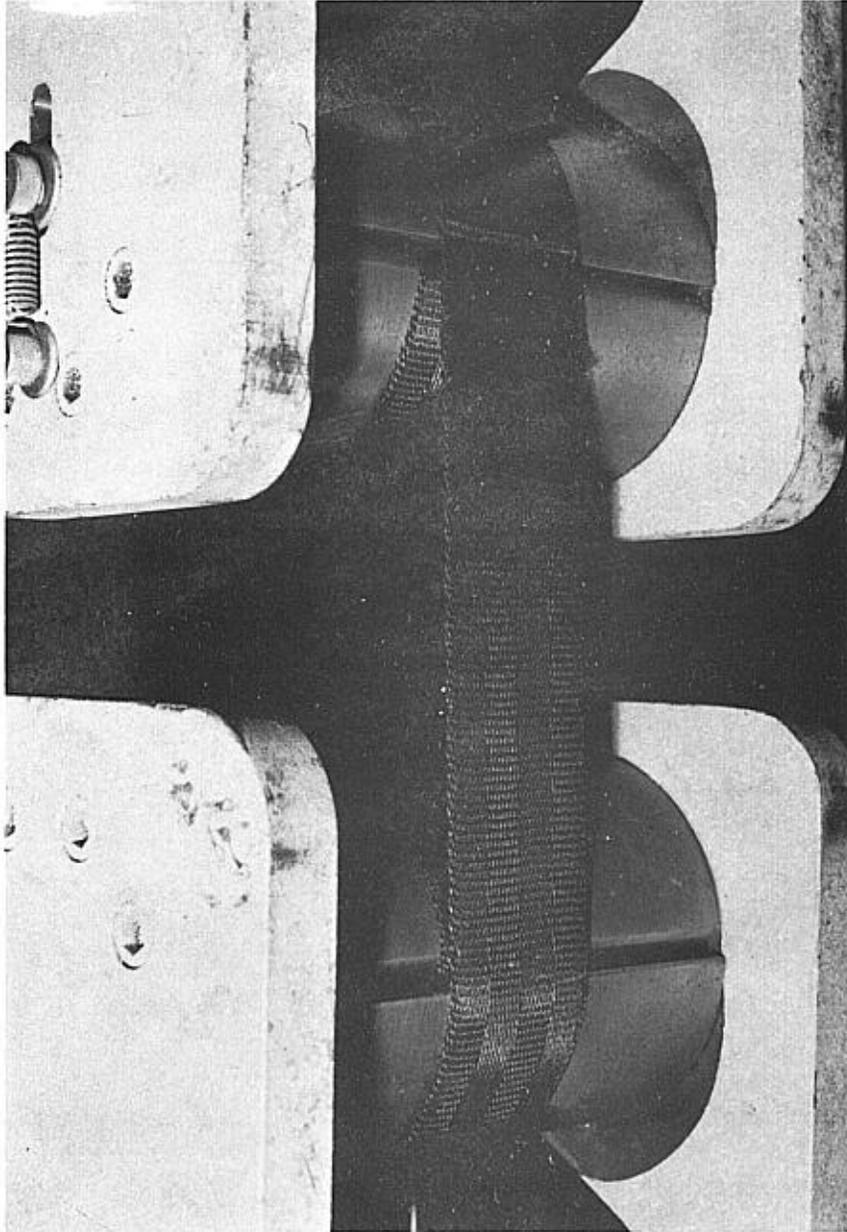
Figure 3. Webbing Test for Basic Tensile Strength Using Sedam Grips.

In the first series, the pure tension failure loads for the Murdock X-854 webbing were 6,740 pounds and 7,080 pounds, an average of 6,910 pounds. Loads were applied at the rate of 10 inches per minute. The failure loads for the longitudinal loading using a seat insert guide installed upside down and reversed were 3,320 pounds and 3,010 pounds, an average of 3,165 pounds. That is a 54 percent reduction in average breaking strength when compared to the pure tensile load test. The failure load for the one combined lateral-longitudinal loading test was 2,960 pounds, a 57 percent reduction in breaking relative to that of the pure tensile breaking strength.

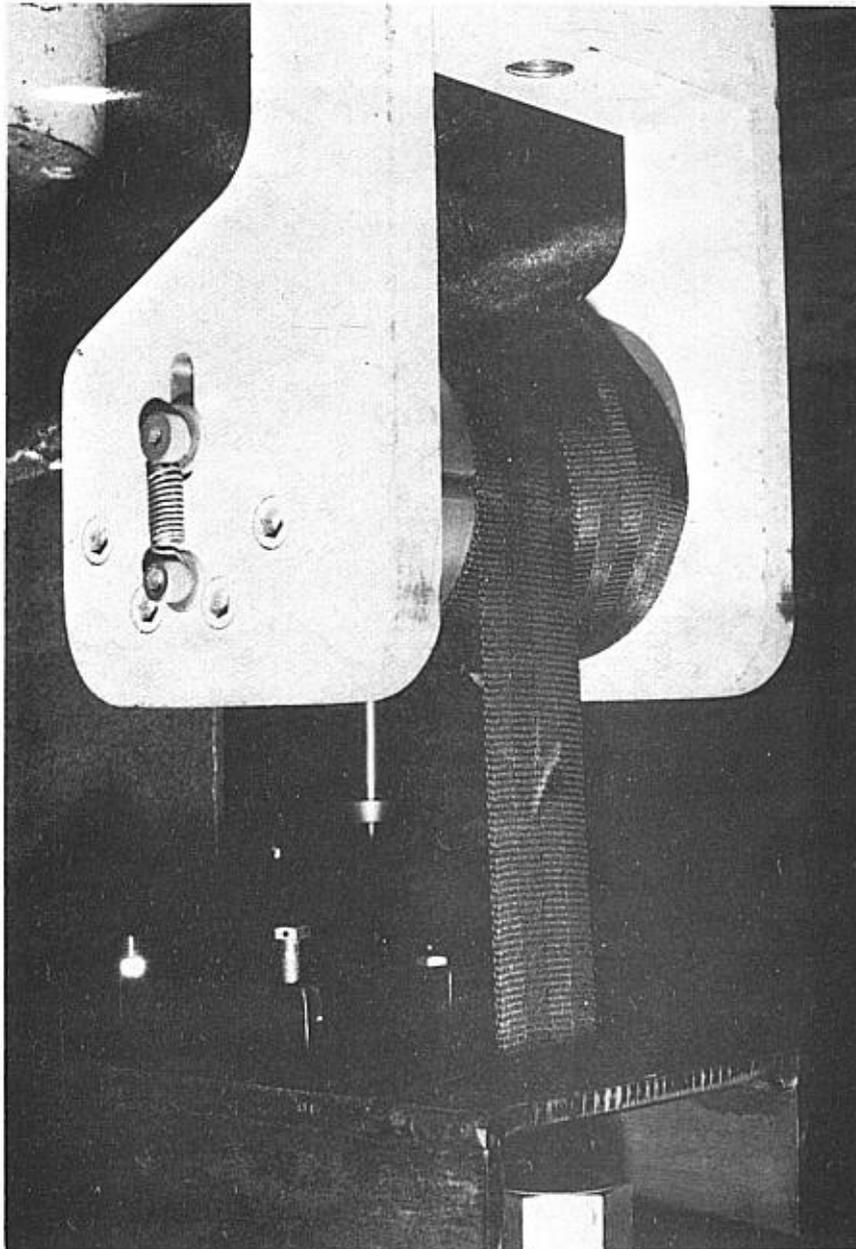
Figure 4. Test Fixture for Simulating Longitudinal Loading of Shoulder Harness Webbing Over Seat Insert Guide.

Sikorsky and Pacific Scientific notified USAARL of their findings. Sikorsky found the average failure load for Murdock X-854 webbing in pure tension was 6,540 pounds. Pacific Scientific found the average failure load was 6,613 pounds. When pulled through a correctly-installed seat insert guide in a longitudinal loading condition, Sikorsky found that the average failure load for Murdock X-854 webbing was 4,733 pounds while Pacific Scientific tests resulted in an average failure load of 4,883 pounds. The percentage reduction in breaking strength using the correctly-installed seat insert guide was 27.6 percent in Sikorsky's test and 26.2 percent in Pacific Scientific's test.

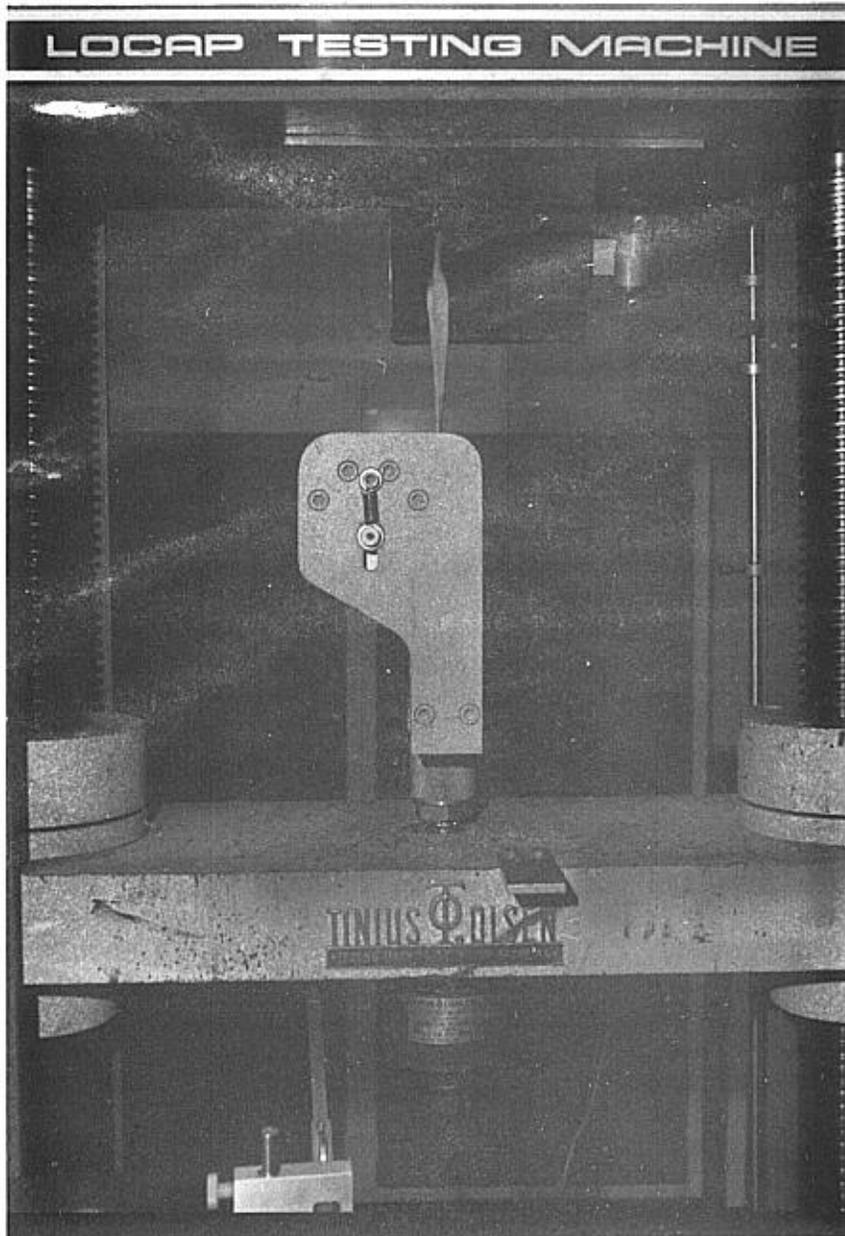
Figure 5. Test Fixture for Simulating Combined Lateral-Longitudinal Loading of Shoulder Harness Webbing Over Seat Insert Guide.

The other potential cause for failure is the stress concentration caused by the ninety-degree bend in the lead-in strap as it comes up the back of the seat from the inertia reel and goes through the seat insert guide to the seat occupant. The stress concentration is compounded by side loads which cause the webbing to bunch up at the side of the insert guide. In order to determine the failure loads for various combinations of strap material and loading geometry, independent test programs were conducted at Pacific Scientific Company, Anaheim, CA; Sikorsky Aircraft, Inc., Stratford, CT; and at the U.S. Army Aeromedical Research Laboratory (USAARL), Fort Rucker, AL.

The second test series utilized webbing samples obtained from Pacific Scientific. Basic tensile strength tests were done on the MIL-W-25361 Type III and the Murdock X-854 webbing, but not on the Murdock Q-921 webbing due to the limited quantity available. The basic tensile failure loads for the Type III webbing were 8,000 pounds, 8,200 pounds, and 8,300 pounds, an average of 8,167 pounds. The Murdock X-854 basic tensile failure loads were 6,900 pounds, 6,880 pounds, and 7,080 pounds, an average of 6,953 pounds. All the other tests in this series used the combined lateral-longitudinal test fixture. All testing was done at a rate of 10 inches per minute. Three tests were run for each webbing type. The results are shown in Table 1.

For the interim, the decision by the manufacturer to replace the Murdock X-854 with the higher-strength Q-921 webbing may be an adequate solution. The design load of 4,000 pounds for the shoulder harness initially was given a 50 percent safety factor and is satisfied through the use of 6,000 pound class webbing. In light of the findings to date, a safety factor of 100 percent would appear more reasonable. This can be attained by using 8,000 pound tensile strength webbing.

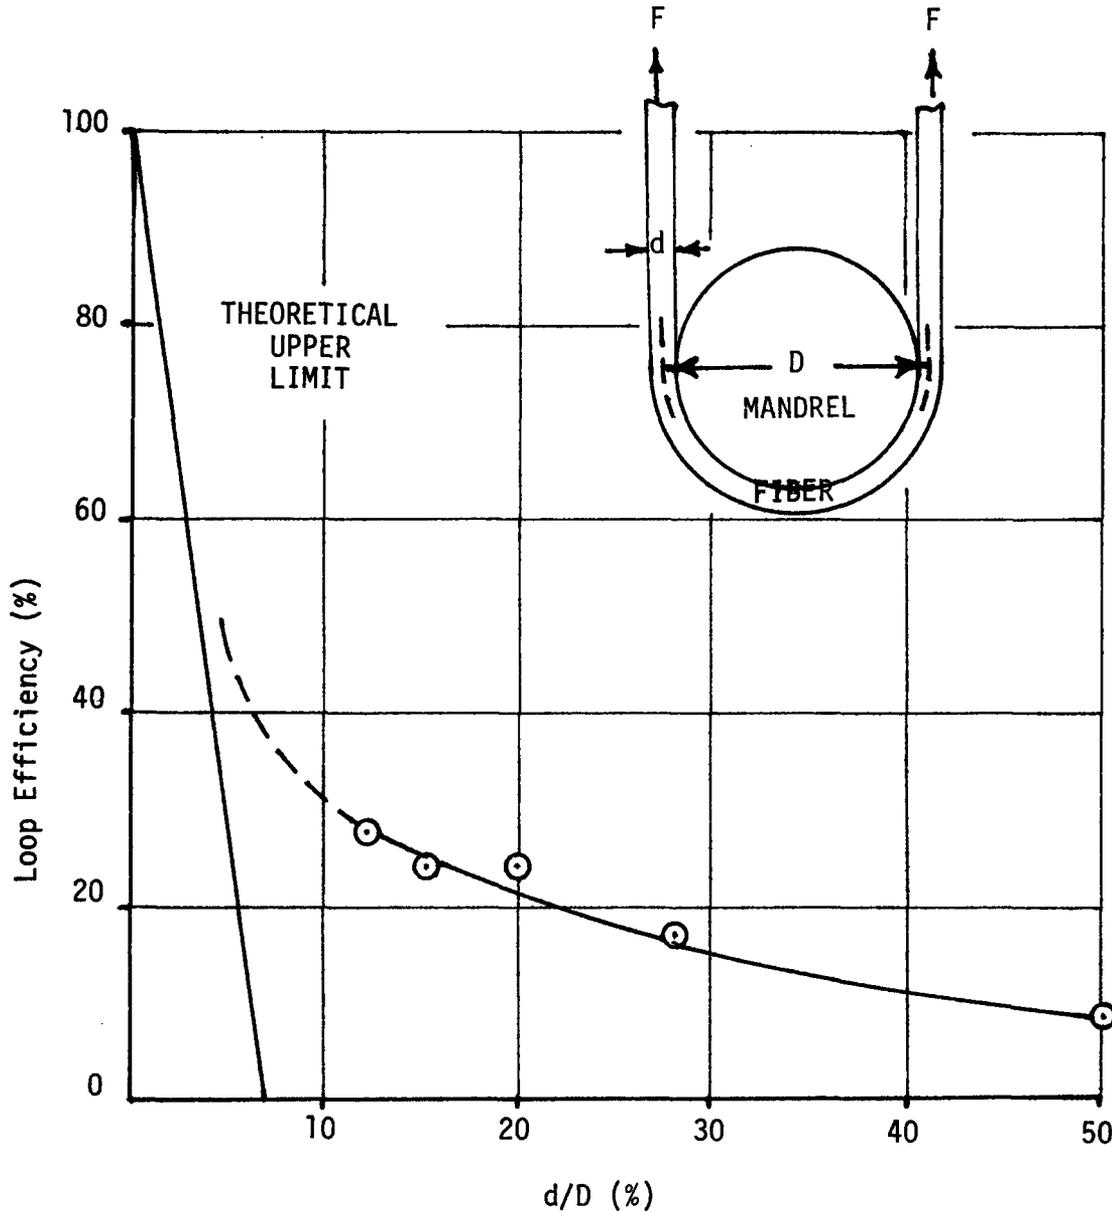
An article found in the *Textile Research Journal* (Schoppee and Skelton, 1974) dealt with the effect of bend radius on the tensile failure strength of individual fibers. Although the article's authors' findings cannot be directly applied to woven webbing, the results found for individual fibers may suggest a trend that also will be found in woven webbing. In particular, they presented a curve showing that high tenacity polyester fiber, which is the material used in the restraint harness webbings addressed herein, is sensitive to the radius of curvature around which it is bent. Their data (Figure 6)

show that the breaking strength of the fiber is reduced by approximately 30 percent when pulled around a cylinder with a diameter no more than 10 times the diameter of the fiber. As the diameter of the cylinder gets smaller, the breaking strength of the fiber continues to decrease. When the ratio of the diameter of the fiber to the diameter of the cylinder approaches 1/20 (i.e., 5 percent), the breaking strength is reduced by 50 percent.

Figure 6. Single Fiber Loop Efficiency for High Tenacity Polyester Fiber (Figure redrawn from Bending limits of some high-modulus fibers, *Textile Research Journal*, Vol. 44, No. 12, Dec 1974, p. 972).
