USAARL Report No. 95-10

**OH-58 Pilot Display Unit (PDU)
Simulated Crash Tests**

December 1994

**United States Army Aeromedical Research Laboratory
Fort Rucker, Alabama 36362-0577**

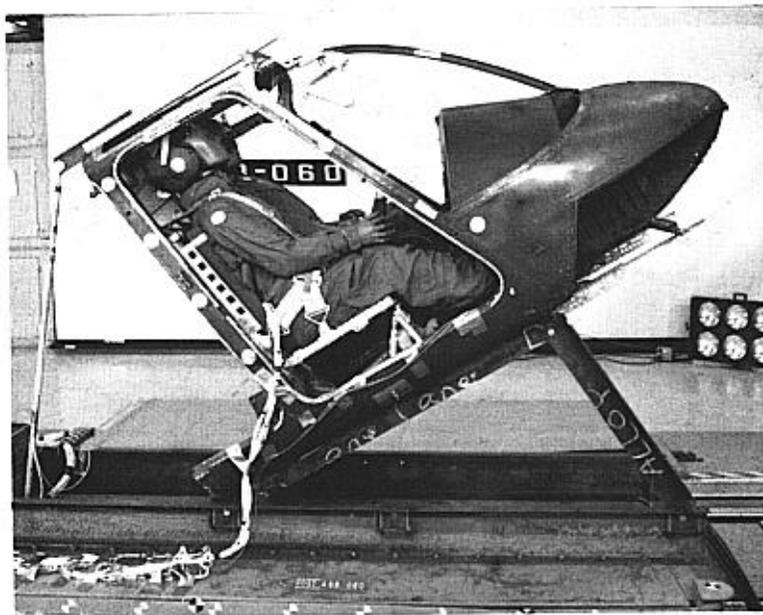
Posttest photos of test 88060 in Figures 4 through 9 show: (a) rotation of helmet rearward on right dummy, but not the left dummy, even though both have equal size 50th percentile heads; the difference may be due to the lack of neck flesh on the Hybrid II (50th percentile) dummy; and (b) the left seat crashworthy seat pan sustained enough downward force from the dummy's buttocks to move the pan down 0.6 inch, and to move the right seat down by 0.3 inch. This was a surprise since the impact vector was 15 G forward, and the seat pans stroke at 12 G vertical. The right seat pan was secured with steel straps to prevent movement in subsequent tests.

Figure 5. Posttest view of no. 88060; note the rearward rotation of helmet after rebound.

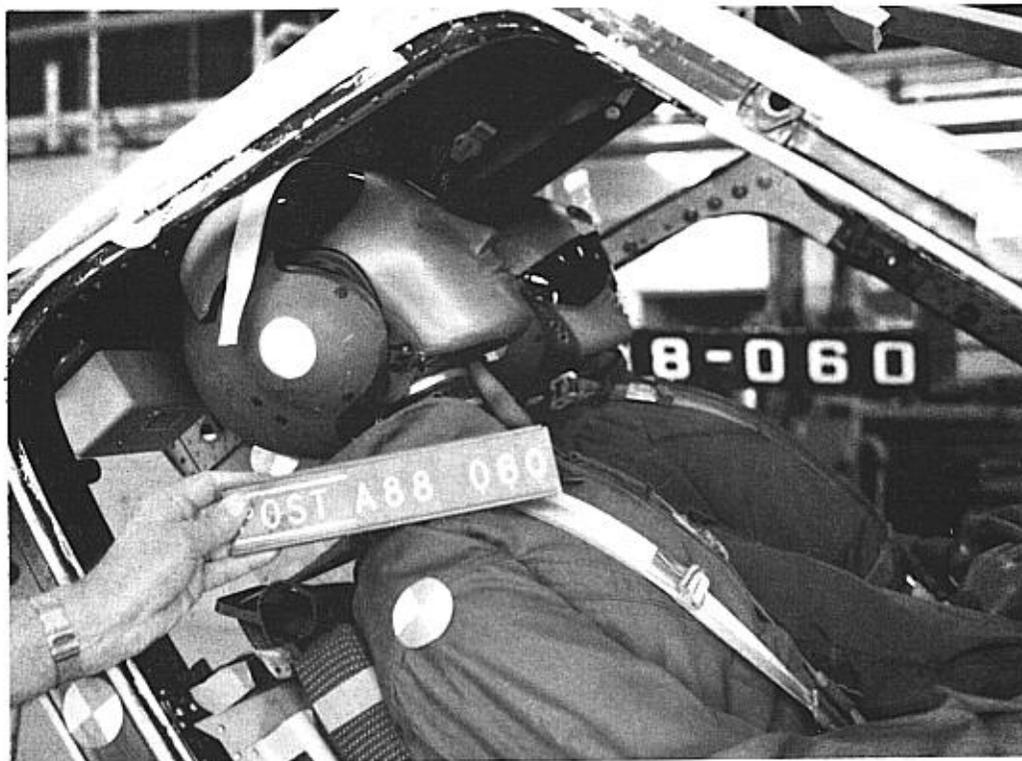
Figure 6. Posttest view of 50th percentile dummy; note helmet rotated until stopped by nape strap.

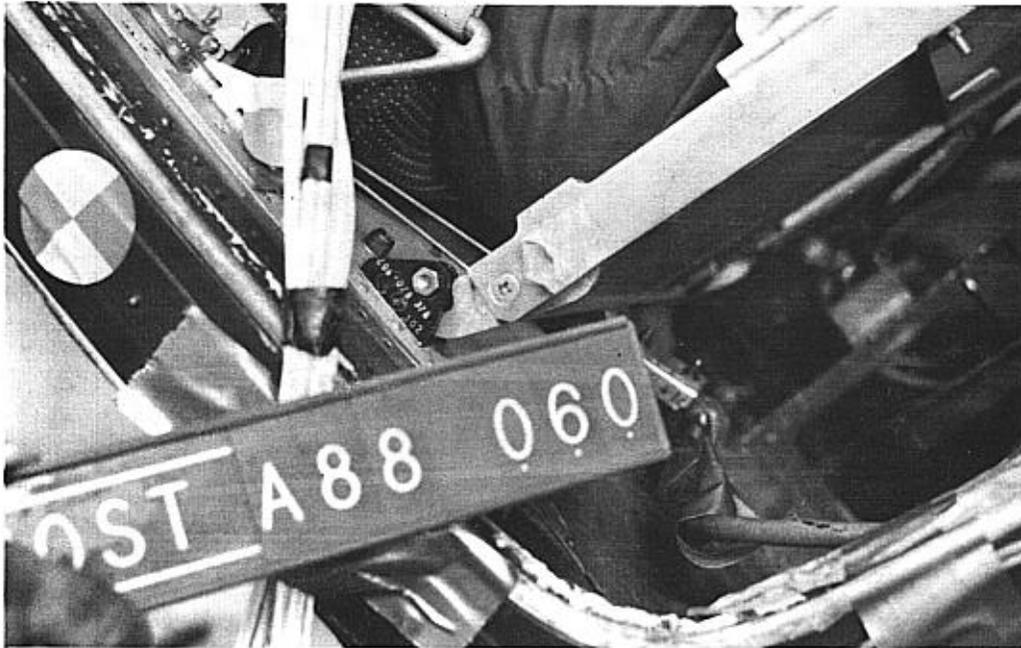
Figure 8. Seat pan downward displacement of 0.3 inch shown between latch and bulkhead support, right side.

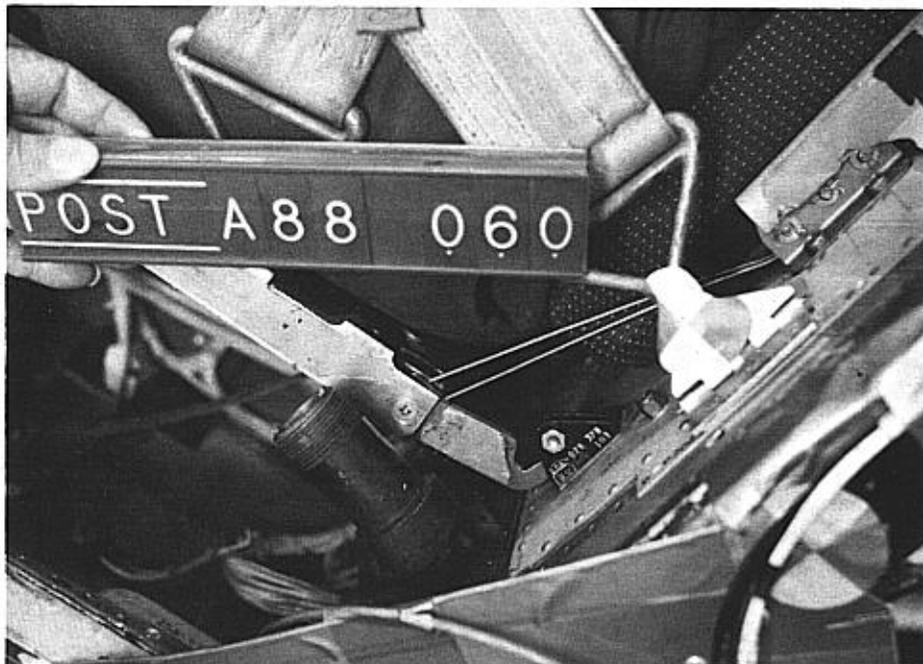
Figure 9. Seat pan downward displacement of 0.6 inch shown between latch and bulkhead support, left side.

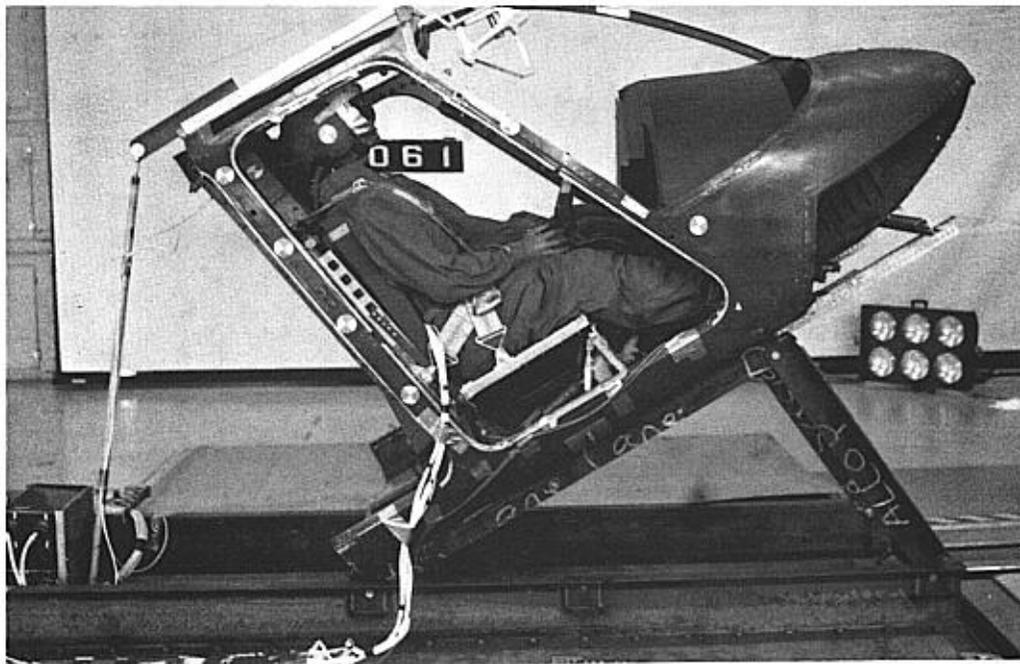
Figure 11. Posttest view of CAMI 88061; note that helmet has not rotated due to tape under chin.

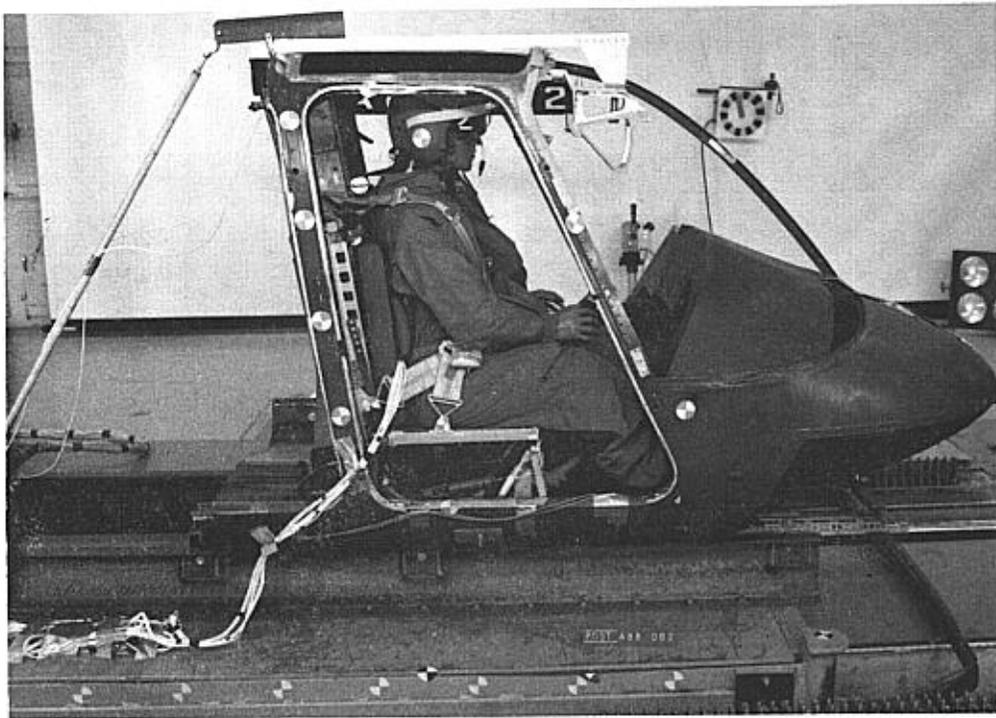
Figure 14. Posttest view of no. 88062; note rebound position of sled about 1 foot from displaced $\frac{1}{4}$ -inch diameter cable.

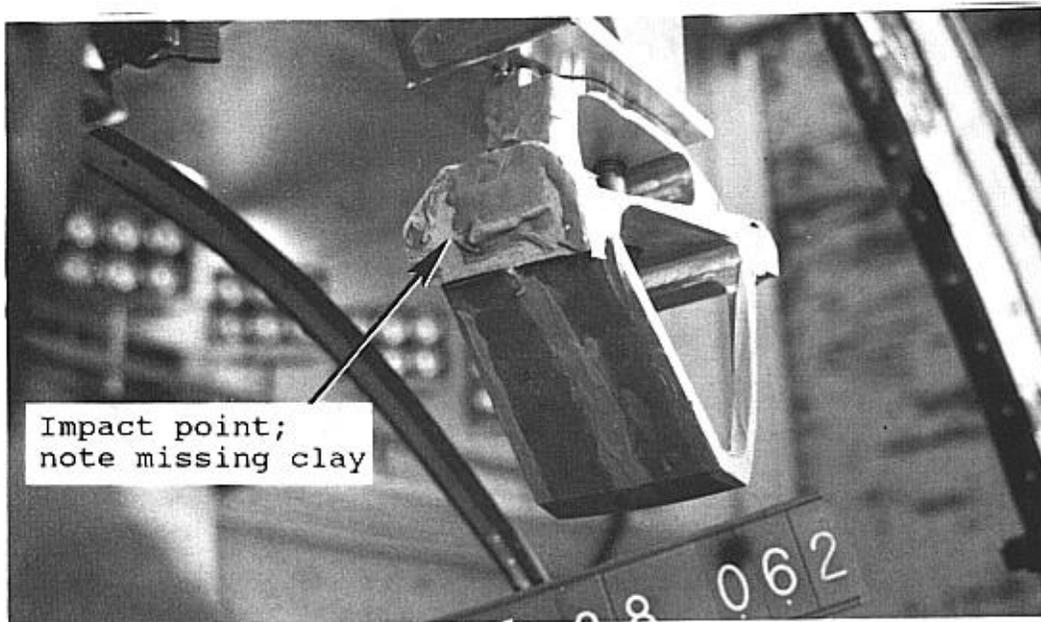
The helmet was replaced after this test due to permanent foam compressive "set" of about 0.05 inch over an area of about 1 square inch in the lower front edge of the foam liner. The foam replacement is required to obtain the full energy-absorbing benefit of the foam liner if impacted again at the same location. The impact location onto the PDU is shown in Figure 15.

Figure 15. Posttest view of no. 88062; note missing clay which was found on helmet of right dummy.

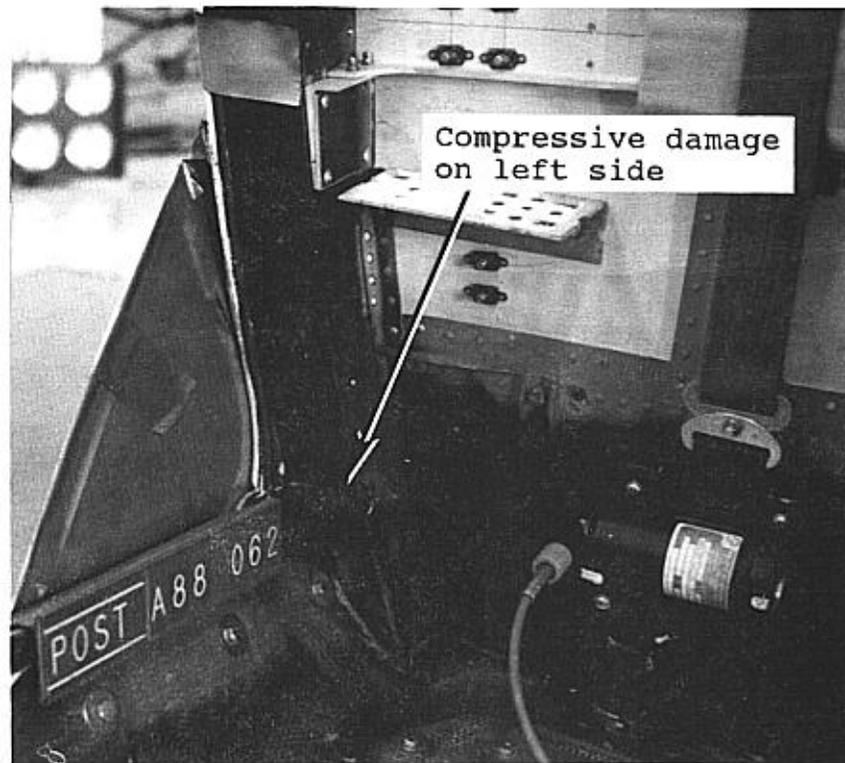
The fuselage station (FS) 73.04 bulkhead was damaged by skin crippling/buckling at the lower outboard edges and at the control "closet" box structure as shown in Figures 16-18. The bulkhead was reinforced prior to the final tests.

Figure 16. Posttest of no. 88062; note buckled "box" section of fuselage station 73.04 bulkhead.

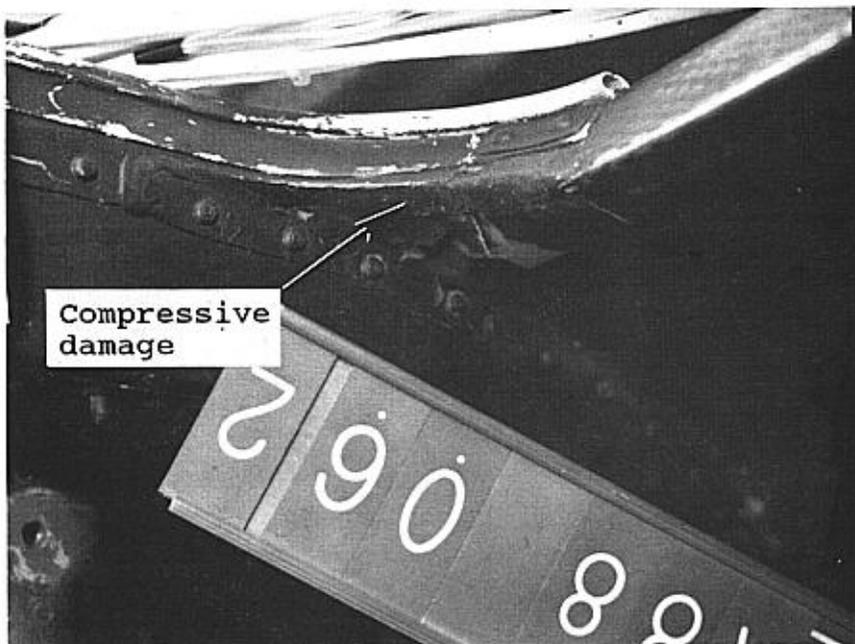
Figure 17. Posttest view of no. 88062; note buckled skin adjacent to "box" section of fuselage station 73.04 bulkhead.

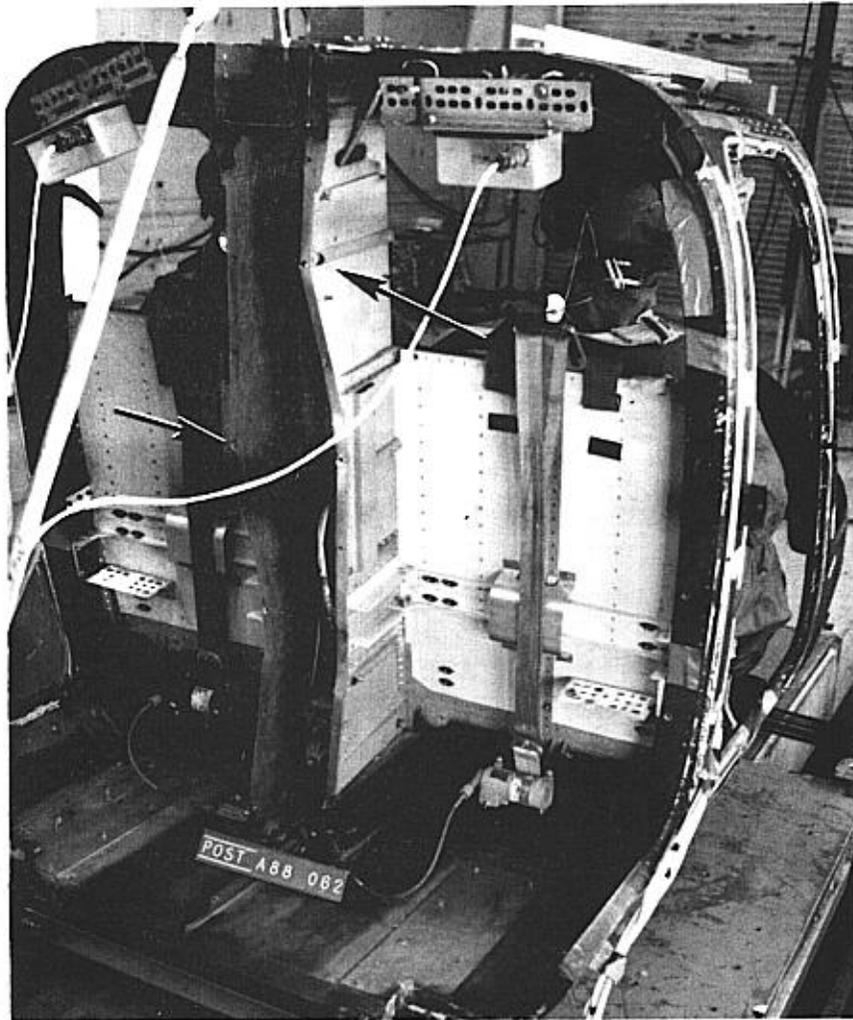
Figure 18. Posttest view of fuselage station 73.04 bulkhead; note buckles in control closet structure by arrows.

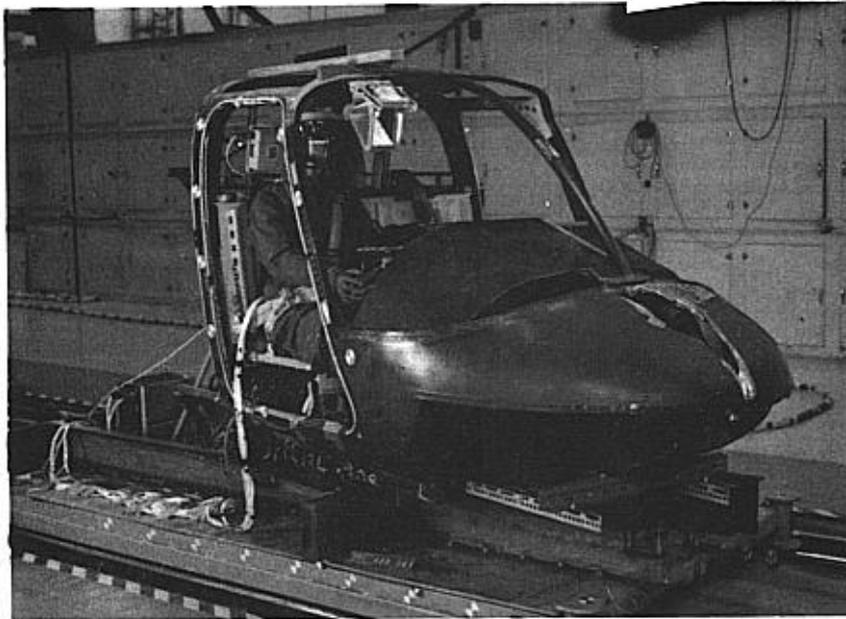
Figure 19. **Pretest view of no. 88063; note 15-degree right yaw orientation, and prior damage to nose structure.**

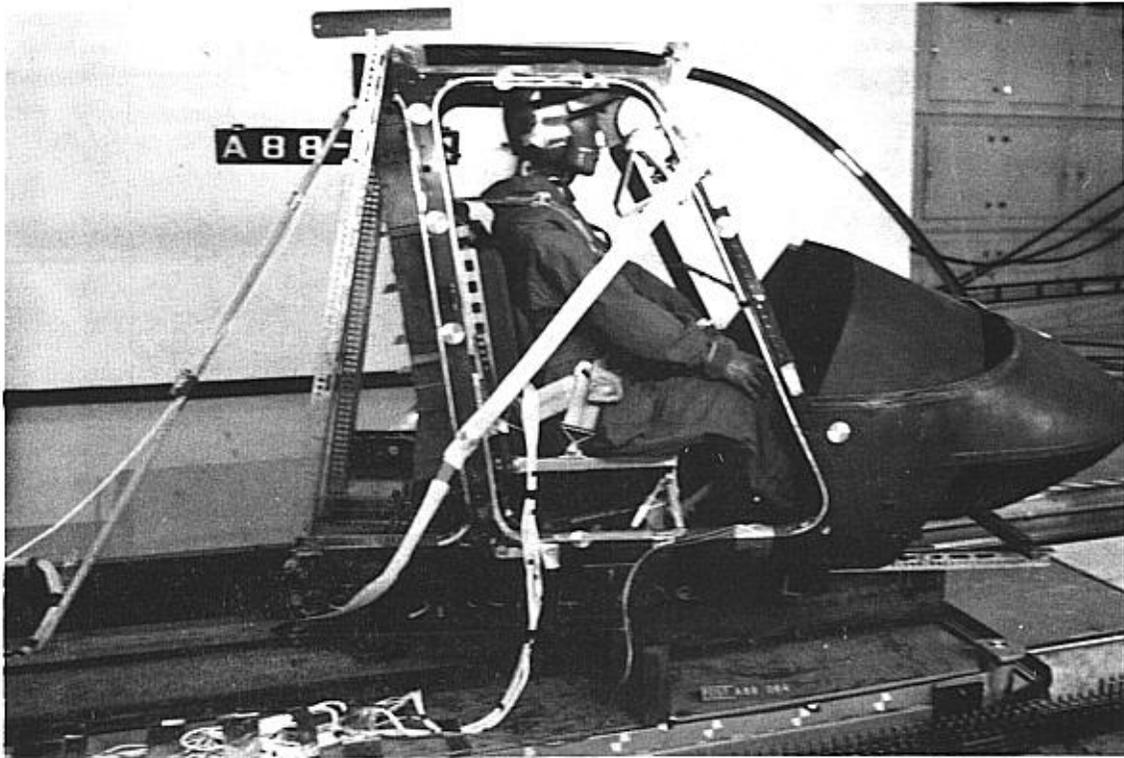
Figure 23. Posttest view of no. 88064; note limp, stretched aluminum diagonal strap, and PDU mount detachment.

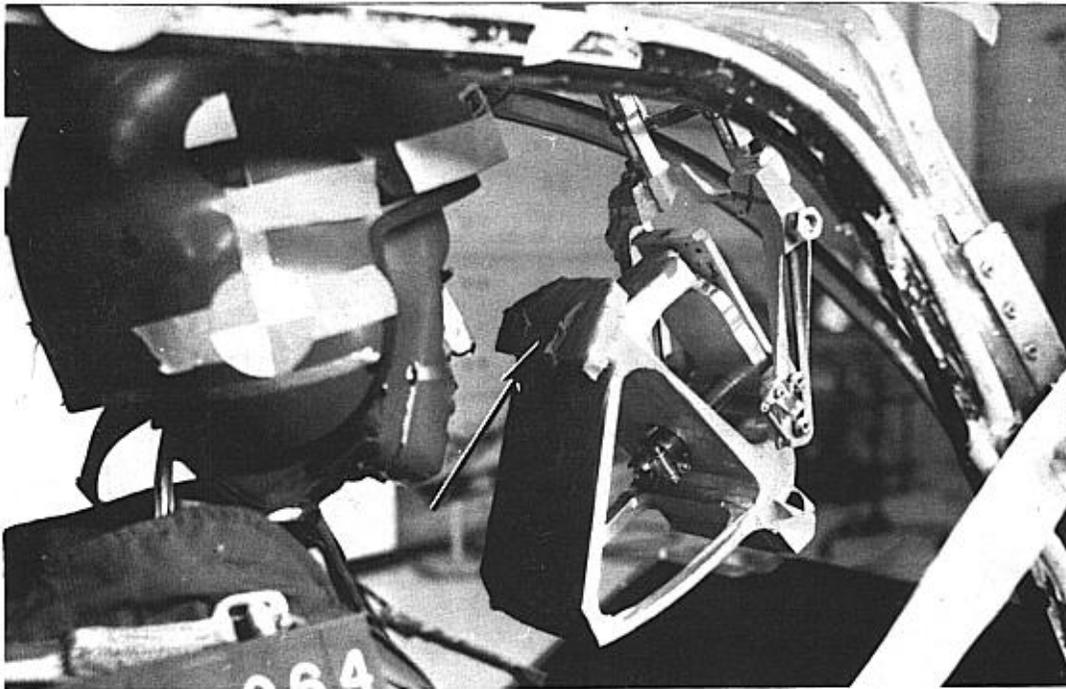
**PDU mount at windshield frame failed partially during rebound, see Fig 24.

Helmet to PDU impact occurred; Figure 31 shows the impact from film analysis. The impact appeared to be severe based on film review since the PDU mount failed at its leading edge rivet attachment to the windshield overhead frame, as depicted in Figures 23, 24, and 26. The impact cracked the helmet visor cover at its center low edge, as shown in Figure 25. The PDU foam also was cracked and the visor cover released the visor knob and visor.

Figure 24. Posttest view of no. 88064; note detached PDU "breakaway" mount and cracked foam at back edge of PDU.

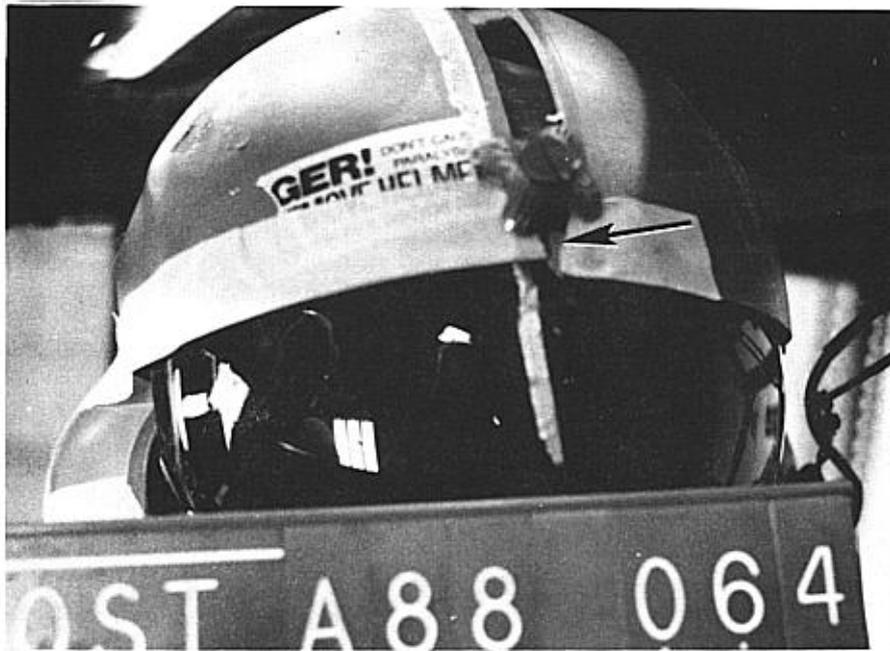
Figure 25. Posttest view of no. 88064; arrow denotes cracked helmet visor cover.

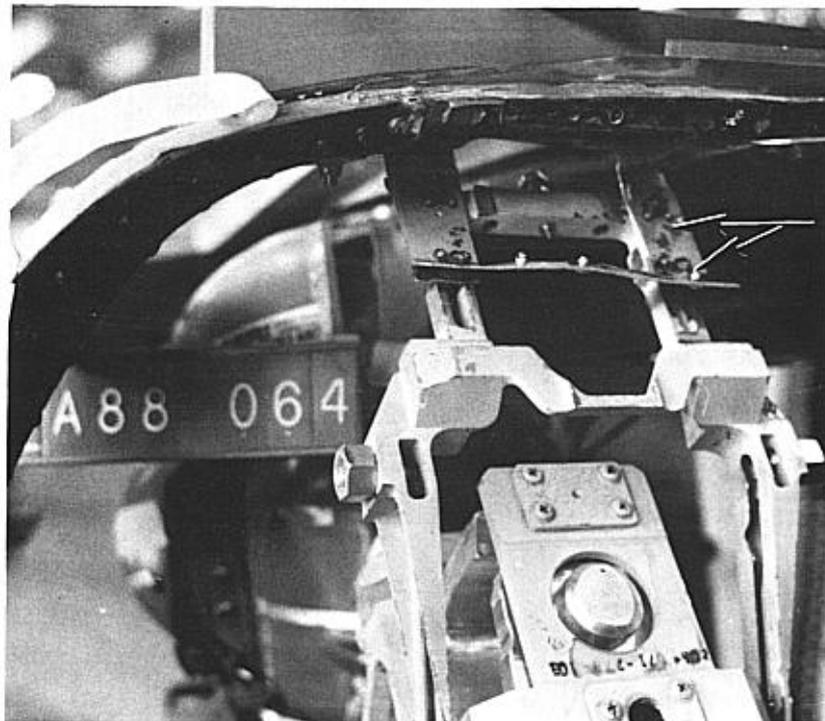
Figure 26. Posttest view of no. 88064; arrow denotes failed rivets which help to secure the PDU breakaway mount.

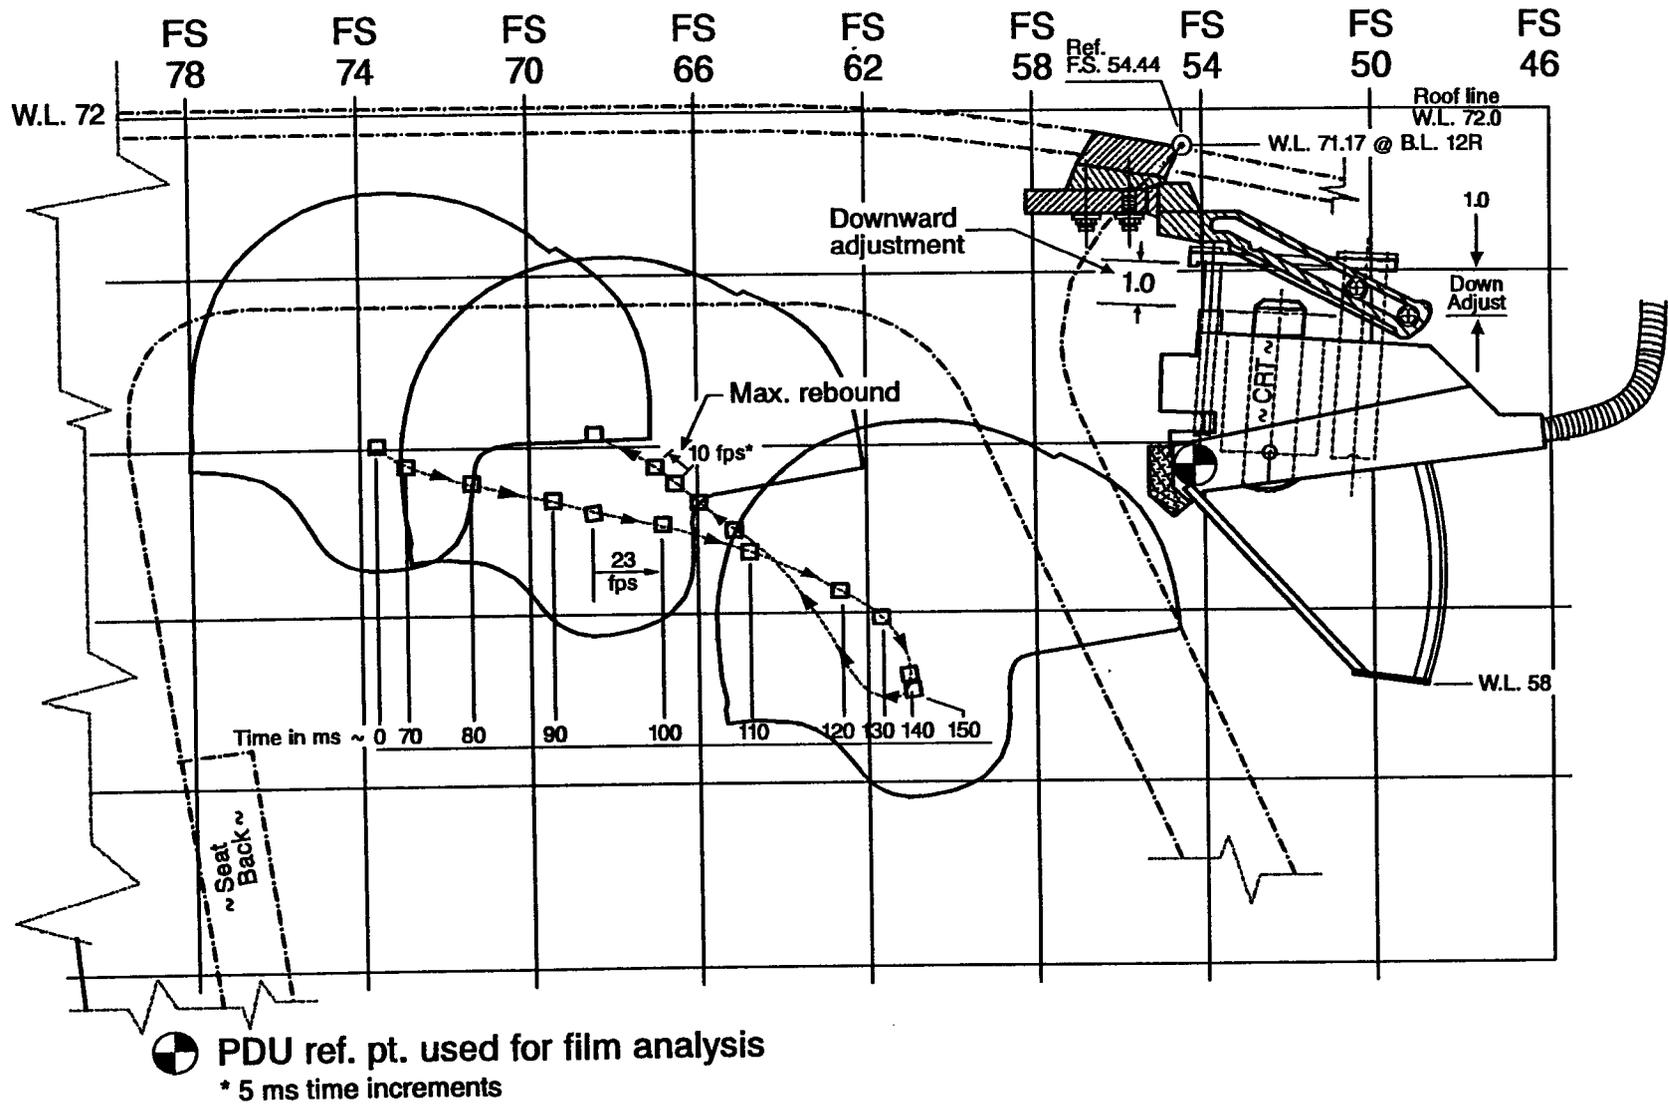
Review of the helmet's movement in Figure 28 shows almost identical movement to the prior test (approximately 13.8 inches in this test, and 13.7 inches in 88060). One would have expected more movement with greater energy and peak G in the sled pulse. It may be the inertia reel locked sooner in the pulse sequence and prevented as much shoulder strap extension. For some unknown reason, the dummy's helmeted head moved downward nearly 6 inches in lieu of 2.1 inches in the identical test 88060; this downward movement caused the helmet to almost miss the PDU with only grazing contact. No marks could be seen on the helmet visor cover and no contact is shown by film analysis in Figure 28.

Figure 28. Helmeted head displacement in second 30-degree pitch down test 88061.

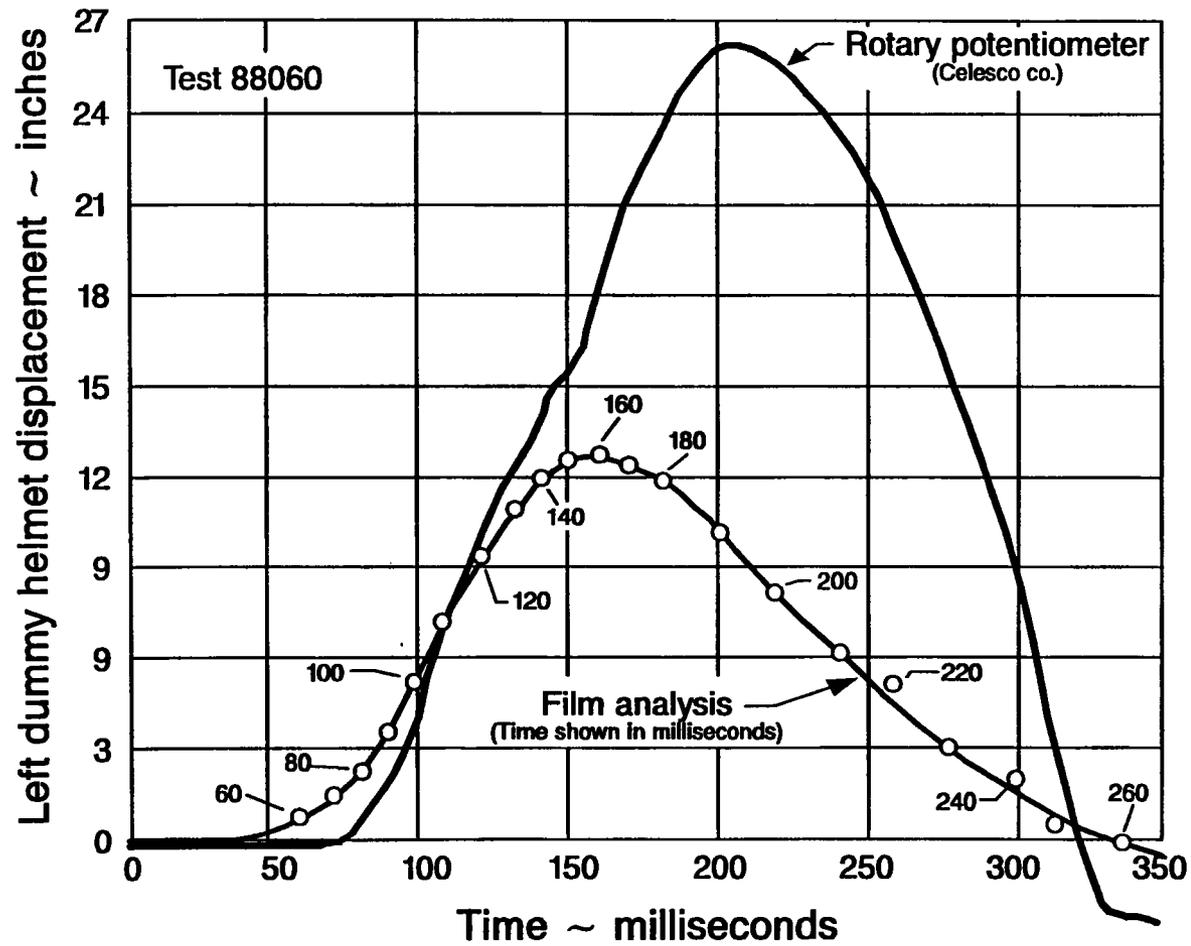
The movement of the helmeted head of the left dummy was recorded by a Celesco potentiometer as shown in figure A-5. the recorded 26-inch value obviously was incorrect based on a cursory film review; the film analysis revealed a movement of 13 inches, half that shown by the potentiometer. Note in Figure A-5 the film showed about 1½-inches of movement before the potentiometer began to rotate (record), and the potentiometer continued to record movement from 15 to 26 inches between 150 and 200 ms. Thus, it is clear the potentiometers on both dummies cannot be used for precise movement data. Discussions with the CAMI test track chief, Mr. Gowdy, indicate the acceleration of the cables from the instruments exceeded the rate limitations of the device. Nonetheless, the first four recordings from the right dummy's helmet are copied and compared in Figure A-2, and all show a similar "overrun" error from 21 to 29 inches. The actual helmeted head movement in all five tests shows movement of 12 to 14 inches. Thus, the film analysis motion is used exclusively in discussing helmet movement in these tests.

Figure A-5. Comparison of left dummy helmet displacement in test 88060: rotary potentiometer vs. film analysis.
