USAARL Report No. 88-15

**SPH-4 U.S. Army Flight Helmet Performance
1983-1987**

**Peter Vyrnwy-Jones
Bernard Lanoue
Douglas Pritts**

**U.S. Army Aeromedical Research Laboratory
Fort Rucker, Alabama 36362-0577**

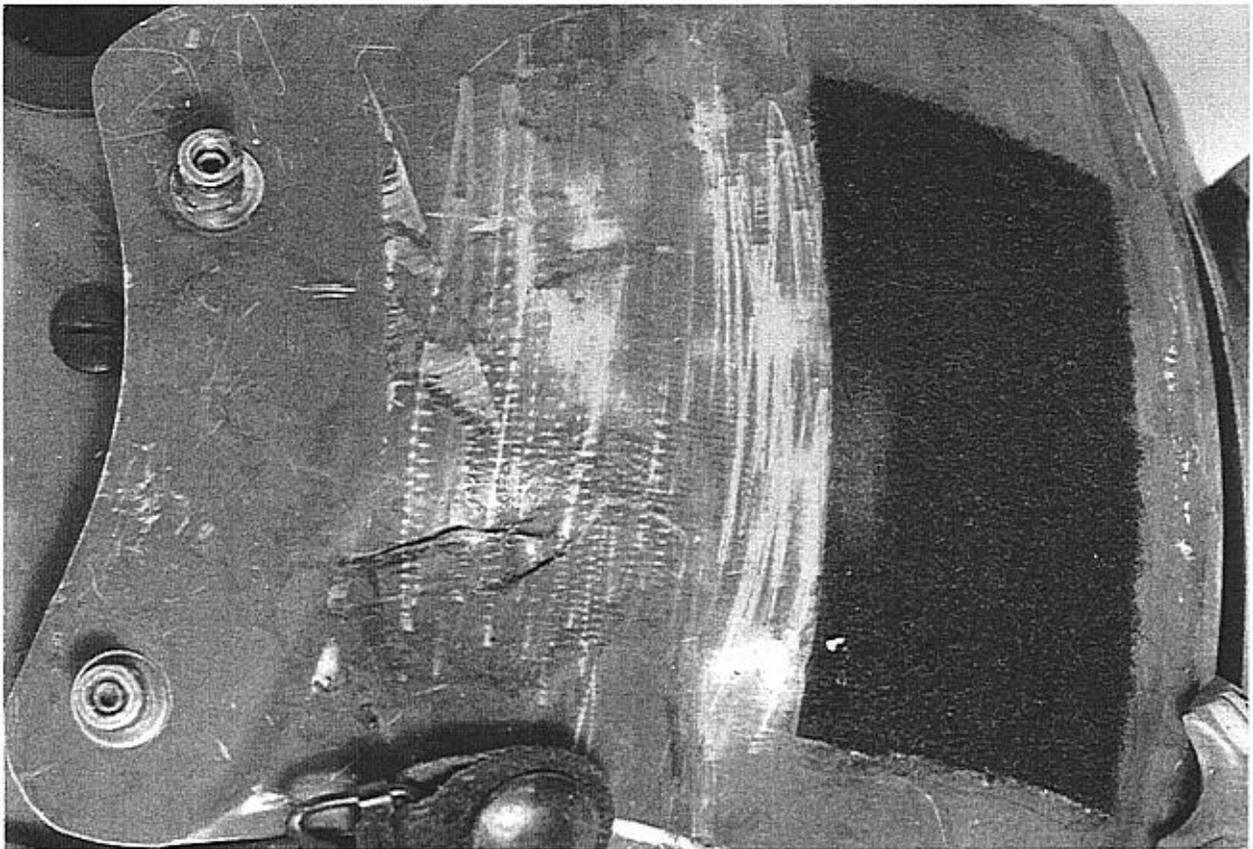
Figure 6. Damage to visor cover of Cobra helmet.

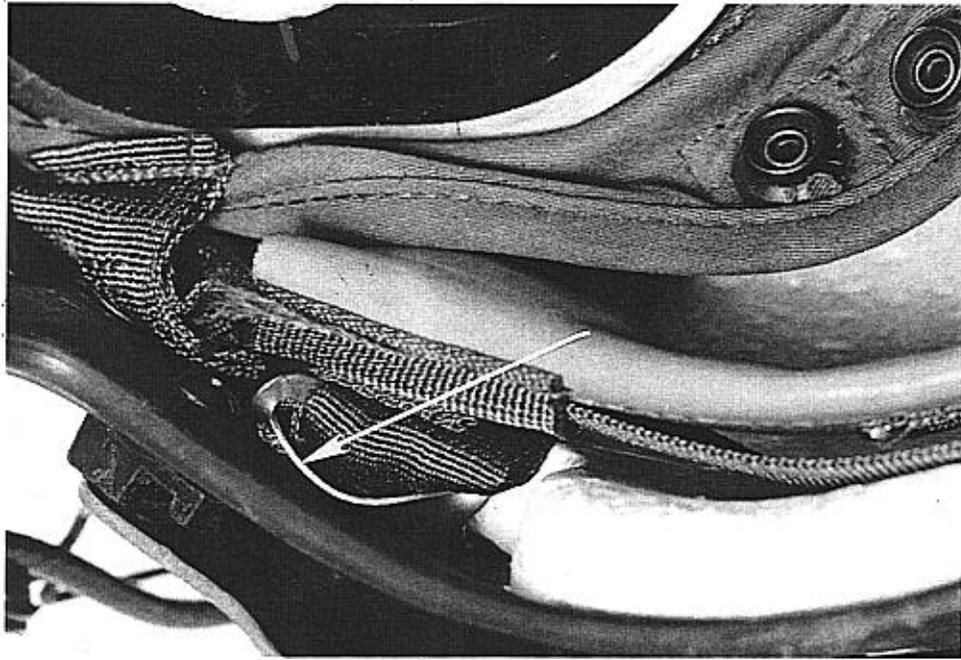
Clip damage occurred on 68 occasions in the present series and, of these, 55 were due to major crown or frontal impacts. The remainder were caused by secondary impacts to the same areas with the main impact being to the sides of the helmet.

Figure 8 illustrates the distribution of clip damage and demonstrates the more extensive damage associated with non-survivable or fatal accidents. Nevertheless, almost 10 percent of survivable accidents had clip damage which required an applied load of at least 300-360 lbs.

Figure 7. Severely deformed suspension clip on SPH-4 helmet.

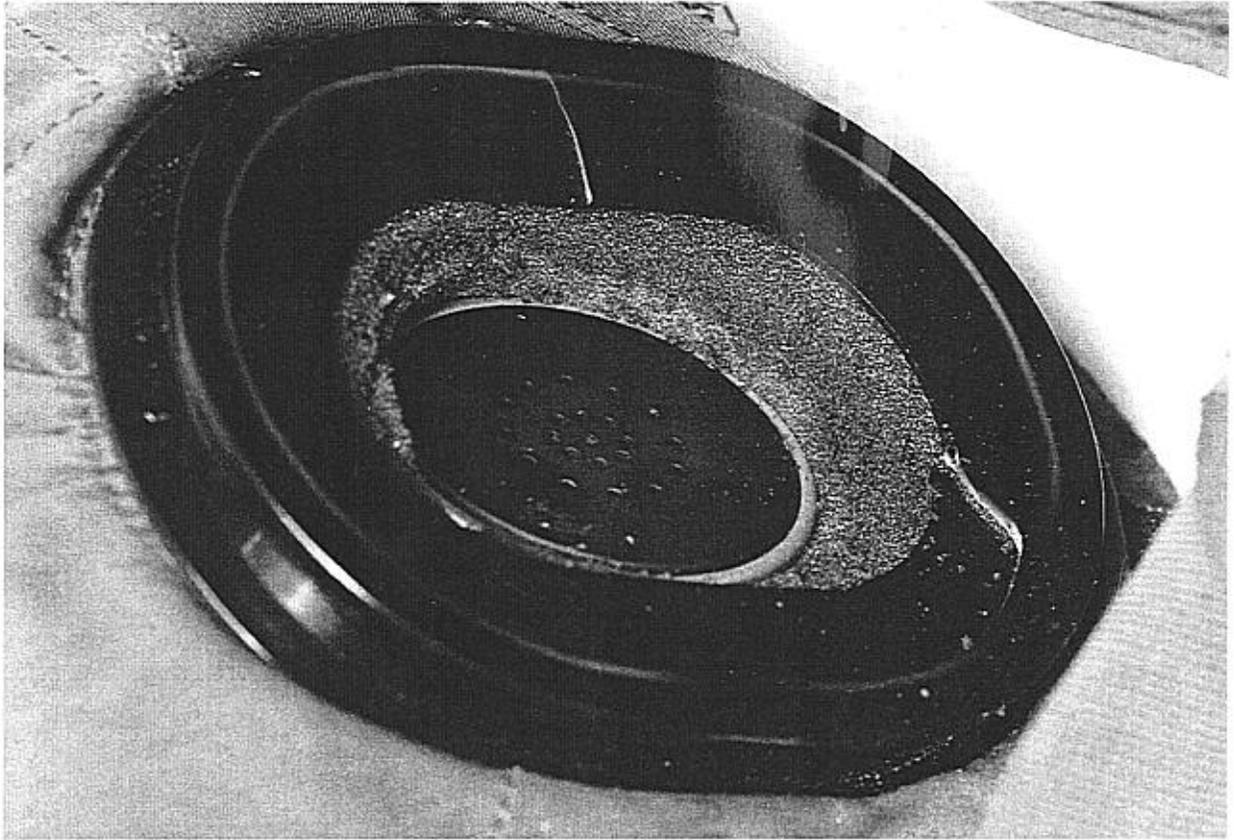
The prevalence of earcup damage in previous studies (Shanahan, 1985) and the high incidence of severe damage to the side of the helmet prompted a careful study of such impact data to be undertaken in the present analysis. Generally, the damage either was minor consisting of only discoloration to the earcup where stresses have exceeded the elastic limit of the earcup material, moderate where there was minor deformation or cracking, or severe where gross deformation or fracture occurred. Figure 9 portrays the type of damage commonly seen and Table 9 records the factual information.

Both earcups were involved in 16 helmets and the left and right cups were damaged on 15 and 13 occasions, respectively. The AIS 1980 distribution for those helmets where earcup damage was recorded is presented in Figure 10.

Figure 9. Example of a damaged earcup.

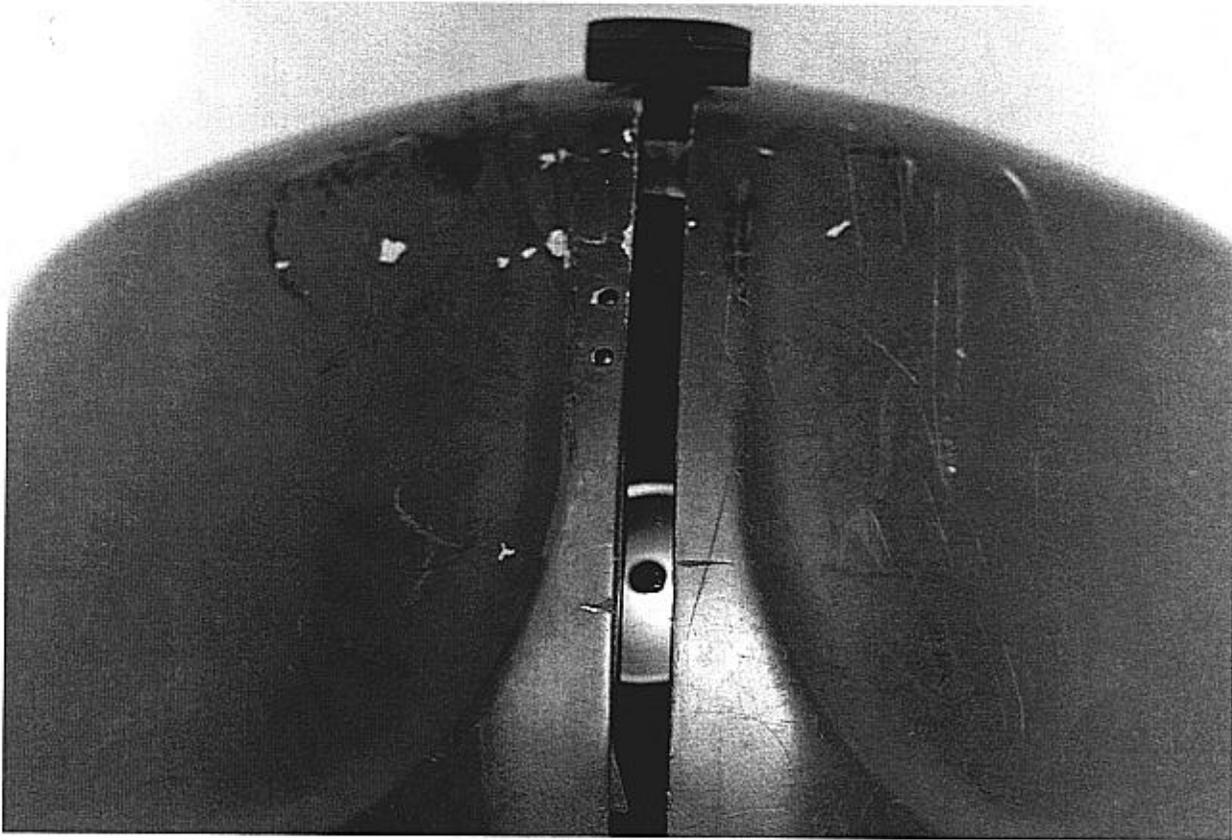
Figure 20 portrays the large increase in helmet volume, which has been the result of trying to optimize the performance of the visor in relation to the HMD unit. A recent accident investigated by USAARL demonstrated a blow to this visor cover could transmit the impact energy directly to a portion of the helmet, where there is no energy absorbing liner. The compressive force was estimated to be in the region of 1000 lbs. There is little doubt that the increased profile and strike range of this helmet were the cause of the injuries sustained in this case.

Figure 21. Apparent minor damage on the IHADSS visor cover which resulted in a fatal head injury.

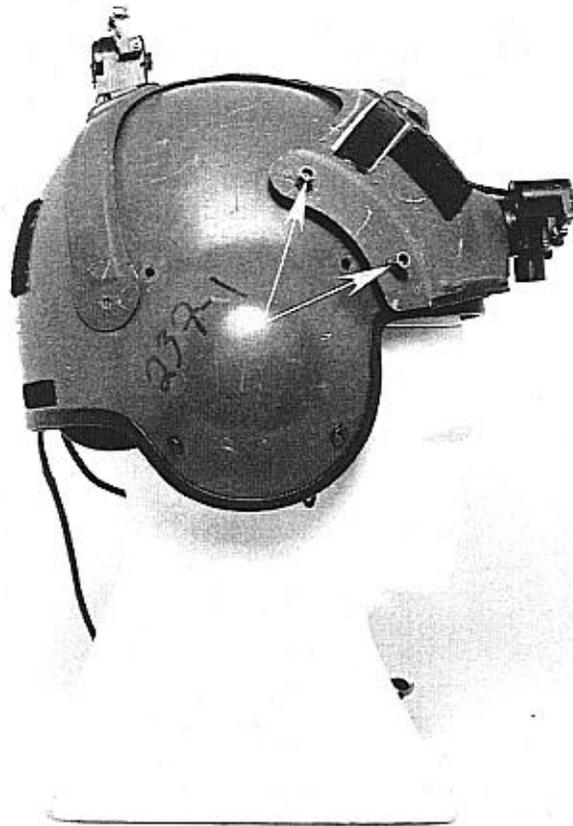
Figure 22. Cobra helmet demonstrating protruding pin collars.

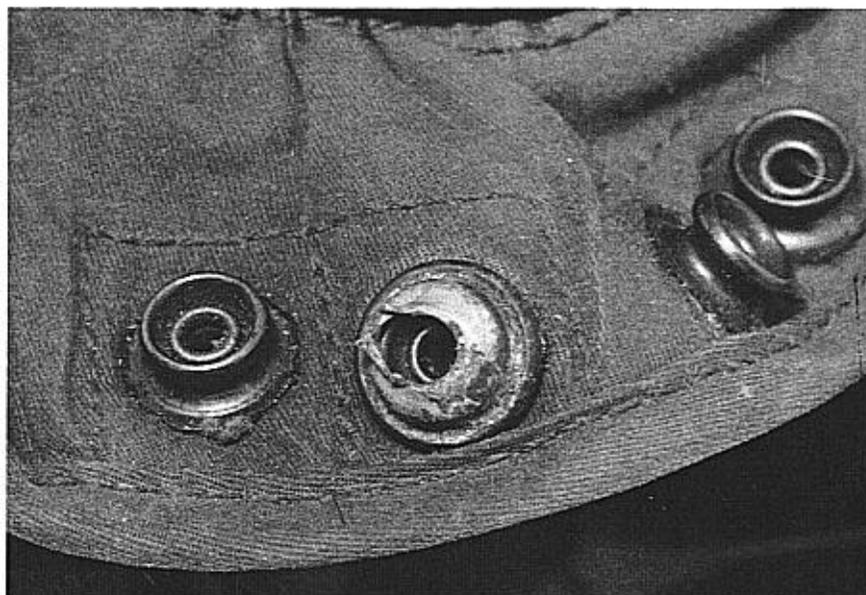
Chinstrap failure occurred on 11 occasions

Nine of these were due to snap failures and two to failure of the bolt retention system. One of the latter was recorded as being due to rotting of the cloth retention system. It had been hoped the introduction of the improved double snap type harness would have eliminated the problem of strap failure. The current study emphasizes the inadequacy of dot fasteners for aircrew helmets. Other types of fasteners are available, and in service throughout the world. These now are being assessed for use in U.S. Army aviator helmets and their introduction would eliminate this long standing, well known, but seemingly perennial problem. Figure 24 illustrates a case of severe deformation of a dot fastener which failed in a survivable accident. An argument often advanced in favor of dot fasteners is their ease in use when donning or doffing a helmet. This is disputed as alternative fasteners are, in the authors' opinions, easier to use, and there seems to be no reason for quick release of a helmet subsequent to an accident. Indeed, all the evidence indicates that the helmet should be kept on until well clear of the crashed aircraft, refuting the argument that quick release is required.

Figure 24. Failure of a dot fastener in a survivable accident.

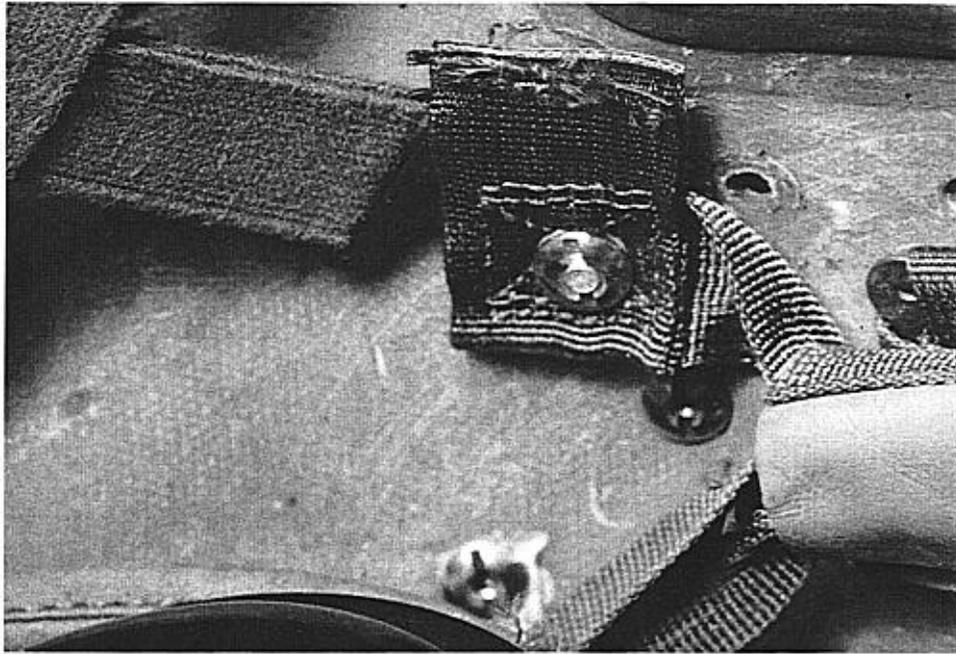
- a. Failure of the suspension tabs--14. See Figure 25.
- b. Earcup detached from cloth retention assembly--4.
- c. Failure of the napestrap--1.
- d. Incorrect fitting of the helmet--1.

Clearly, the main drawback of the SPH-4 is its reliance on a retention system where the chinstrap attaches directly to the cloth suspension system which houses the earcup assembly. This allows excessive stretching to occur during an impact loading and largely accounts for the poor performance of the SPH-4 under simulated and real impact conditions. The suspension system retention tabs are of inadequate strength and have failed in survivable accident conditions. An SPH-4 from a recent survivable accident exhibited failure of all four retention tabs. The subsequent helmet loss resulted in the pilot receiving major head injuries with loss of consciousness--a totally unacceptable outcome. A brief check of suspension systems at USAARL revealed though some were of adequate strength, others were easy to tear apart. Quality control of stitching obviously is important, and as such components often are assembled by the lowest bidder, variation in their attributes is to be expected. Anecdotal evidence from the aviation community indicate the wearing of NVGs under normal operating conditions causes the helmet to shift on the head, thereby altering the optical axis of the system. This necessitates the aviator having to manually recenter the equipment - obviously an undesirable and unnecessary flight task. Helmet stability has become important not only in impact situations, but also in operational conditions where the maintenance of a stable viewing platform is essential. Therefore, future helmet designs should incorporate features which facilitate this desirable result. Ideally, the chinstrap should be attached directly to the helmet shell, incorporate a new fastener system, and the nape strap should be improved to avoid forward rotation of the helmet.

Figure 25. Failure of suspension retention tab stitching.
