USAARL Report No. 2009-02

Noise and Reverberation Reduction in Post Chapel Activity Room

By Adrianus J.M. Houtsma

U.S. Army
Aeromedical Research
Laboratory

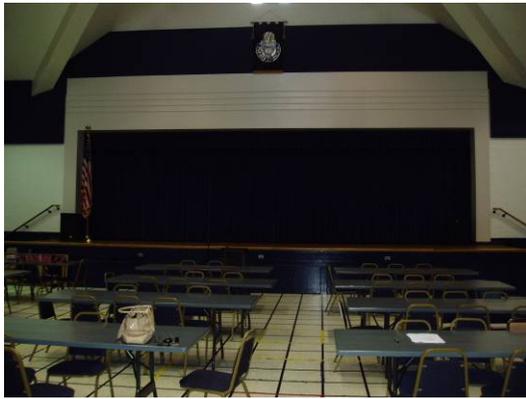
Figure 1a. Chapel Annex, north wall, with stage closed off by curtain.

The overhead ceiling baffle proposal was never executed but, instead, an additional amount (about 1000 ft²) of wall-mounted sound-absorbing panel material was added to the rear and side walls above the existing acoustic paneling. Figures 1a- through 1d provide an illustration of the four walls and their acoustical treatment; the dark-blue band represents the newly-installed added acoustic paneling. In June 2007, a second set of reverberation time measurements was made to quantitatively document the subjective acoustic improvement reported by the activity room users. This report details the equipment and methods used, the raw acoustic results, and the mathematics of extracting RT₆₀ reverberation times (i.e., the time required for a sound to decay by 60 decibels [db] in a space after the sound source is turned off). The report is also intended to demonstrate a relatively simple method to take such measurements using general-purpose equipment and dedicated signal processing software.

The lower white-colored wall segments of rear and side walls show the original sound-absorbing paneling. The dark-blue covered wall segments are the newly added sound-absorbing wall panels. The white-colored areas above the blue panels are acoustically untreated brick wall segments.

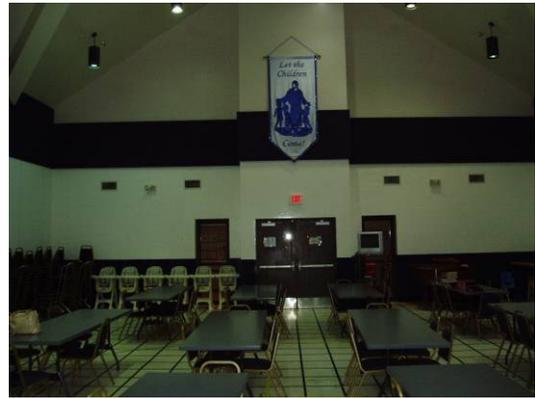
Figure 1c. West (left side) wall.

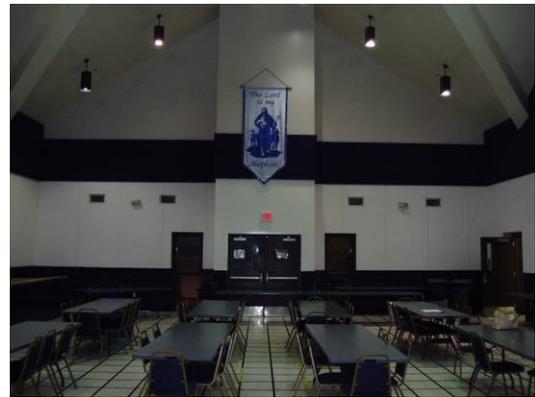
Figure 1d. East (right side) wall.
