**USAARL Report No. 91-7**

**Concept Evaluation of the UH-60  
Externally Mounted Rescue Hoist**

**January 1991**

**United States Army Aeromedical Research Laboratory  
Fort Rucker, Alabama 36362-5292**

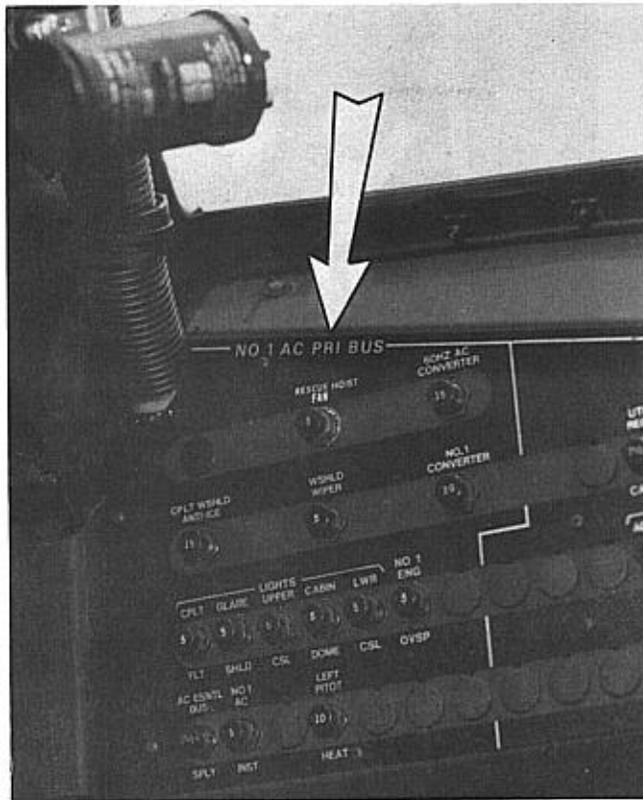
Figure 7. Circuit breaker panel located above and behind copilot's seat (rescue hoist fan 5-amp circuit breaker).

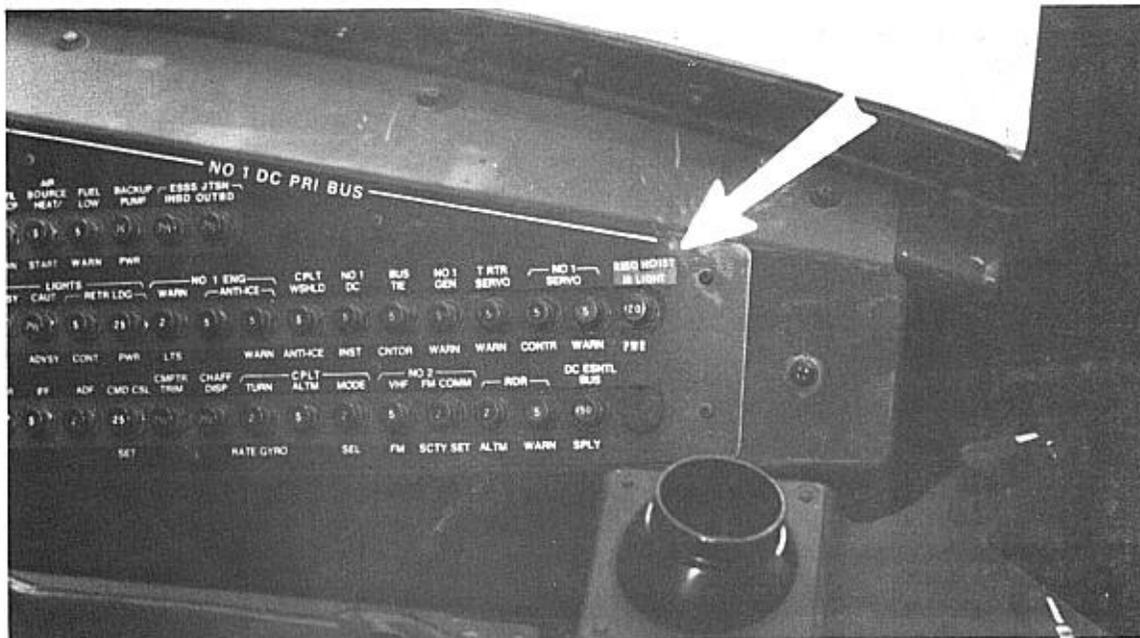
Figure 8. Circuit breaker panel located above and behind copilot's seat (hoist IR light 5-amp circuit breaker).

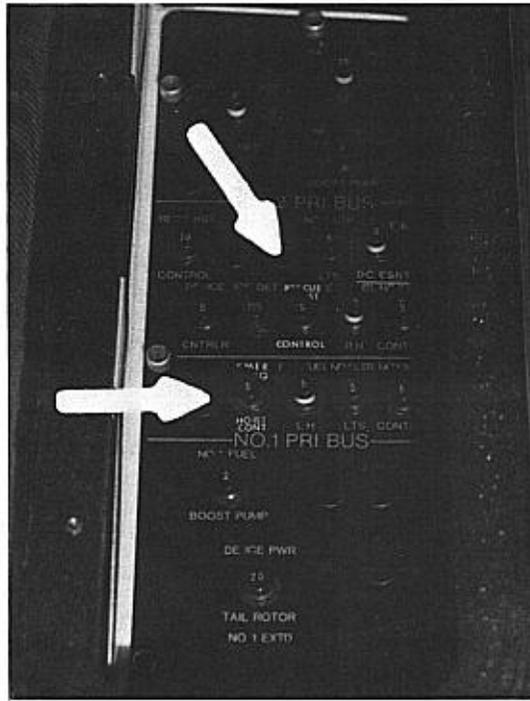
Figure 9. Mission equipment circuit breaker panel located over left gunner/crewmember seat (hoist control 5-amp circuit breaker and emergency hoist control 5-amp circuit breaker).

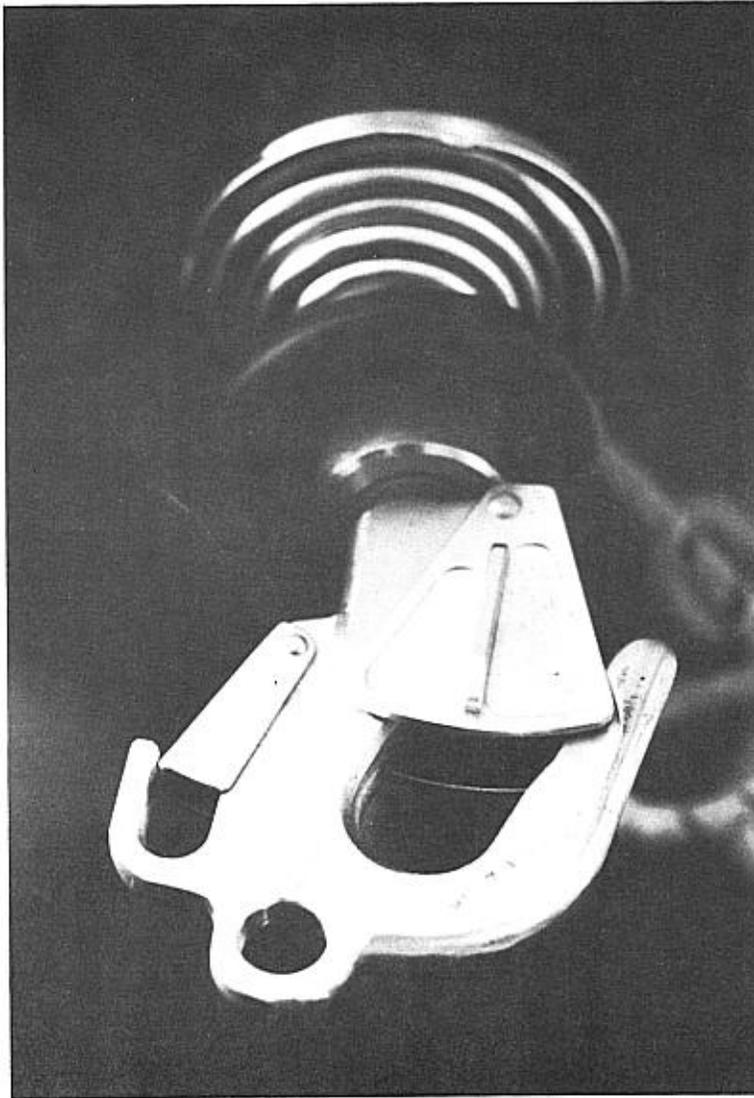
Figure 11. Candidate EMRH hoist hook.

b. Aircrewmembers noted the lack of a pit pin keeper to secure the hook lock flange in the closed position on the EMRH hook. This pit pin keeper was present on the seven IMRH hooks surveyed, and is a required safety feature on the IMRH.

2.2.4.7 The EMRH and the IMRH hooks were found to possess positive lock (latch) mechanisms which are spring loaded to the closed position. The hoist hook of the IMRH was preferred over the hoist hook of the candidate EMRH. Safety issues relating to the design of the EMRH hook are addressed in the Safety subtest paragraph 2.5.3.4.

a. The lack of a safety pin or pit pin keeper on the EMRH hook safety latch could be catastrophic (cause death) to the lifted patient. Probably, it would occur several times during the life of the item in the MEDEVAC fleet. It is given an RAC of IC. Installation of a pit pin keeper would eliminate this hazard.

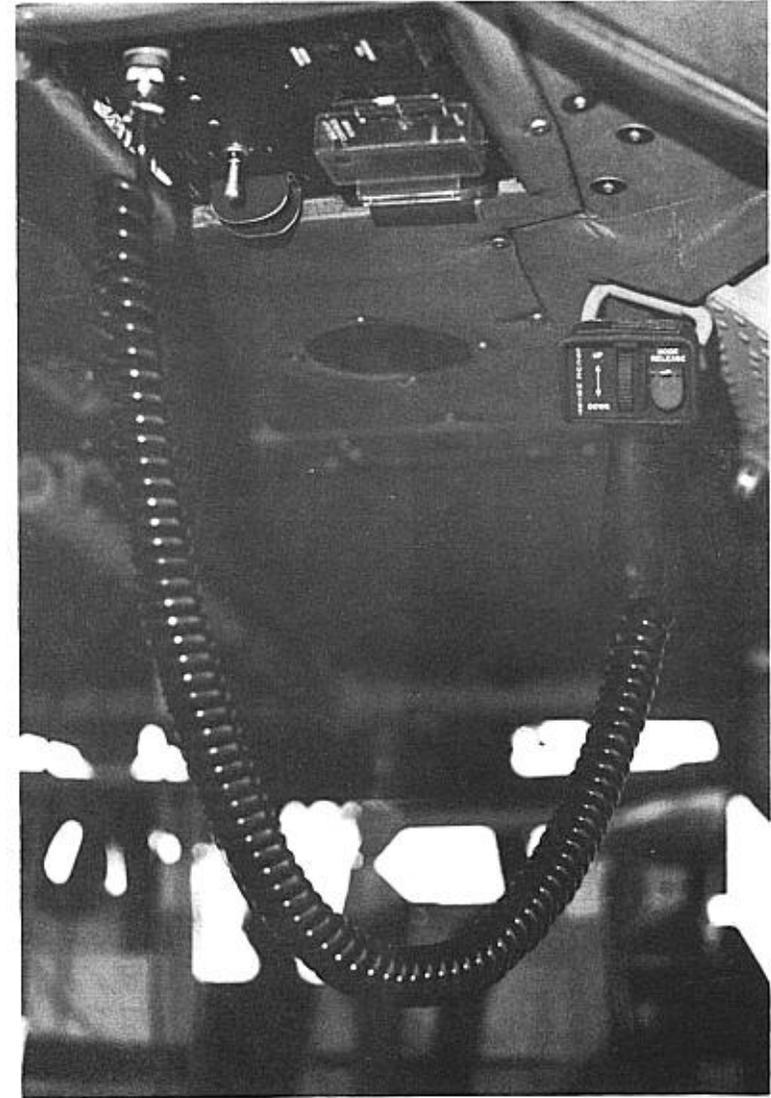
Figure 12. EMRH pendant and overhead control panel.

1.4.2 The aircrewman's pendant provides the primary mode of hoist operation from the cabin (Figure 12). A thumb wheel switch on the pendant, spring loaded to neutral, controls the rescue hoist in either direction. The hoist operational speed is governed from zero to 215 fpm, depending on thumb wheel displacement. The pendant also incorporates a "press to talk" trigger switch which enables the aircrewmember/operator to communicate on the aircraft's internal communication system (ICS). It also includes a cargo hook release switch (nonoperational). The pilot rescue hoist control panel located on the center avionics console enables either pilot to override the aircrewman's pendant and operate the hoist from the cockpit at a set rate of 100 fpm. This box incorporates the master on/off switch for hoist operation, an up/down switch, the cable shear switch for emergency cable jettison, a squib test circuit consisting of a test/norm switch with a test "good" indicator light, and a boom switch (nonoperational). If primary power EMRH is lost for emergency operation, a backup control power switch provides backup electrical power. This switch allows backup control to override a hardover condition caused by preliminary electric power failure or a means to run the hoist in case of a limit switch failure. The switch is located on the overhead hoist control panel in the cargo compartment and operates the hoist at a fixed rate of 85

fpm. It is protected by a safetied switch guard to prevent inadvertent operation in this mode.

a. The EMRH incorporates a blue/green high temperature warning light located on the cabin overhead control panel. All eight aircrewmember participants said this light was necessary, but must be placed on the pendant. The IMRH pendant warning light is located on the pendant. When the aircrewmember is performing a hoist operation, he is looking at the patient, monitoring and controlling the litter movement, and monitoring and directing the pilots on aircraft position. The aircrewmember cannot look above and behind to monitor a possible overtemp condition. His attention is focused totally outside the aircraft.

(9) Although hydraulic overtemp is not considered to be a concern with the EMRH operation, there still is the possibility of internal component mechanical or aircraft subsystem failure. Due to this concern, it is recommended the hydraulic overtemp warning light be moved to the pendant.

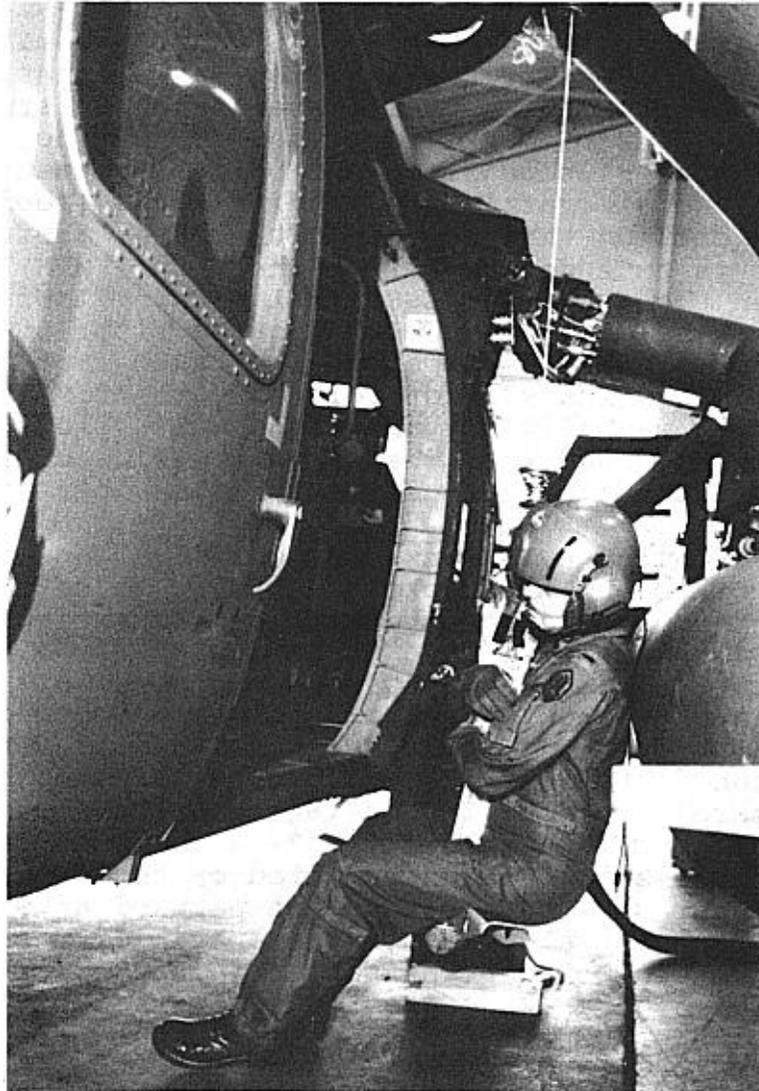
Figure 13. Forest penetrator lift, one man, below cabin floor, 250-gallon ESSS.

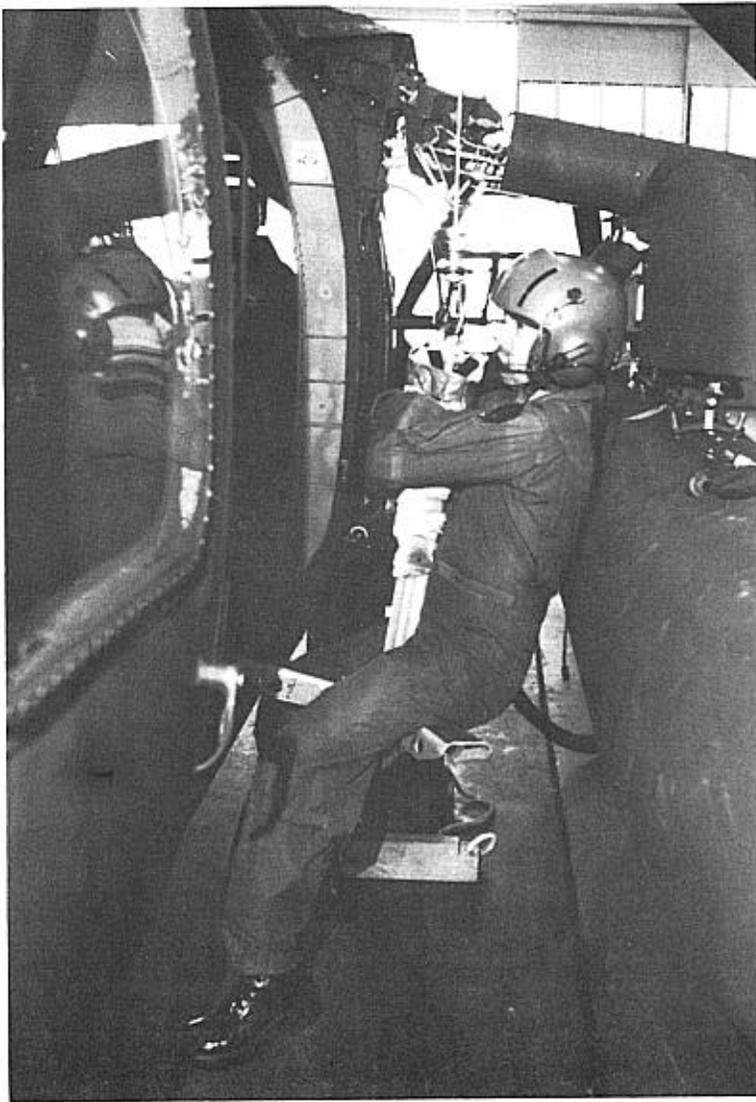
Figure 14. Forest penetrator lift, one man, above cabin floor, 250-gallon ESSS.

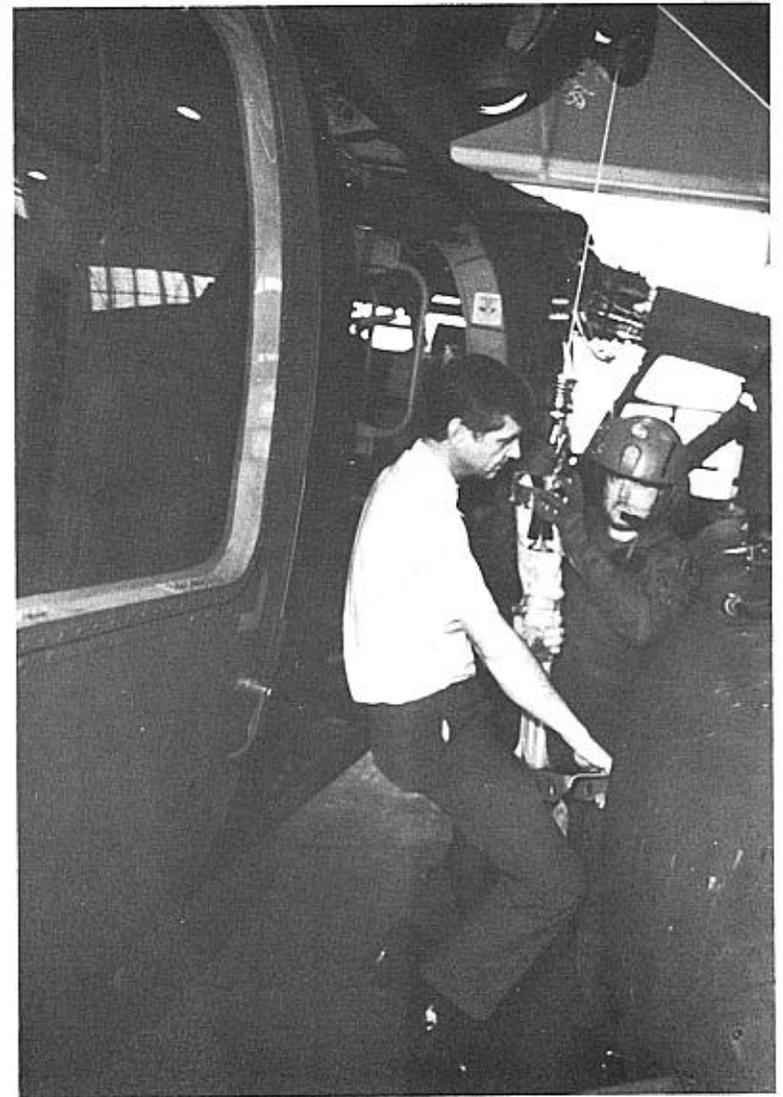
Figure 15. Forest penetrator lift, two man, cabin floor level, 250-gallon ESSS.

a. There is a possibility of contact between the metal fold-down seat of the forest penetrator and the UH-60 ESSS 230-gallon tank (Figure 15) during both EMRH and IMRH operations. Further analysis must be accomplished on these tanks to determine the strength of the tank wall and possibility/probability/consequences of fuel tank damage by inadvertent contact with the forest penetrator seat during actual hoist operations.

a. Contact between the metal fold-down seat of the forest penetrator and the ESSS 230-gallon fuel tanks is certain within the life of the EMRH or IMRH. Hazard classification could be from IA to IVD as a function of the possibility of fuel tank damage in varying mission scenarios. Temporary corrective action would be a restriction prohibiting forest penetrator use during hoist operations until further analysis can be accomplished on the ESSS fuel tanks.

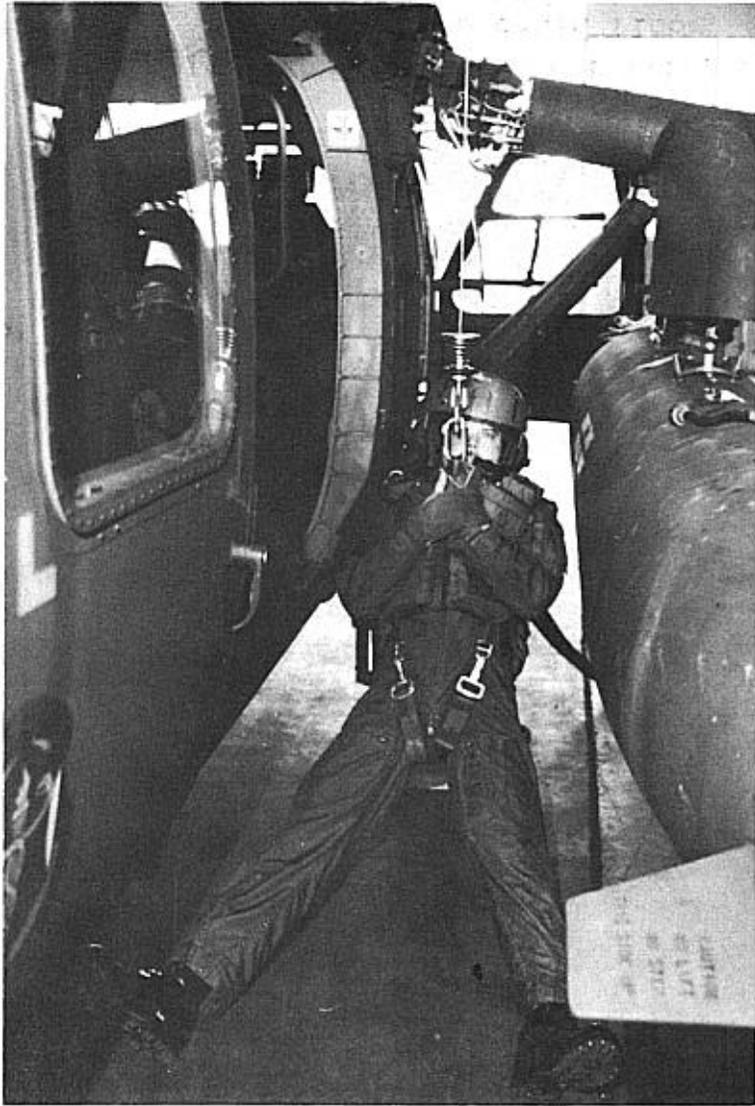
Figure 16. SARVIP lift, one man, perpendicular to airframe axis.

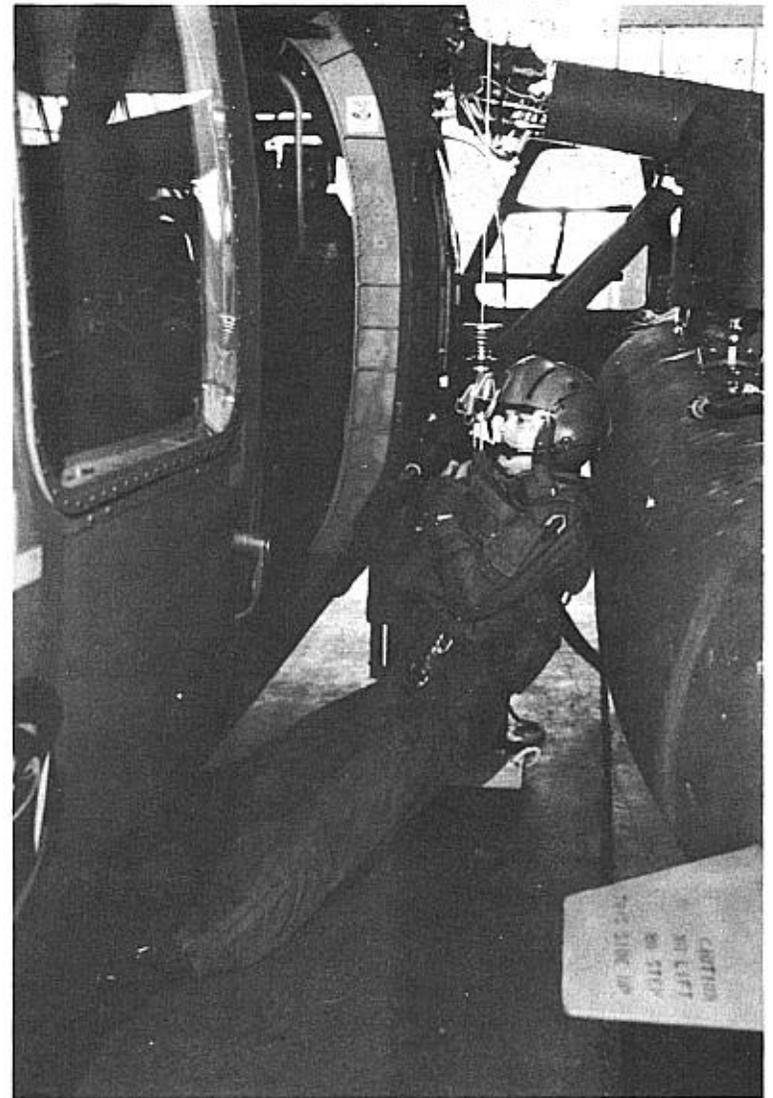
Figure 17. SARVIP lift, one man, parallel to airframe axis.

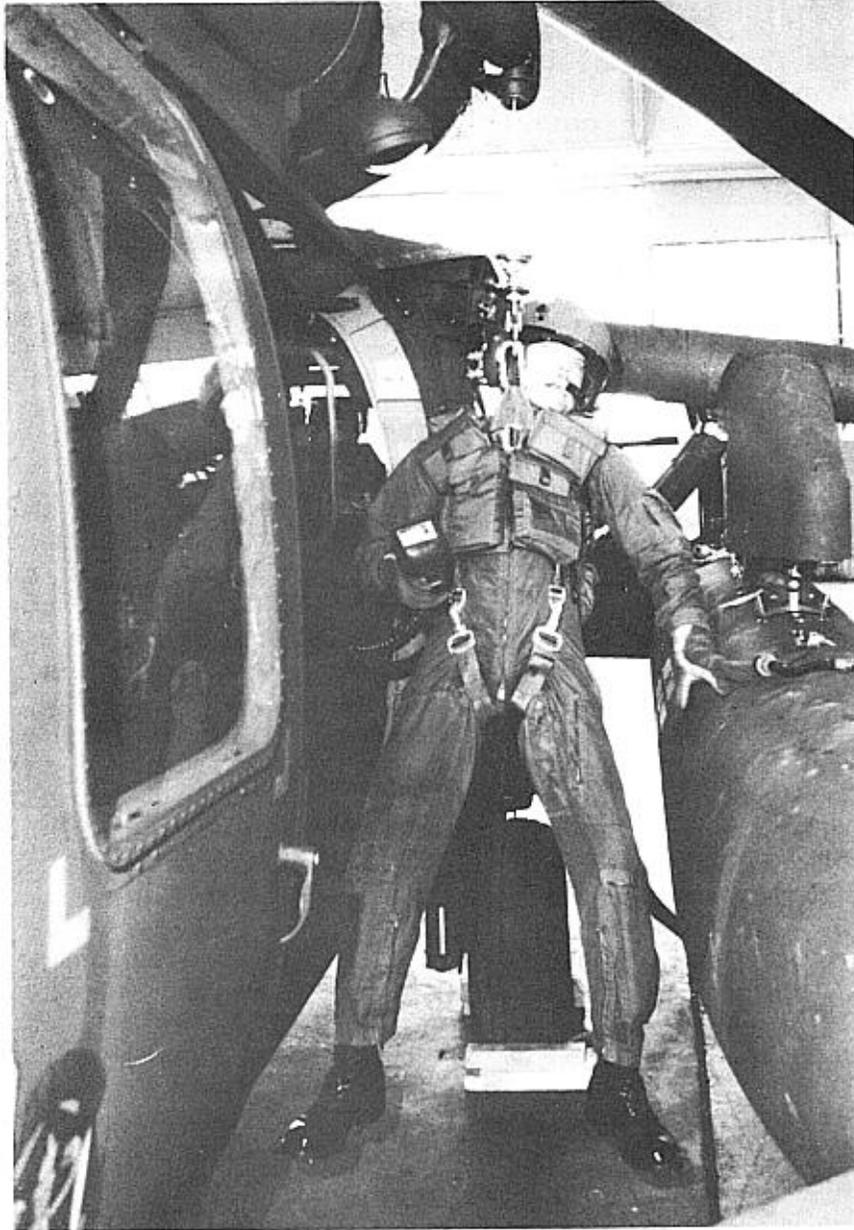
Figure 18. SARVIP lift, one man, perpendicular to airframe axis.

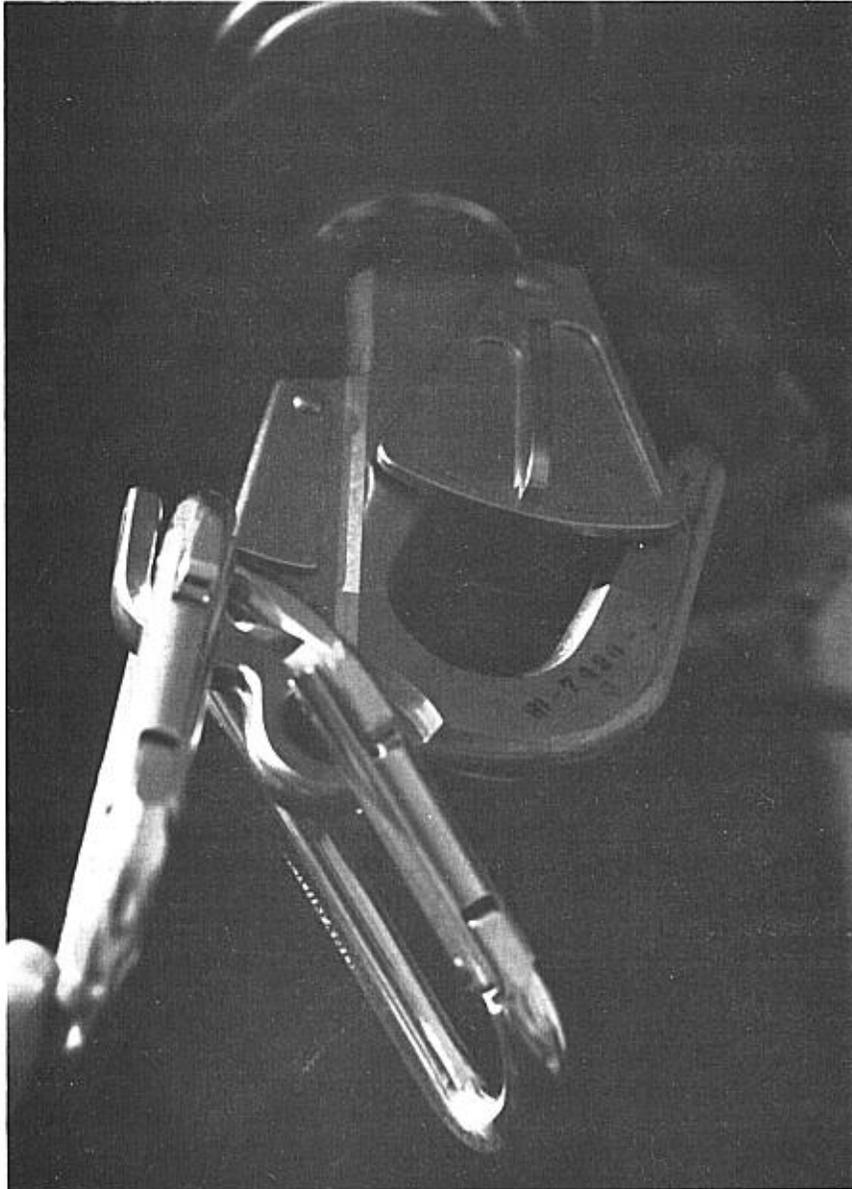
2.3.4.6 EMRH and IMRH hoist hooks were found to be compatible with intended support equipment and connecting points. The auxiliary hook on the EMRH will accommodate two carabiners, but the safety latch provided cannot close (Figure 19). Lateral forces or torque will allow the second carabiner to rotate out of the hook and be released. This issue will be addressed in the Safety subtest paragraph 2.5.3.4.

Figure 19. EMRH accessory hook with two carabiners (safety latch open).

b. Under current and planned MEDEVAC mission scenarios, the operational auxiliary hook hazard could be catastrophic (cause death) and could occur frequently in the MEDEVAC fleet during over-water rescue scenarios. It is given an RAC of IB. Elimination of the auxiliary hook would eliminate this hazard. Training of all aircrews on over-water rescue and the danger associated with the auxiliary hook adequately would control this hazard.

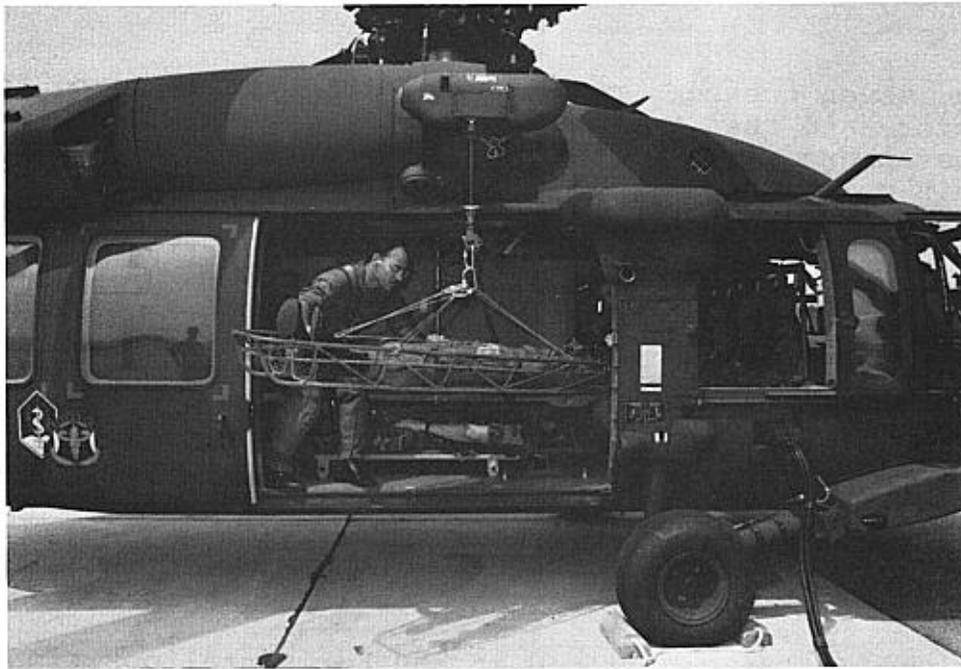
Figure 20. Litter carousel fly position, six-man configuration, Stokes litter in horizontal position, loading head first.

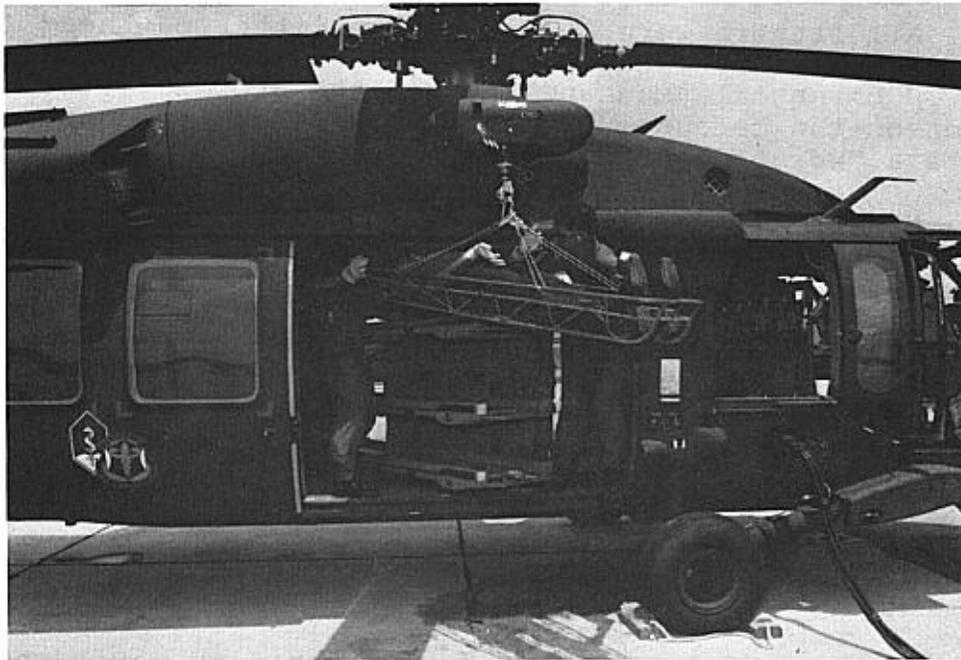
Figure 21. Litter carousel 45° position, six-man configuration, Stokes litter in horizontal position, loading head first.

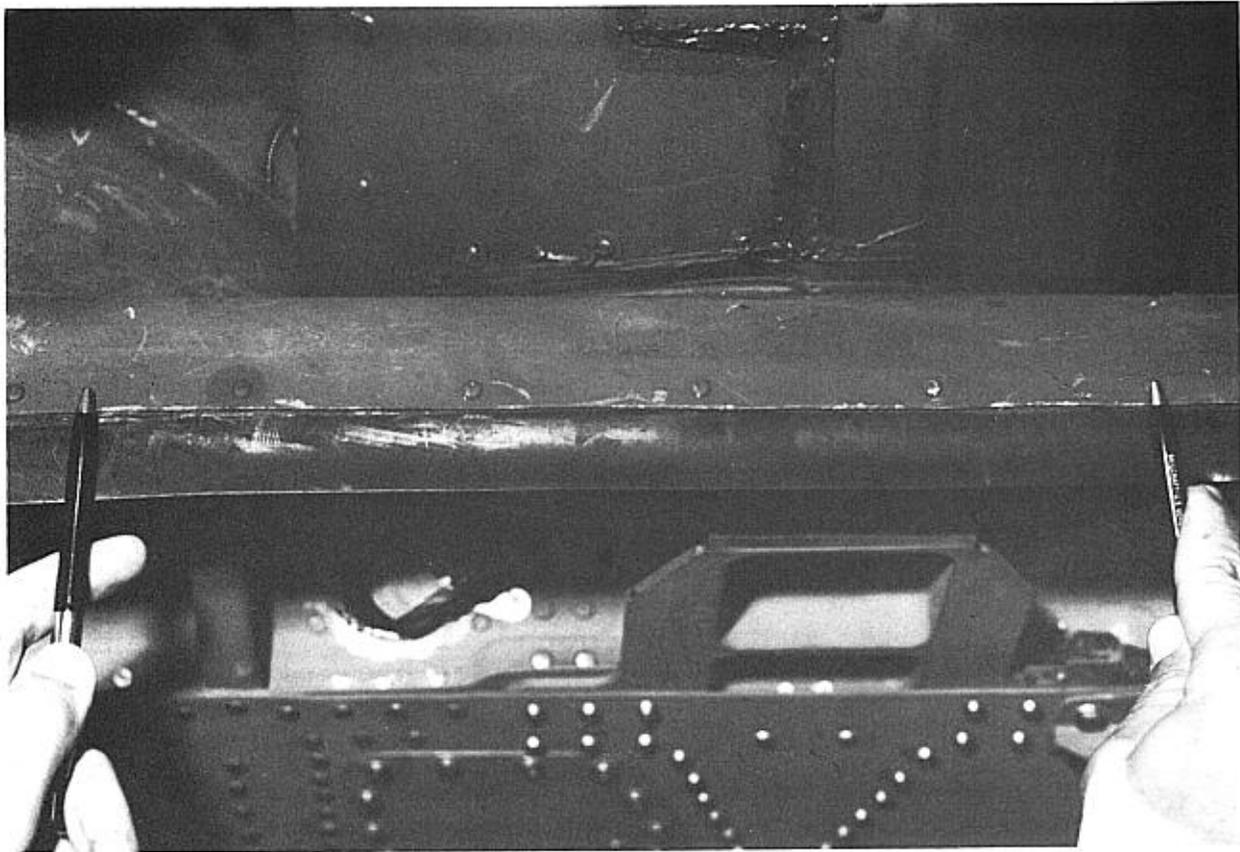
c. During the loading and maneuvering of litter loads on the upper litter pans of the MEDEVAC carousel, the EMRH cable contacted and slightly abraded a 12½-inch section of the upper cabin door weather stripping and cabin roof (Figure 22). Damage was minimal due to the caution used by the test participants.

Figure 22. Abraded upper cabin door weather stripping.

c. The EMRH cable contacts and abrades the upper cabin door weather stripping and cabin roof. This condition will cause minor damage but will occur frequently during EMRH operations with use of the MEDEVAC carousel. It is given an RAC of IVA. This hazard can be controlled with a protective roller or bar installed along the cabin roof edge where the abrasion is experienced.

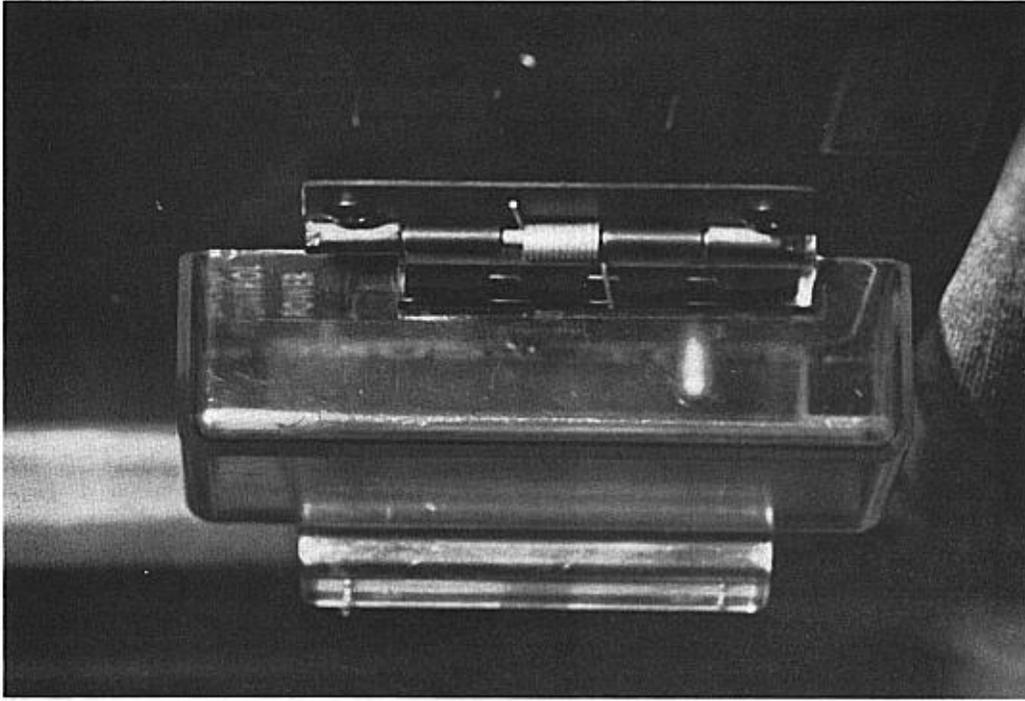
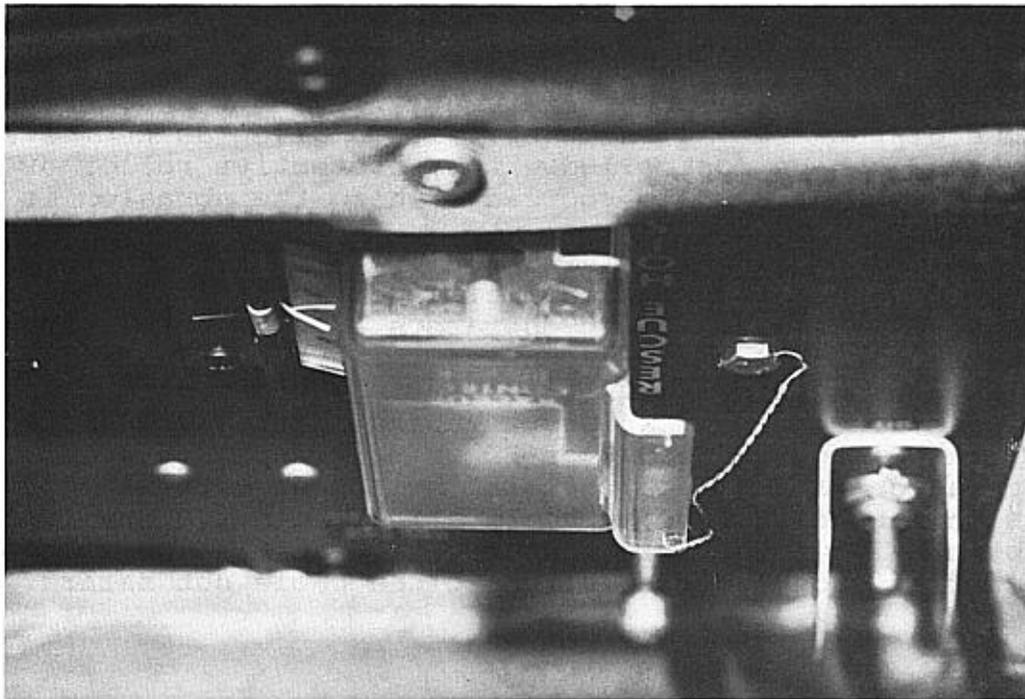
b. The safetied switch guard (plastic cover) which protects the backup control power switch on the EMRH system has been identified as a major annoyance by the aircrews and it will be subjected to constant breakage if fielded in its present state and location. Breakage of the cover could result in inadvertent activation of the backup power control. This condition would not cause damage to the airframe or crew, but would unnecessarily alert the crew to a false emergency situation and possibly diminish mission performance. The hazard can be eliminated by reducing the cover in all dimensions. The grasp lip could be extended horizontally from the base rather than from the side (Figures 23 and 24), and the cover would still adequately protect the toggle switch and a pressure activated switch.

Figure 23. Backup control power switch guard (rear view).

Figure 24. Backup control power switch guard (side view).
