USAARL Report No. 93-27

**Analysis of Injury Severity
Caused by Flight Motor Overpressure
of the Javelin Antiarmor Missile**

James E. Bruckart

July 1993

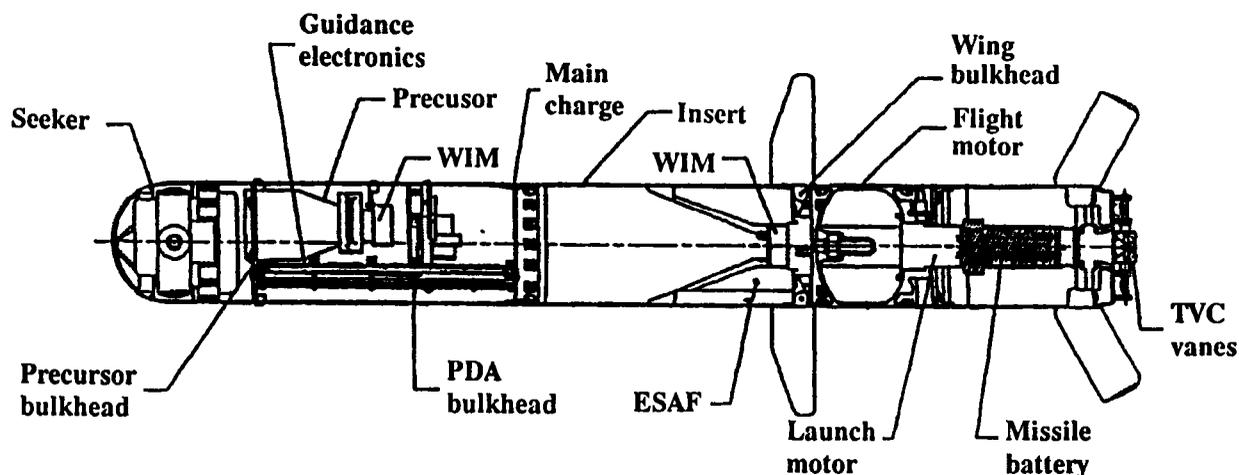
Figure 1. Javelin missile configuration.

The Javelin system consists of a command launch unit (CLU) and missile round. The CLU includes a sight system for surveillance, target identification, and target lockon. The missile round consists of the launch tube assembly, battery/coolant unit, and missile. The missile is shown in Figure 1. The battery/coolant unit supplies electrical power to initiate launch and cooling gas to precool the missile seeker before launch. Estimated system weights are presented in Table 1 (Texas Instruments, 1992).

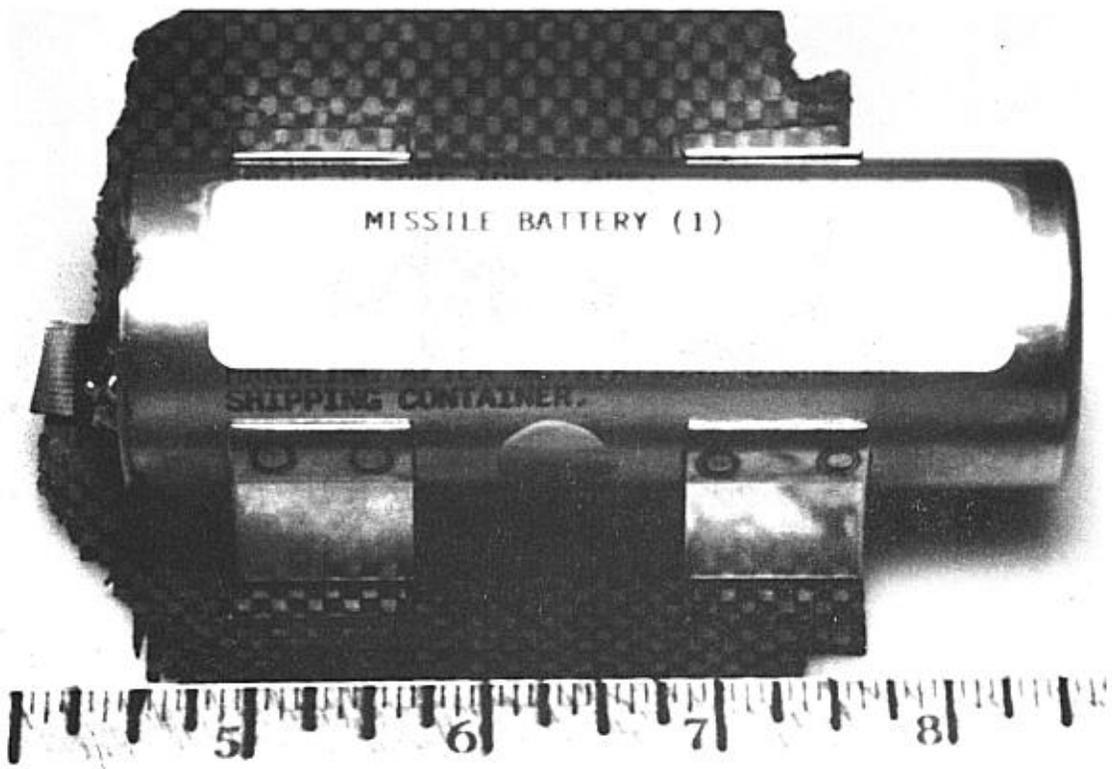
Figure 2. Missile battery.

The simulated malfunction produces several small debris items including pieces of circuit board and composite materials with low mass. The large debris items include the (a) missile battery, (b) launch motor housing, (c) CAS motors [4 each], (d) control fins [4 each], and (e) TVC vane [4 each]. These items are shown in Figures 2-6 and the rearward velocity from a simulated malfunction (25 January 1993) is shown in Table 2.

Debris item	Mass (g)	Kinetic energy (J)
Missile battery	376	68.5
Launch motor housing	825	119.2
CAS motor (#1)	130	37.4
CAS motor (#2)	130	21.2
CAS motor (#3)	130	21.2
Control fin (#1)	64	9.5
TVC vane (#1)	19	11.1
TVC vane (#2)	19	4.75

The two largest items of debris (launch motor housing and missile battery) may have sufficient impact energy to cause significant injury. If the launch motor housing or battery strikes the PASGT helmet, it can transmit sufficient energy to cause a closed head injury. This injury will produce several minutes of unconsciousness and, rarely, seizures. In addition, the same items will cause significant tissue damage if they strike the unprotected groin. These are both considered critical (category II) injuries. The head injury hazard can be reduced by adding impact attenuation characteristics (such as an energy-absorbing liner) to the PASGT helmet. The groin injury could be prevented with strike protection.

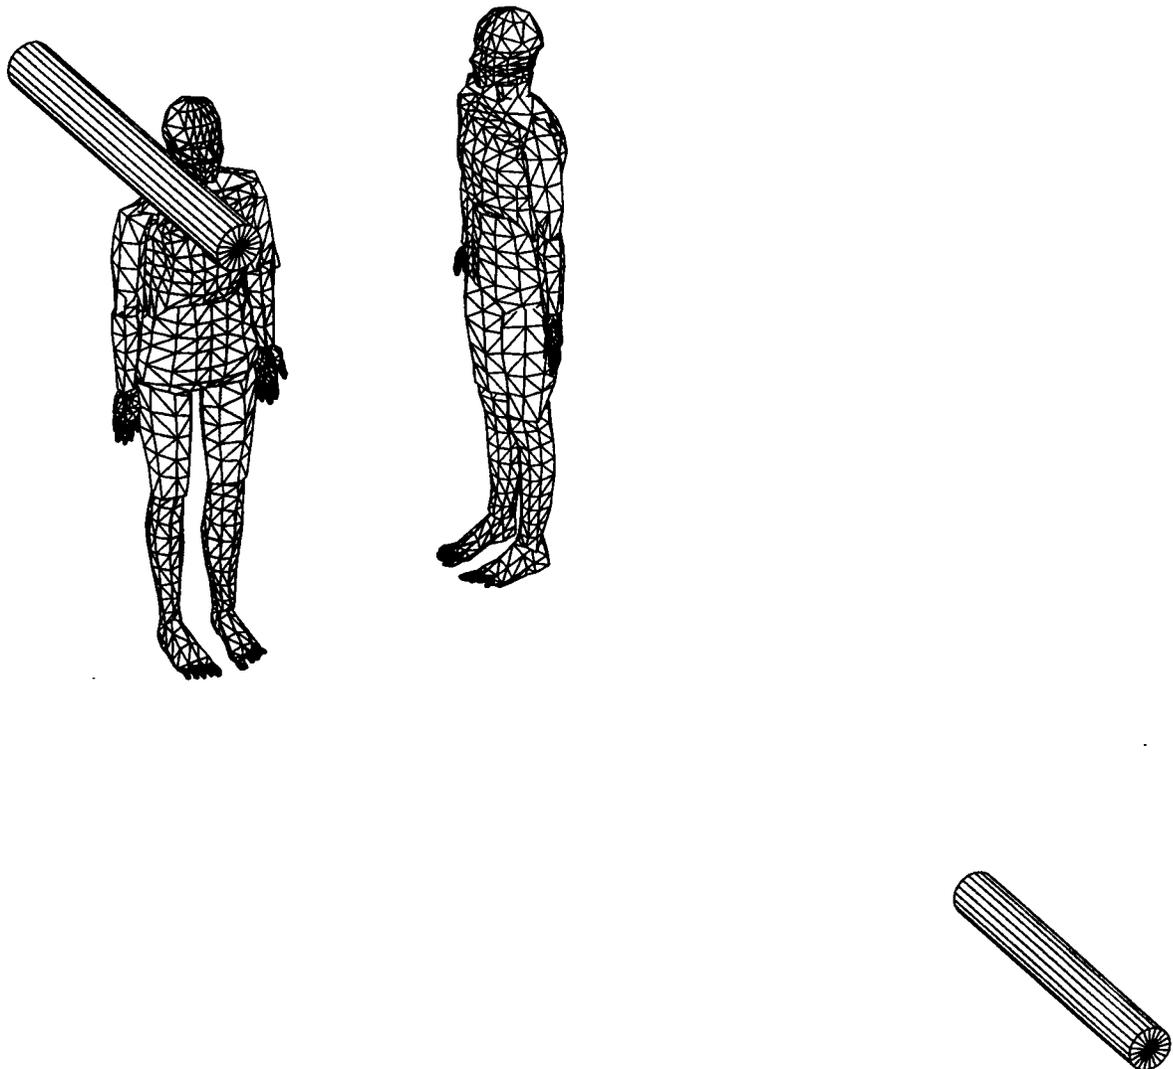
Javelin missile test firings showed the flight motor ignites 0.4 seconds after the missile is launched. At that time the missile was 1.5 meters above the ground, 4.6 m (15 feet) down range, and had achieved a forward velocity of 13.4 m/s (44 fps). Figure 7 shows the relative distance between the gunner, assistant gunner (possible position), and missile at the time of malfunction. The position of the assistant gunner during missile launch has not been decided, but it should not be closer to the missile than the gunner.

Figure 7. Schematic showing standing position for gunner, assistant gunner (exact duty position not yet decided), and missile at time of malfunction.

Malfunction simulations show only a small probability that the gunner will be struck by a piece of debris. In these tests, the launch motor and battery have gone to the right and left side of the gunner position, respectively. If the debris spreads randomly within a cone shaped area behind the missile (60 degrees wide by 60 degrees elevation), most debris items will strike the ground or miss the soldiers. The probability that a piece of debris will strike a soldier is estimated by dividing the surface area of the soldier by the surface area of the 15-foot (4.6 m) radius sphere contained within the impact cone. The probability of being struck by at least one large piece of debris is the sum of the probabilities for each single piece of debris.
