USAARL Report No. 98-18

**The Role of Protective Visors in Injury Prevention During
U.S. Army Rotary-Wing Aviation Accidents**

January 1998

**U.S. Army Aeromedical Research Laboratory
Fort Rucker, Alabama 36362-0577**

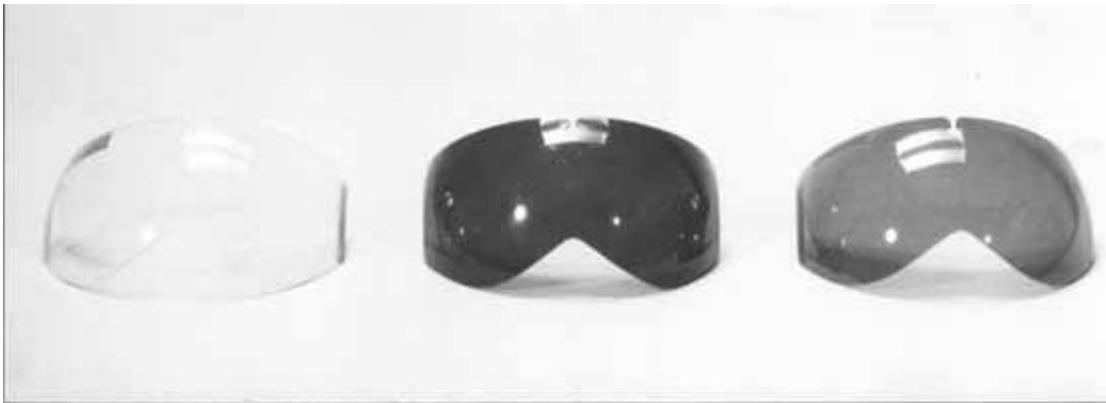
Figure 1. Examples of Class I (clear), class II (tinted), and laser protective visors.

In Army aviation, visors are classified as Class I or II (Figure 1). These classes are defined in military specification MIL-V-4351 1C, "Visors, flyer's helmet, polycarbonate." Class I visors are clear, having a photopic (daytime) luminous transmittance of 85 percent or greater. Class II visors are tinted, having a photopic luminous transmittance between 12 and 18 percent. An exception to the Class II luminous transmittance requirement is granted to the tinted visor used in the Integrated Helmet Unit (IHU) of the Integrated Helmet and Display Sighting System (IHADSS) in the AH-64 Apache. The IHADSS Class II visor has a photopic luminous transmittance between 8 to 12 percent. This lower transmittance range is needed to improve visibility of real-time imagery provided by the IHADSS helmet-mounted display. Regardless, all visors generally are held to the optical specifications for refractive power, prismatic deviation, distortion, haze, impact resistance, etc., cited in MIL-V-4351 1C. The test for compliance of impact resistance uses a caliber .22 T37 fragment simulating projectile at an impact velocity between 550 and 560 feet per second. The test is conducted in accordance with MIL-STD-662.

Another deviation from the visor classes above is special purpose visors which are designed to provide protection from lasers (Figure 1). The luminous transmittance of laser visors can vary greatly depending on the wavelengths or combination of wavelengths for which the protection is being provided. Over the years, a number of types of laser visors have been evaluated for use (Rash and Martin, 1990; Bohling and Rash, 1991; Rash, Bohling, and Martin, 1991). However, except for a brief fielding period during the Desert Shield/Desert Storm war, the authors are not aware of any official designation of laser visors. However, a number of various types of laser visors are in use among many Army aviation units.

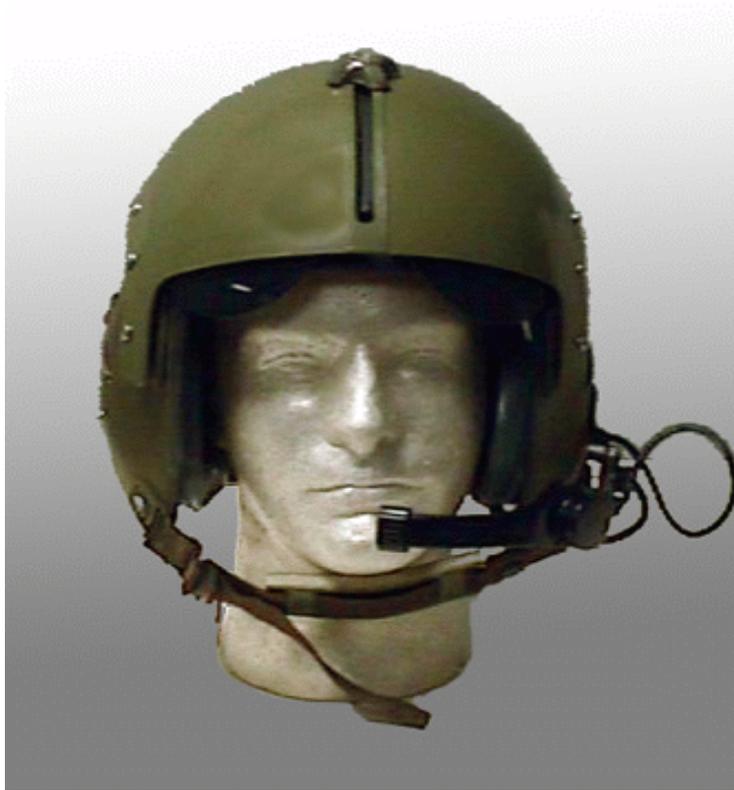
Figure 2. Aviator's Protective Helmet No. 5 (APH-5).

The APH-5 was based on a previous U.S. Navy design. It was molded from glass fabric and polyester resin, providing force distribution and penetration resistance. Helmet fit was achieved by means of pads used to contour the helmet to the head. While maintaining previously available impact protection, the APH-5 provided minimum hearing protection from aircraft noise (McEntire, 1997). The APH-5 incorporated a single visor.

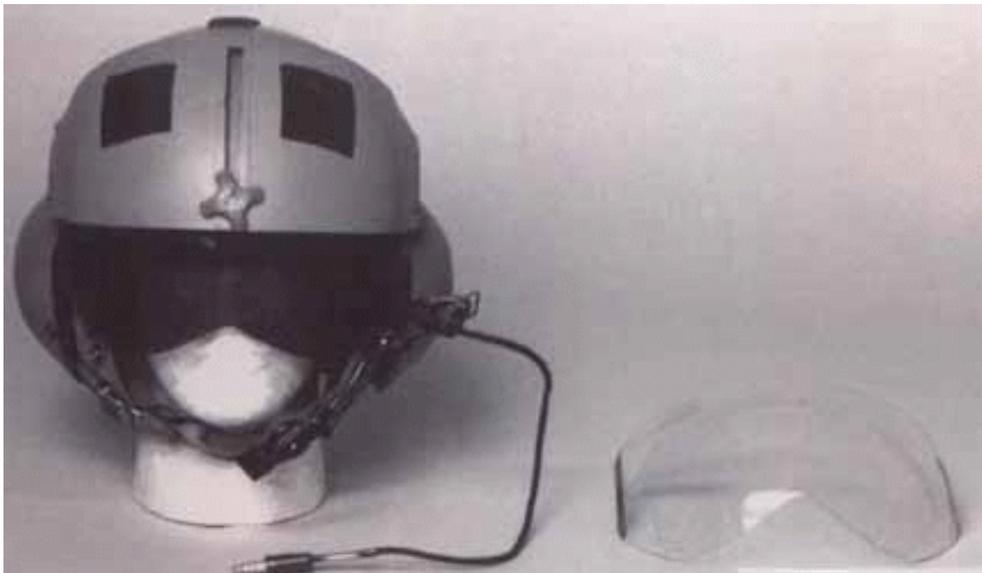
Figure 3. Special Protective Helmet No. 4 (SPH-4).

The SPH-4 was introduced in 1969. At that time, it provided state-of-the-art acoustic and crash protection to aircrew members. The single visor configuration was a tradeoff between weight, impact protection, electronics, etc. A maximum weight, a critical factor in fatigue and crash dynamics, was set at 3.5 pounds. The standard SPH-4 underwent two minor changes: in 1974, a thicker foam liner was used and, in 1982, a thinner shell was adopted. Post-fielding dual-visor adaptor kits were evaluated but rejected due to undue neck muscle fatigue which would be incurred. The recommended visor use at that time was to wear standard issue sunglasses under the clear visor (USAAVS,1975).

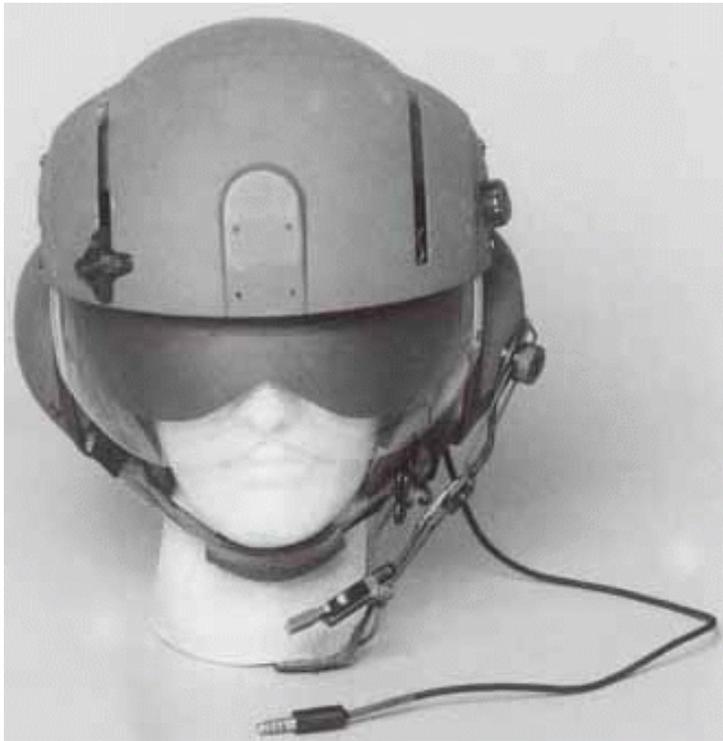
Figure 4. Special Protective Helmet No. 4B (SPH-4B).

The SPH-4B, a vastly improved version of the SPH4, was fielded initially in July 1991. Its outward appearance is similar to that of the SPH-4. However, its performance is quite different. It has an improved StyrofoamTM liner, new energy absorbing earcups, an improved retention system, a lighter shell of KevlarTM, an Aviator's Night Vision Imaging System (ANVIS) mount, a Thermoplastic LinerTM (TPL)TM, and a dual visor assembly (Carter, 1992). The dual visor design allows the use of either or both visors. The SPH4B is issued with a Class I (clear) and Class II (tinted) polycarbonate visor. The clear visor is mounted on the outside track, with the tinted visor being closer to the face.

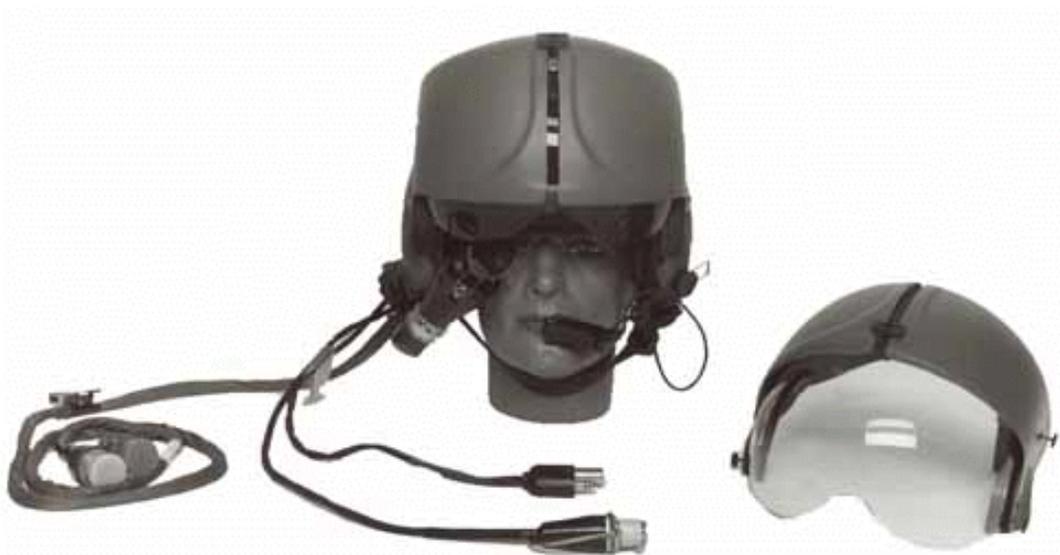
Figure 5. Integrated Helmet and Display Sighting System (IHADSS) Integrated Helmet Unit.

The IHADSS helmet was developed specifically and exclusively for use in the AH-64 Apache attack helicopter. First fielded in the early 1980's, the IHADSS helmet incorporates a helmet mounted display and head motion sensing capability. The IHADSS helmet provides impact and acoustical protection at least equivalent to that of the SPH-4 (which was, at the time of the IHADSS fielding, the current aviator helmet). Two visors (Classes I and II) are provided in separate visor housings. While only allowing use of a single polycarbonate visor at a time, the two visor housings can be rapidly changed out using simple thumbscrews. [Note: Due to the uniqueness of the IHADSS, the visors must be custom trimmed to enable them to be lowered over the helmet mounted display optics.] The IHADSS helmet was a crashworthiness challenge because now the helmet was being used as a platform for an HMD but still had to provide the visual, acoustical, and impact protection expected from a standard helmet.

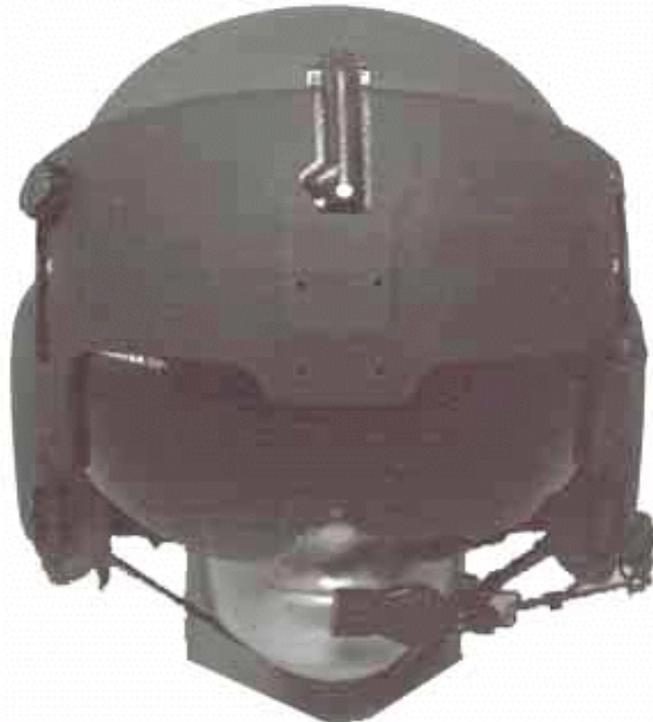
Figure 6. Helmet Gear Unit No. 56/P (HGU-56/P).

The most recently fielded aviator helmet is the HGU-56/P. Besides providing improved impact protection over the SPH-4B, the HGU-56/P moves toward an Army goal of having one common aviation helmet. The final version was fielded in 1995. The HGU-56/P (2.6 pounds) has a reduced weight over the SPH-4B (2.8 pounds). It retained the TPL™ liner and crushable earcups, but the Kevlar™ cloth shell used in the SPH-4B was replaced with a nylon and graphite cloth shell. The HGU-56/P uses polycarbonate visors, clear and tinted, mounted in a dual visor assembly. The clear visor is mounted closest to the face, reversed from the mounting in the SPH-4B. This change was initiated in hopes that future ANVIS designs would allow visor usage without degrading user performance.

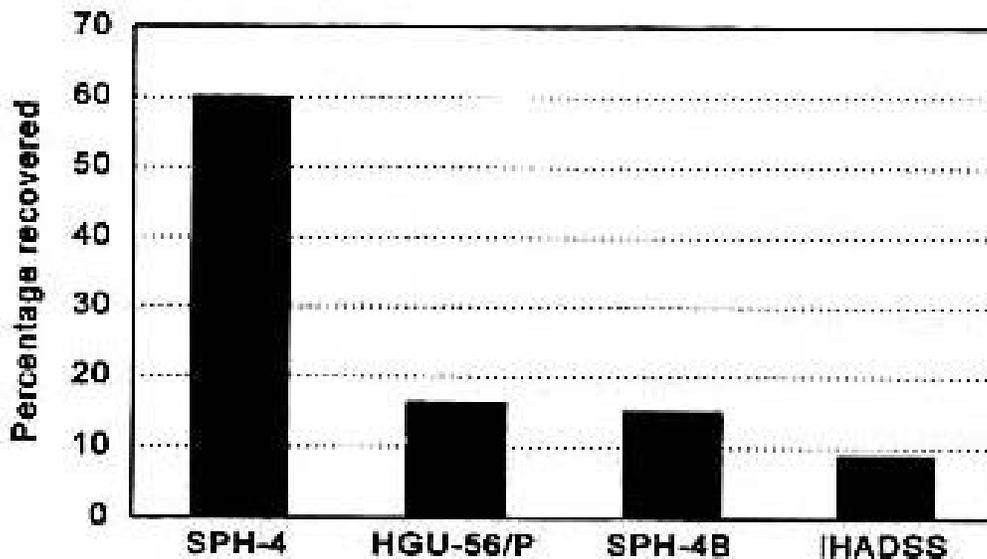
Figure 7. Helmets recovered form ALSERP 1990-1996.

Because head injuries remain the predominant cause of severe and fatal injuries to Army aircrew (McEntire, 1997), helmet safety has been a major focus of the ALSERP program. In an inspection of the Army ALSERP data collected during the years 1990-1996, information on 80 mishaps was studied. Included in the data was information concerning the ALSE of 55 aviators and 25 aircrew, all wearing one of the four basic Army aviation helmets: the SPH-4, the SPH-4B, the HGU-56/P and the IHADSS (Figure 7). While information was unable to be collected in some accidents due to postcrash fires and other traumatic events, the statistics do indicate that the majority (70.8 percent) of accident victims did experience some degree of head, neck, or facial injury. Half of all air crash victims were fatalities.

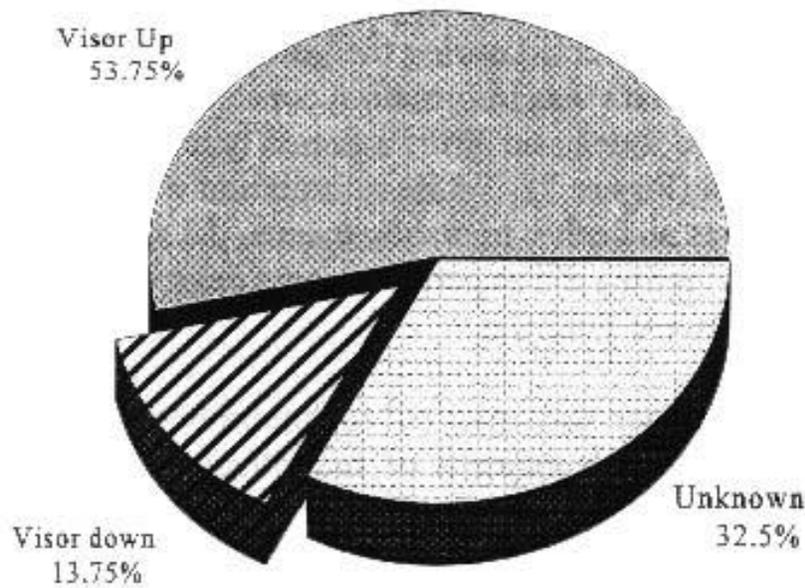
Figure 8. Visor Position for ALSERP 1990-1996 data.

For all retrieved helmets, visor damage was analyzed to determine the visor position at the time of impact. Of the helmets recovered, a majority of individuals (53.75 percent) were found to have been wearing their visor in the "up" position. [These figures include individuals who were flying with ANVIS. Because the visor cannot be deployed while using ANVIS, the visor is assumed to be in the "up" position.] Only 13.7 percent of the individuals were found to have been wearing their visors down at the time of the mishap (Figure 8). Helmets and visors too badly damaged to ascertain this information were classified as "visor position unknown." For the accidents where visor position was known, it is of interest to note that the frequency of head/neck and facial injuries experienced by both groups, visor up and down, was identical (70 percent) but varied drastically in severity. Those who wore their visors down frequently were reported to have minor injuries caused by the visor (often due to the visor edge impacting the cheek), but experienced fewer fatalities (18.2 percent for visor down versus 53.5 percent for visor up). This trend is consistent with results reported by Vymwy-Jones, Lanoue and Pritts (1988). Their study reported fatality rates of 26 percent among aviators wearing their visor down versus 34 percent for visor up.
