USAARL REPORT NO. 72-07

DYNAMIC AND CRASHWORTHY EVALUATION
OF THE UH-1B, C, D, H, MEDICAL ATTENDANT'S SEAT

January 1972

U. S. ARMY AEROMEDICAL RESEARCH LABORATORY

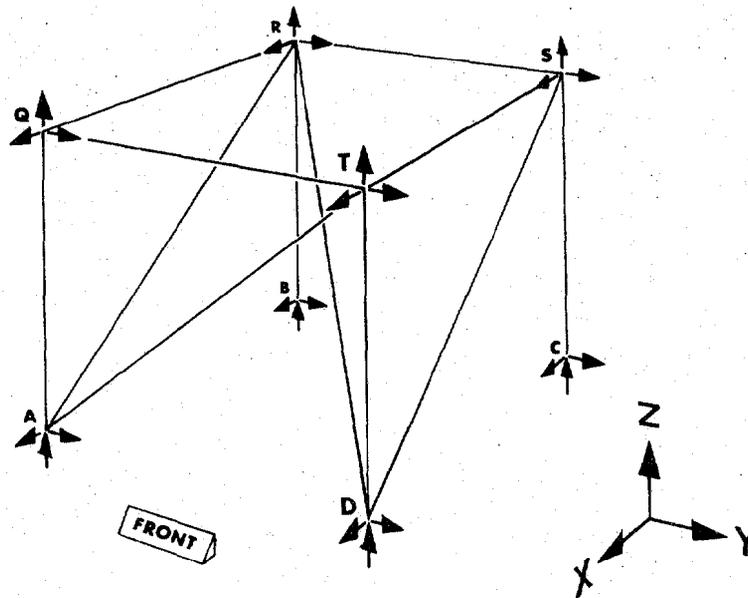
Figure 3. Representation of Structural Members for Analysis.

From the static analysis it was found that the weakest apparent member in the basic seat was the horizontal bolt securing the right rear female tab to the rear lateral seat pan frame member. The analysis predicted that this bolt would shear at an input to the seat of 7.4G, vertical deceleration. To allow for variation in the properties of materials and accuracies of instrumentation, the upper limit of input for the tests was placed at 8.0G. A low level of input, 4G, was used for each test as a baseline to see how the loading changed in the seat with changes in configuration.

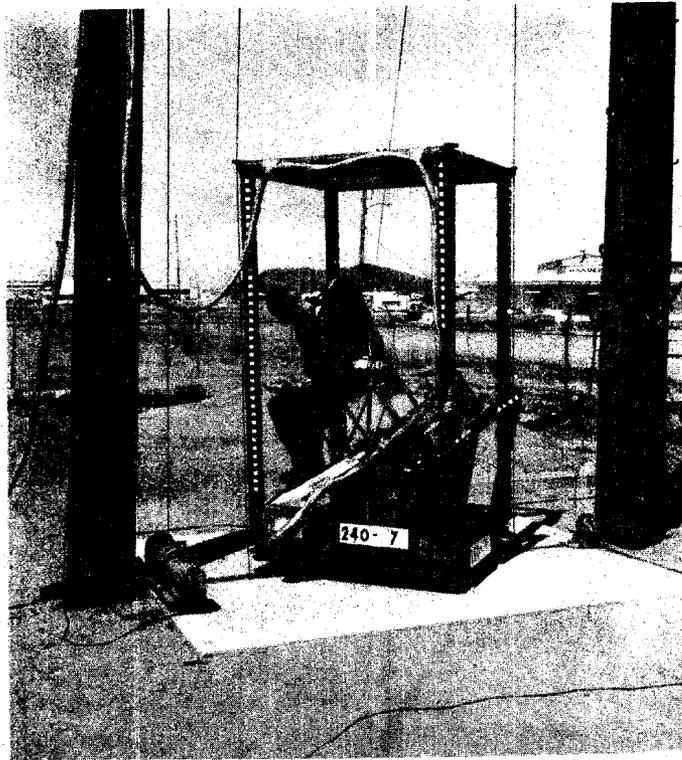
Figure 23. Seat Configuration 3 after Test 7.

Post-test inspection revealed no apparent damage although, when the test film was viewed, the seat back was seen to deflect elastically a considerable distance upon impact. Figure 23 shows a post-test side view. Peak dummy chest vertical deceleration was 28.8G.

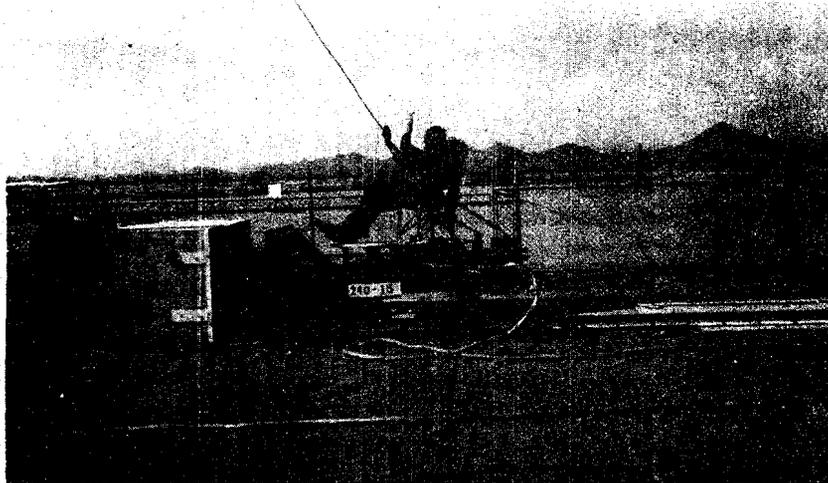
Figure 46. Seat Configuration 4 After Test 15.

Post-test inspection revealed four failures or incipient failures. The right and left side longitudinal seat tubes failed at the back brace tube joints (shown in Figures 47 and 50), the left side steel seat back tube was bent at the stiffener, the left side back brace tube was bent, and the male tangs on the upper end of all four leg assemblies were bent. The leg fittings were probably bent as a result of load shifting after failure of the longitudinal seat tubes. (See Figure 49) The maximum deceleration measured in the dummy was 8.91G in the longitudinal direction in the pelvis.

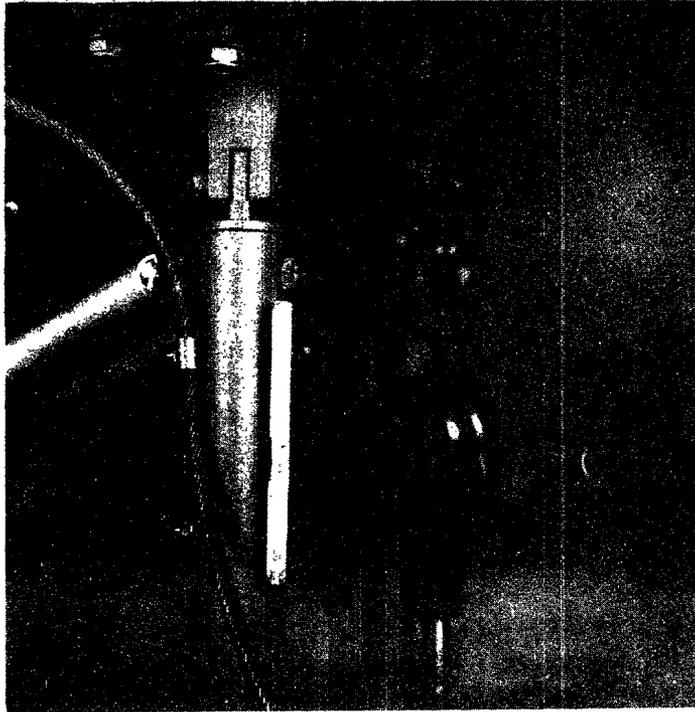
Figure 64. Correct Installed Position of Inertia Reel Mounting Plate. Note Locking Cable Secured to Upper Mounting Bolt.
