USAARL REPORT NO. 77-7

AEROMEDICAL EVALUATION OF UH-1 INTERNAL ADVANCED PERSONNEL RESCUE HOISTS
WESTERN GEAR CORPORATION HOIST MODELS 42277R1 AND 42305R1
BREEZE CORPORATION HOIST ECP-720 MODIFICATION

February 1977

US Army Aeromedical Research Laboratory
Fort Rucker, Alabama 36362

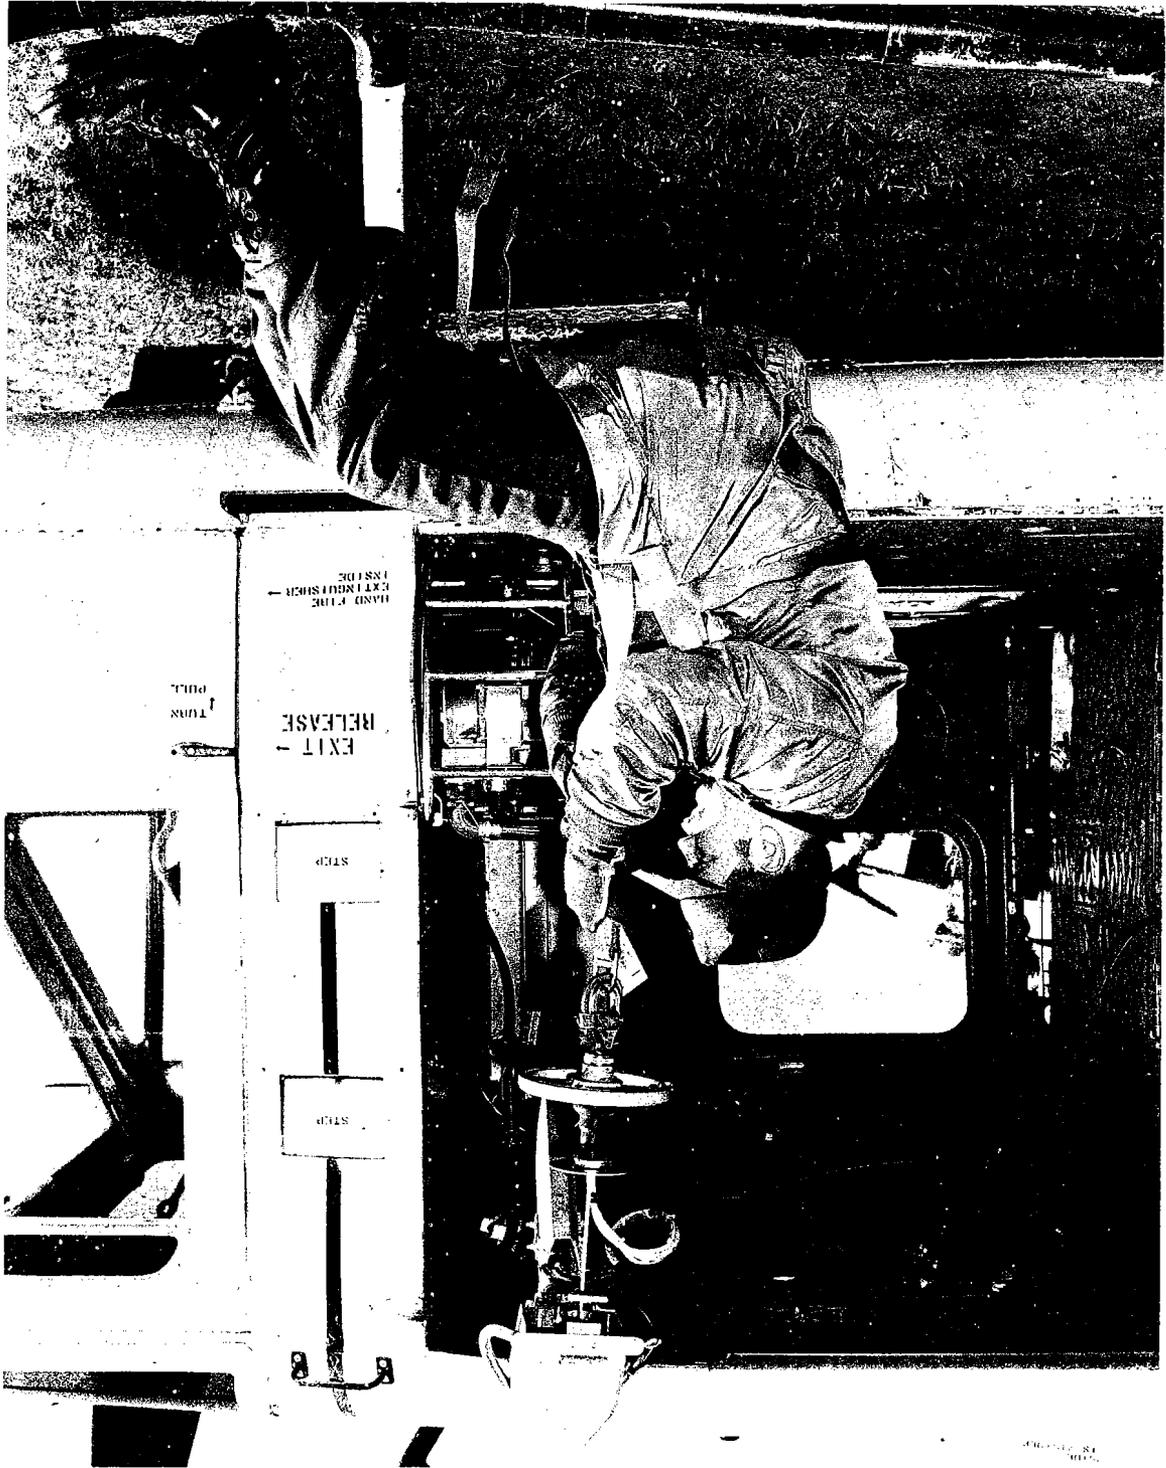
PHOTO F

Photographs A, C, E, and G illustrate the WGH hoist effect on entrance door and cabin space compared to the Breeze ECP-720 hoist photographs B, D, and F. Conservation of entrance door space, as well as absence of actuator base plate, is noted in photographs of WGH.

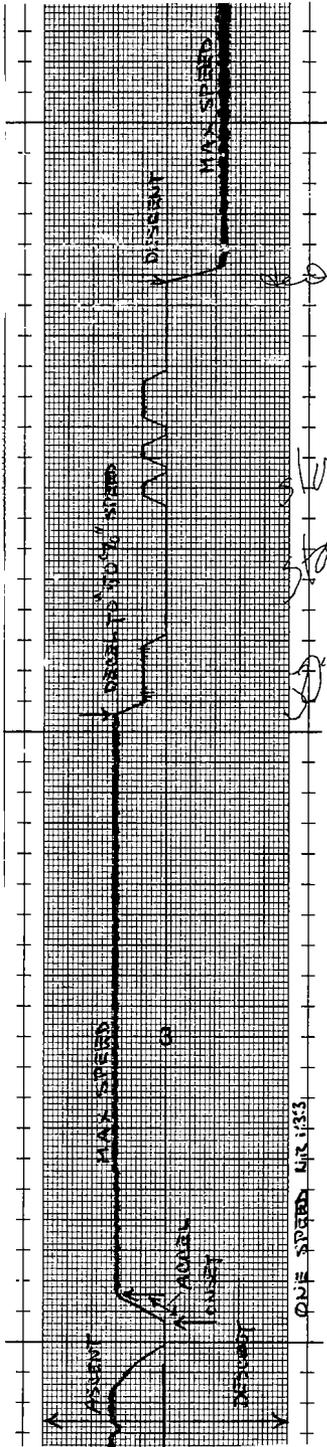
FIGURE 3 - 125 FPM

Figures 3 and 4 illustrate sample data acquisition of the velocity/acceleration profile recorded from the instrumented WGC hoists numbers 133 and 135.
