USAARL Report No. 95-10

**OH-58 Pilot Display Unit (PDU)
Simulated Crash Tests**

December 1994

**United States Army Aeromedical Research Laboratory
Fort Rucker, Alabama 36362-0577**

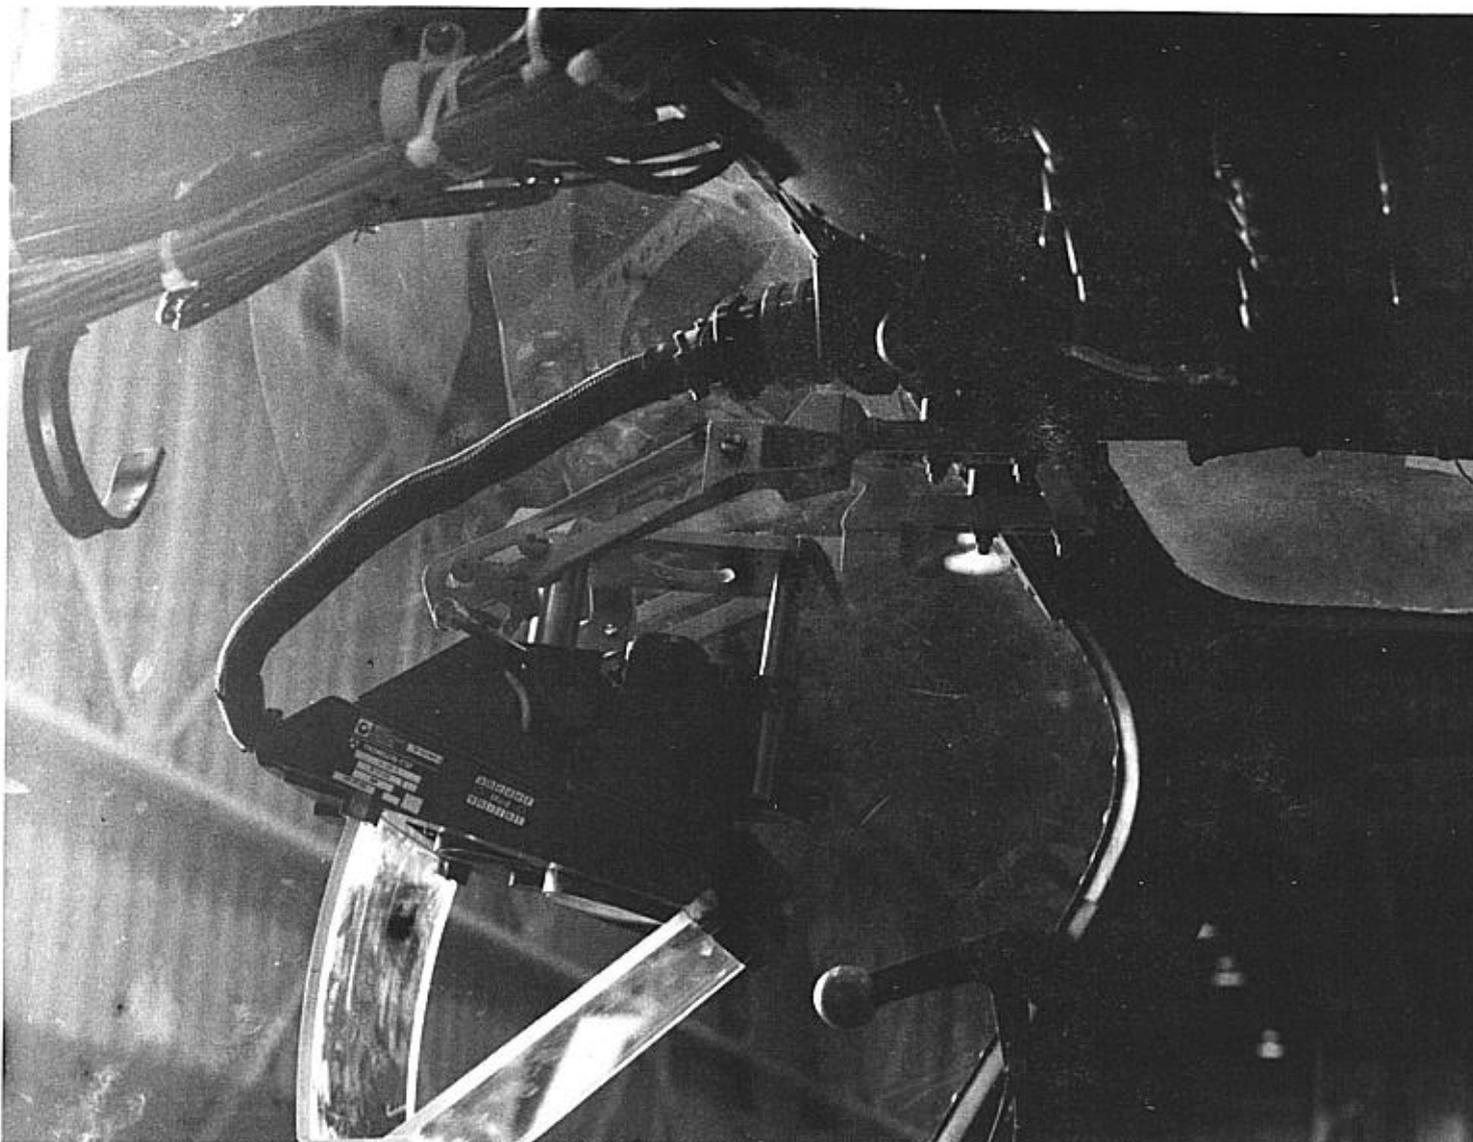
The unit as installed in the OH-58 helicopter is shown in Figures 1 and 2. The PDU is designed to break free at a deceleration of 2 G from the normal (flight) position, move forward and downward to the end of the slotted track, as shown in Figure 3. The prototype PDU was "drop" tested at the BHT facility in 1987 and the unit slid forward properly at 2 G deceleration (Powell, 1988). The PDU mount is detailed in BHT drawing 206-071-280-105.

Figure 1. Left side view of PDU installation, breakaway position shown.

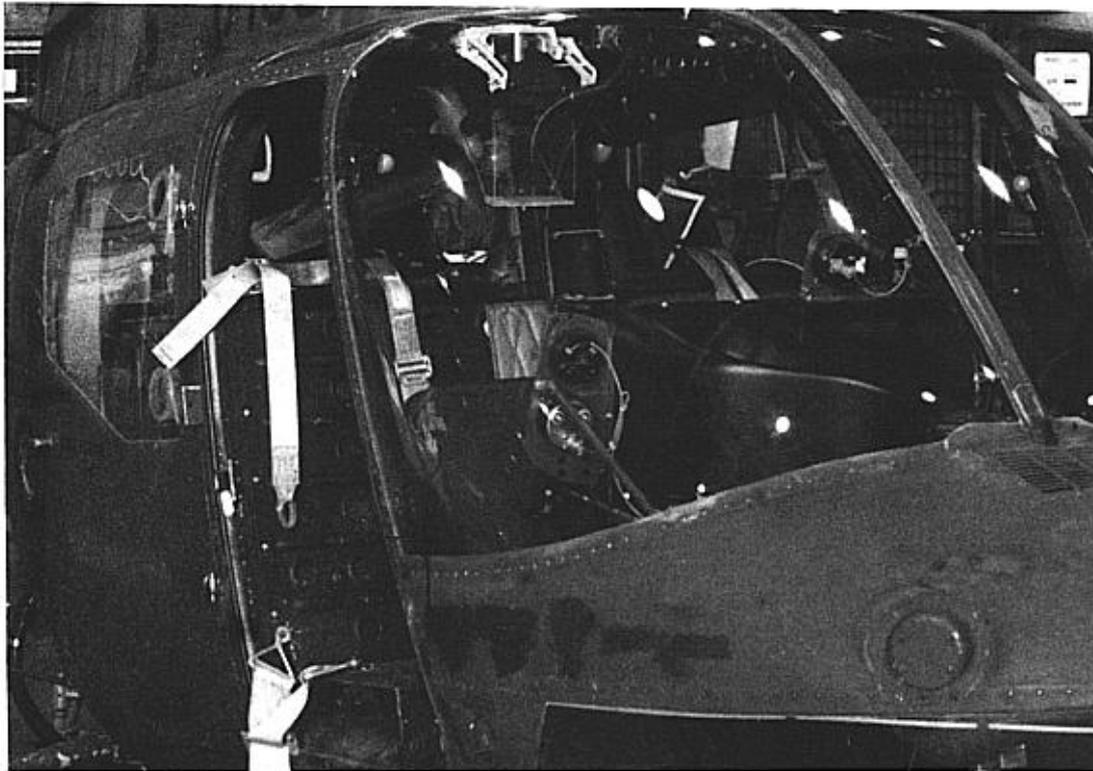
Figure 2. Front view of PDU installation, normal in-use position shown.

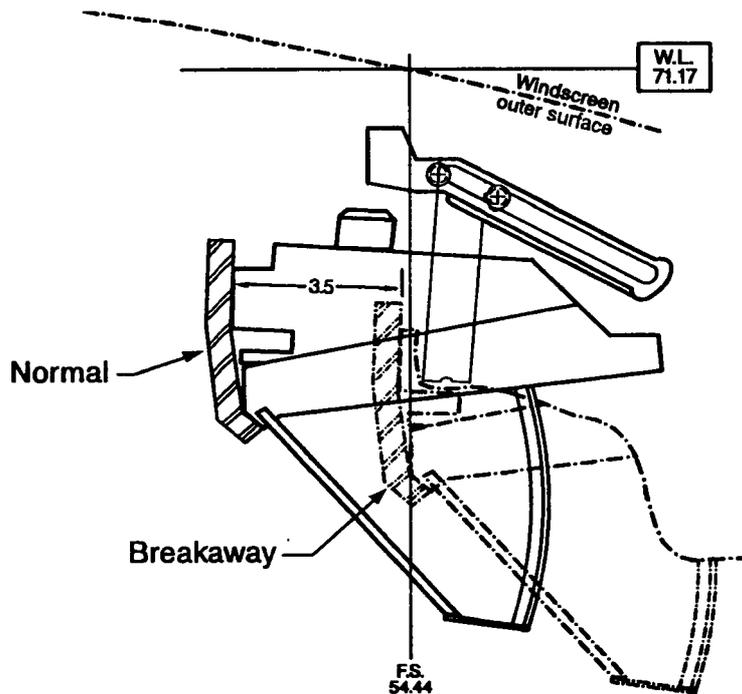
BHT prepared a dummy PDU test specimen and mount for the OH-58 test cockpit as shown in Figure 4. The dummy PDU was located the same as the actual device would be after "breakaway," i.e., 3.5 inches forward down the 29-degree slope ramp as shown in Figure 3. The dummy PDU was constructed to simulate the actual PDU adjusted 1 inch down from the "full-up" adjustment; thus the test was conservative because the eye height of the 50th percentile dummy actually was 0.27 inch higher than would be normal in most standard plastic mesh seats with the buttock reference point (BRP) at waterline (WL) 32.73 in lieu of WL 33.0 on the test crashworthy seat. The extra 0.27 inch represents a 59th percentile eye height for an upright pilot (Donelson and Gordon, 1991). However, the usual slumped flying posture indicates this would be an 83rd percentile pilot in slumped posture (slump subtracts approximately 0.9 inch). In any event, the test was conservative because a large percentile dummy eye height was used with the PDU adjusted down 1 inch for a small pilot so that a PDU strike was more likely to occur.

Figure 3. Profile sketch of PDU location in OH-58 cockpit showing the normal and crash breakaway position.

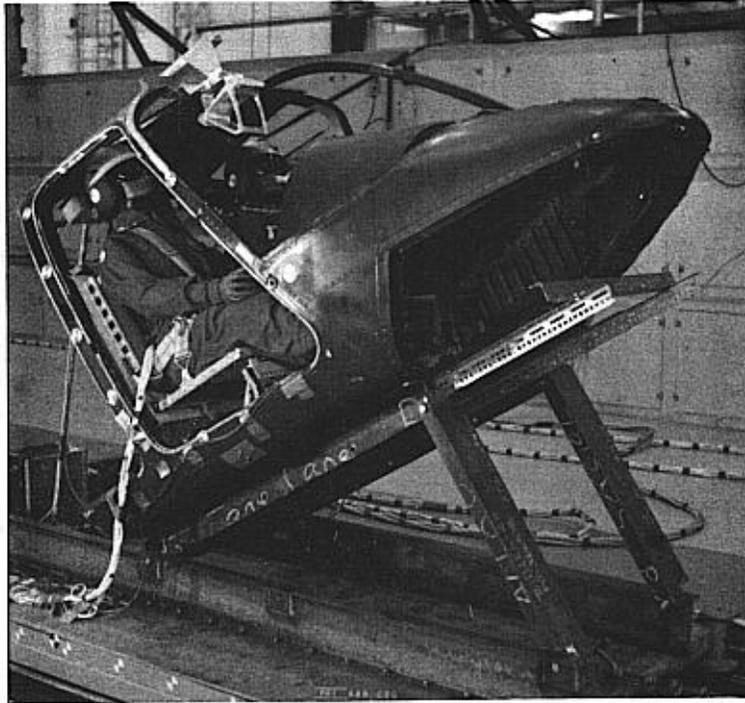
The setup for test 88060 is shown in Figure 4. As shown in Table 1, this test simulates a pitch down crash in which the vertical force is slightly greater than half the forward force. At 500 G/sec acceleration onset and 15-G peak combined with only 23.5 fps velocity, the impact was of moderate level. As shown in Table 3, the neck tensile force of 444 pounds and 613 inch-pound moment about the lateral (y) axis is about half that of the values in test 88063. The force transfer into the PDU ½-inch ENSOLITE™* foam from the helmet impact did not register on the neck load cell or the head accelerometers.

Posttest photos of test 88060 in Figures 4 through 9 show: (a) rotation of helmet rearward on right dummy, but not the left dummy, even though both have equal size 50th percentile heads; the difference may be due to the lack of neck flesh on the Hybrid II (50th percentile) dummy; and (b) the left seat crashworthy seat pan sustained enough downward force from the dummy's buttocks to move the pan down 0.6 inch, and to move the right seat down by 0.3 inch. This was a surprise since the impact vector was 15 G forward, and the seat pans stroke at 12 G vertical. The right seat pan was secured with steel straps to prevent movement in subsequent tests.

Figure 4. Pretest view of no. 88060; note the absence of crashworthy seat cushion and the dummy PDU and mount.

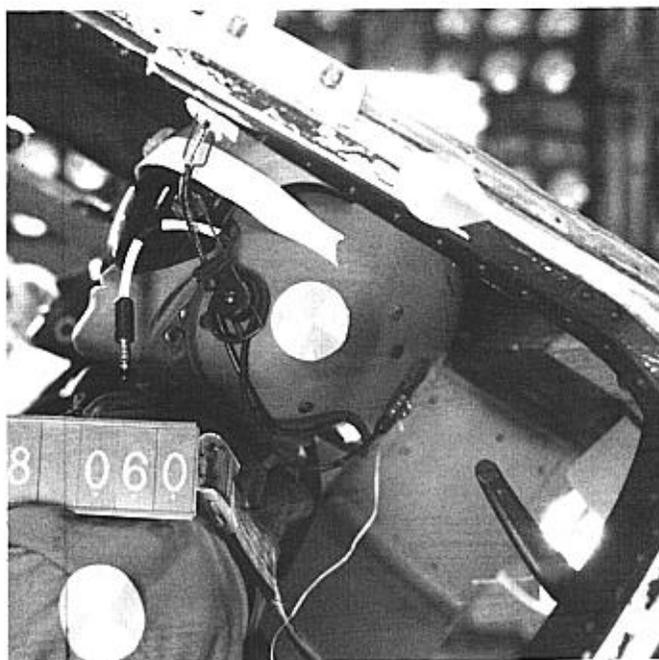
Figure 7. Posttest view of 95th percentile dummy in left seat.

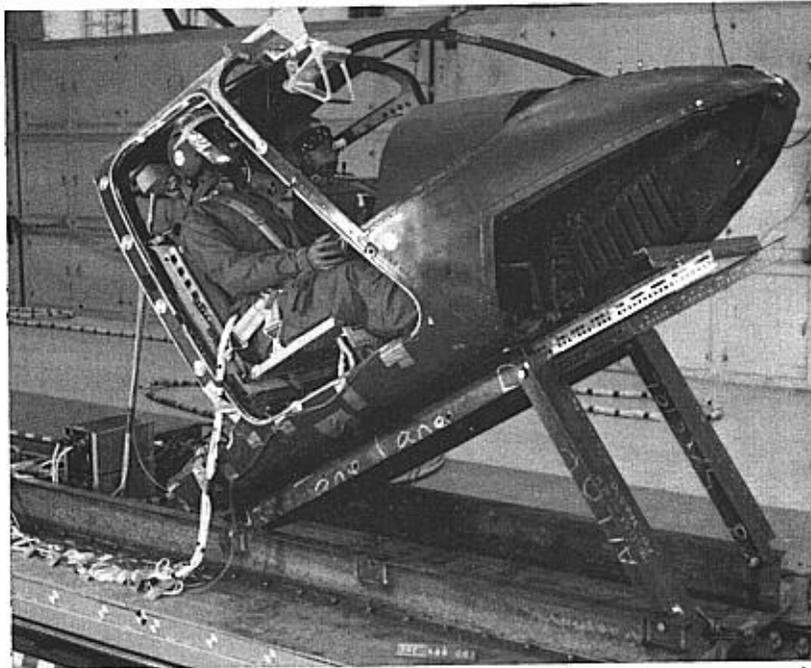
The setup is shown in Figure 10, the straps to secure the right seat are shown along with the reinforcement of the left forward door bulkhead. The posttest photo is at Figure 11.

Figure 10. Pretest view of CAMI 88061; note aluminum strap on inside of left door frame and steel strap on right seat.

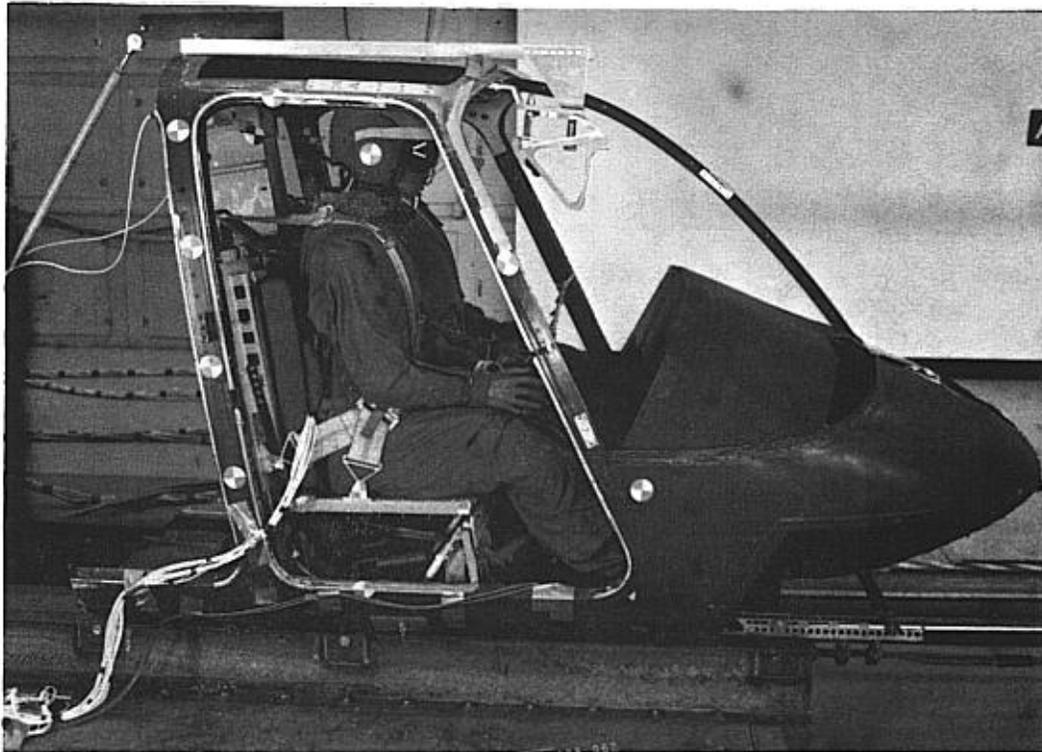
In this pure longitudinal x-axis test, the likelihood for PDU impact is greatest. The right dummy was placed 1.5 inches forward in the seat by use of a wooden spacer between the dummy and the seat cushion as shown in pretest Figures 12 and 13. Damage to the aircraft structure is documented in Figures 14 through 18.

Figure 12. Pretest of no. 88062; note potentiometer cable attached to back of helmet.

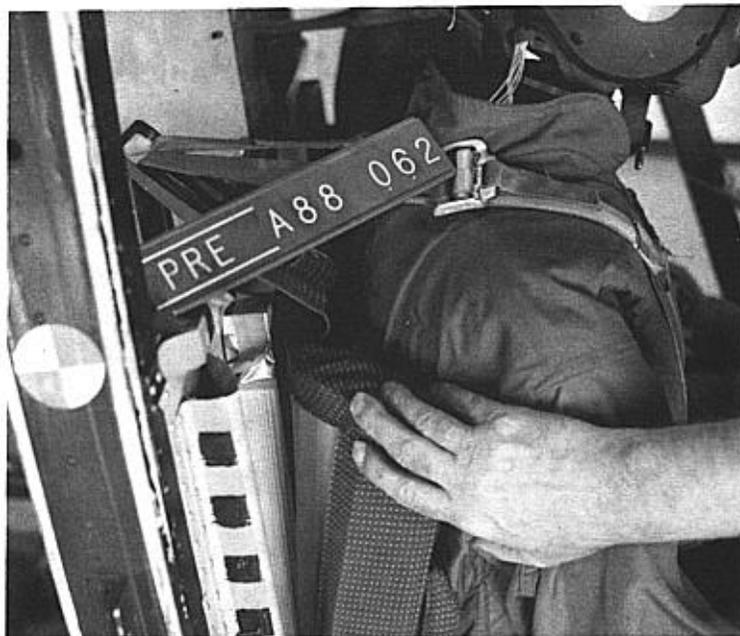
Figure 13. Pretest view of no. 88062; note board placed at back of seat to place right dummy 1.5-inch forward.

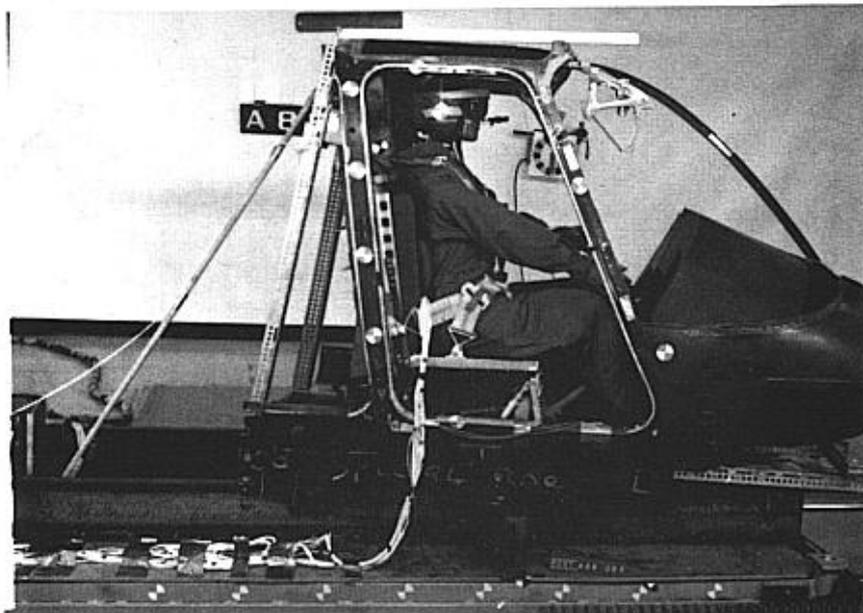
Figure 20. **Posttest view of no. 88063; note the actual production PDU mount in place and bulkhead 73.04 reinforcement.**

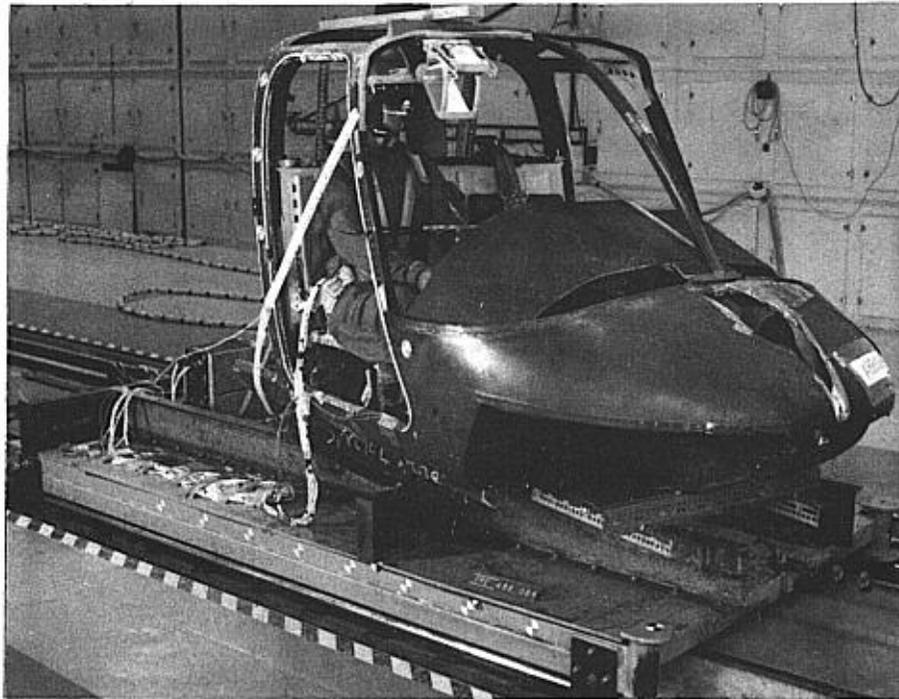
This test was a repeat of test 88063 except the dummy was moved forward 1.5 inch by placing a wooden block behind it and to the right by 1.5 inch by simply sliding the dummy to the right, flush against the lap belt inner surface (Figure 21). In addition, an 0.05 x 1.5-inch aluminum strap was added to the right door opening as shown in the same figure. This strap was intended to reduce elastic deflection of the upper door post.

Figure 21. Pretest view of no. 88064; note diagonal aluminum strap added to prevent forward movement of upper door post.

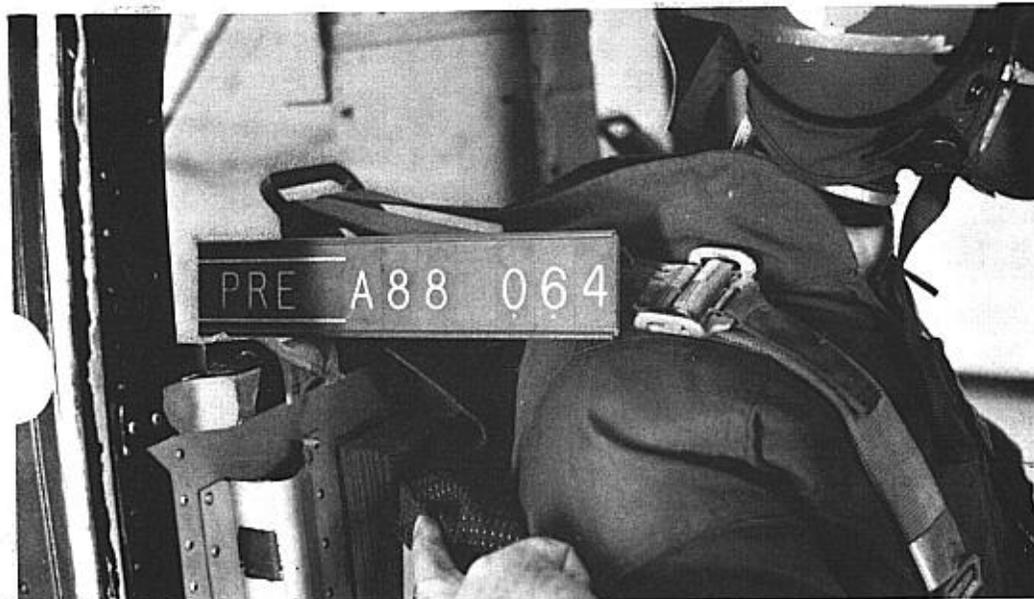
Figure 22. Pretest view of no. 88064; note board behind back cushion to move dummy forward 1.5 inch.

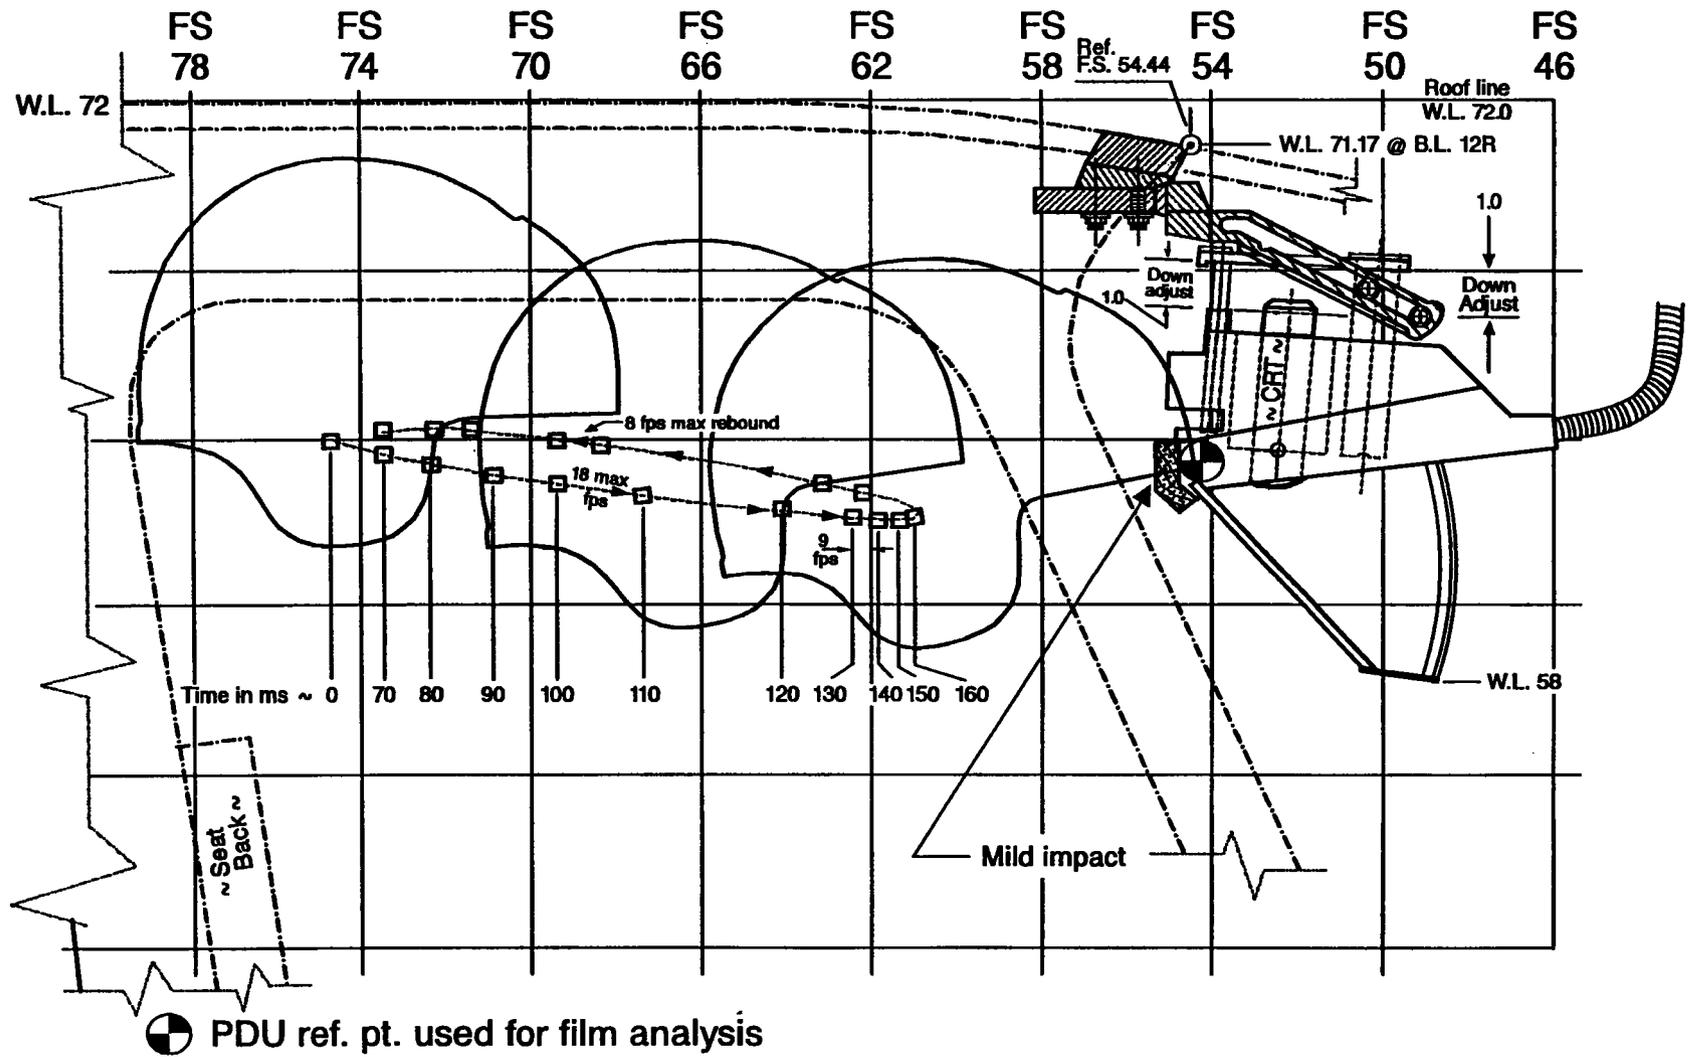
The movement of the right pilot's helmeted head was determined by film analysis and is shown to one-quarter scale for all five runs in Figures 27 through 31.

Figure 27. Helmeted head displacement in 30-degree pitch down test 88060.
