USAARL Report No. 88-15

**SPH-4 U.S. Army Flight Helmet Performance
1983-1987**

**Peter Vyrnwy-Jones
Bernard Lanoue
Douglas Pritts**

**U.S. Army Aeromedical Research Laboratory
Fort Rucker, Alabama 36362-0577**

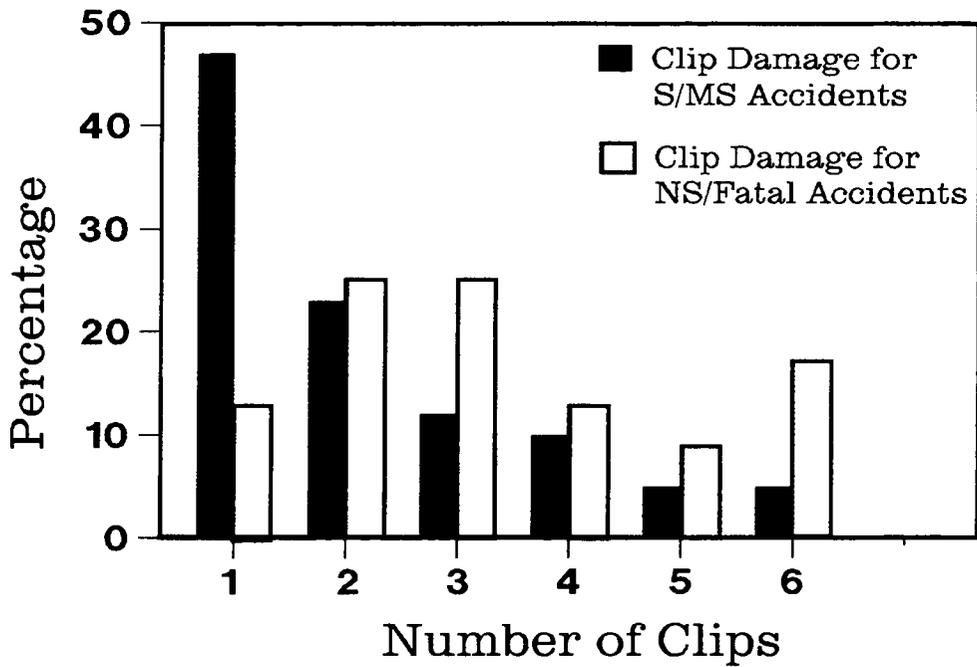
Figure 8 illustrates the distribution of clip damage and demonstrates the more extensive damage associated with non-survivable or fatal accidents. Nevertheless, almost 10 percent of survivable accidents had clip damage which required an applied load of at least 300-360 lbs.

Figure 8. Clip damage distribution for SPH-4 helmets, comparing survivable/marginally survivable (S/MS) accidents with nonsurvivable (NS)/fatal accidents.

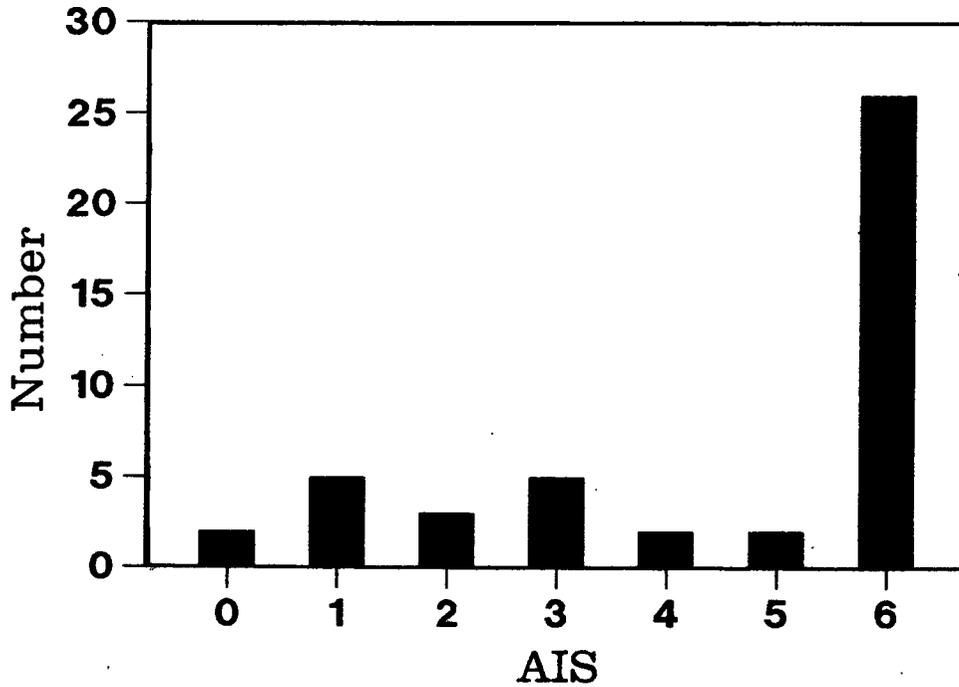
Both earcups were involved in 16 helmets and the left and right cups were damaged on 15 and 13 occasions, respectively. The AIS 1980 distribution for those helmets where earcup damage was recorded is presented in Figure 10.

Figure 10. AIS 1980 distribution for helmets with earcup damage.

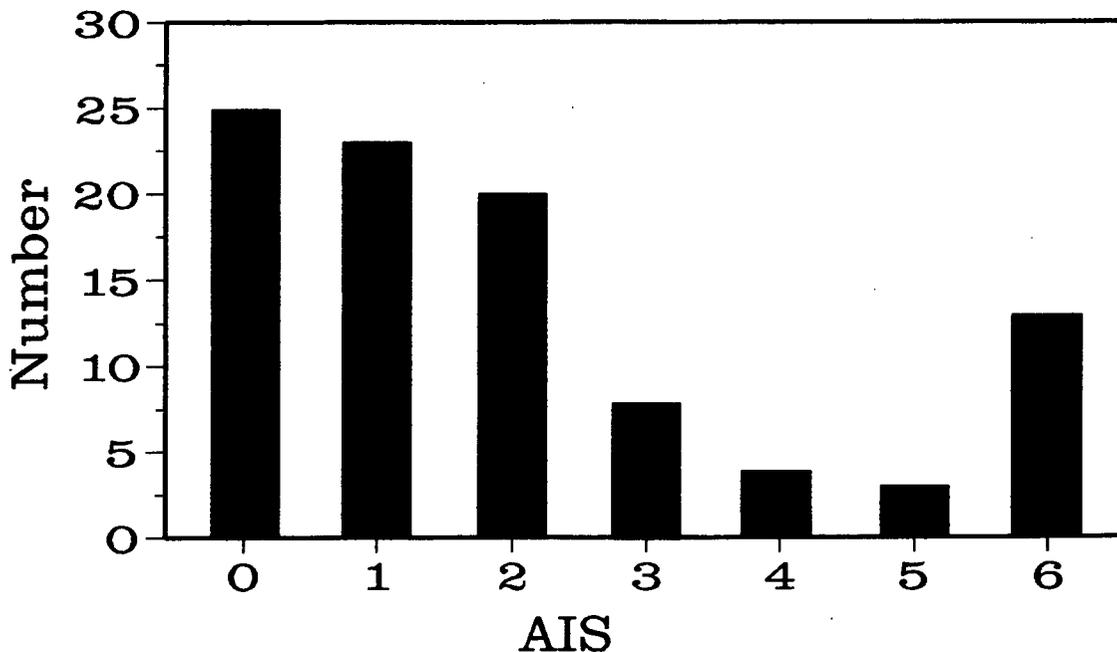
The distribution of head injuries in terms of severity as described by the AIS 1980 system are depicted in Figure 11. This compares the AIS distribution of survivable and potentially survivable cases with that for all cases including non-survivable accidents. As already explained, AIS values range from 0 (no injury) to 6 (currently considered untreatable).

Figure 11. AIS 1980 distribution for survivable/marginally survivable cases.

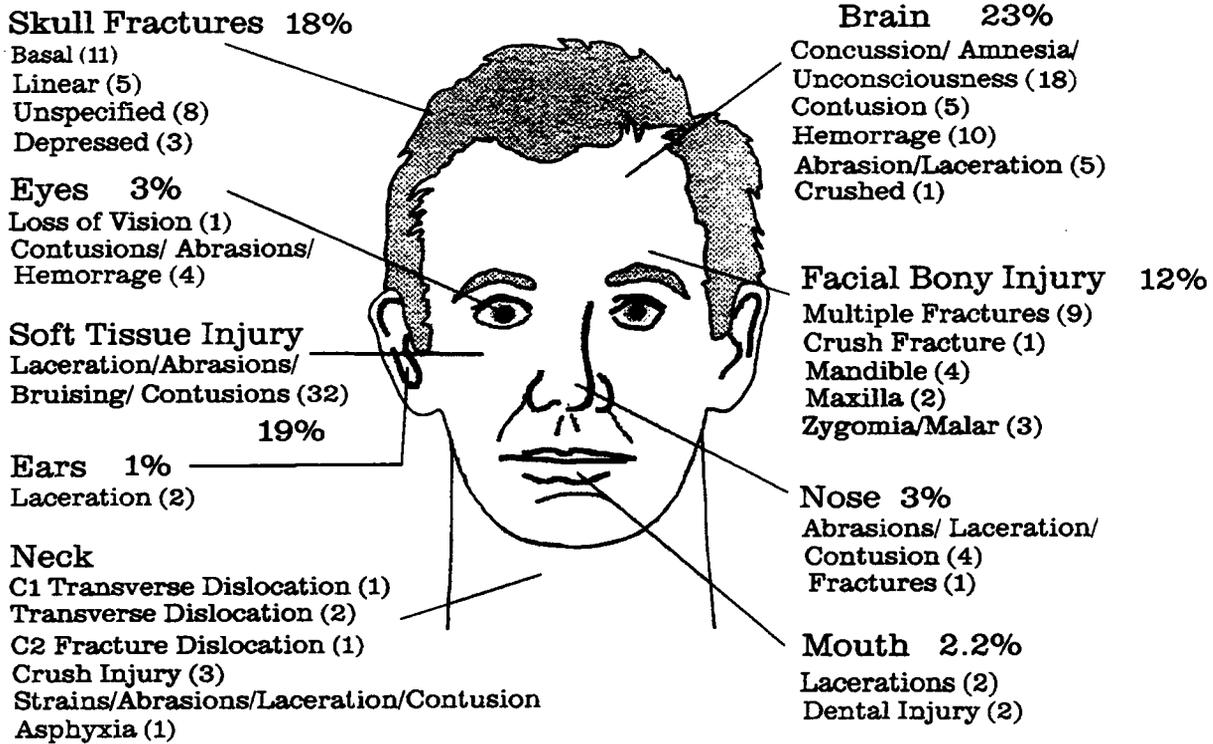
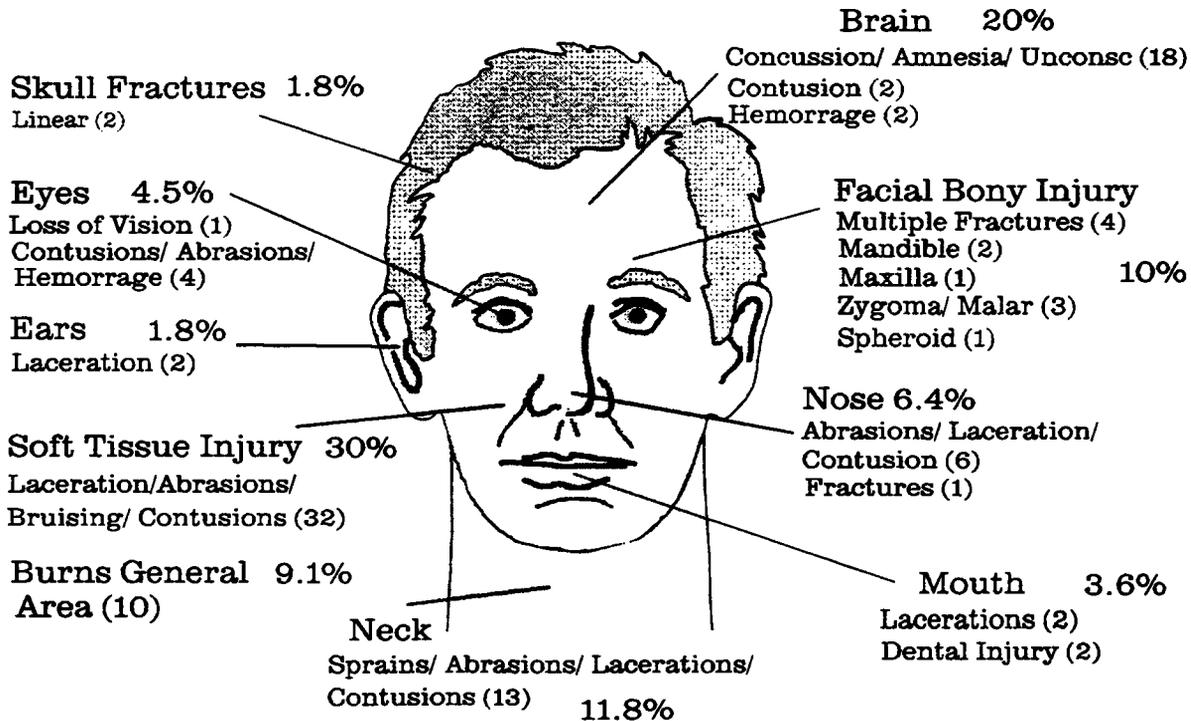
Figure 12. Head injury distribution - all cases.

Figure 13. Head injury distribution - survivable and potentially survivable cases.

The distribution of the head injuries is illustrated in Figures 12 and 13. The most common recorded type of skull fracture is basilar and these almost invariably are caused by lateral impacts to the helmet, as described by Shanahan (1985). In the present series, all basilar skull fractures, except for one, occurred in nonsurvivable impacts. The exception (AH-64) is discussed below.

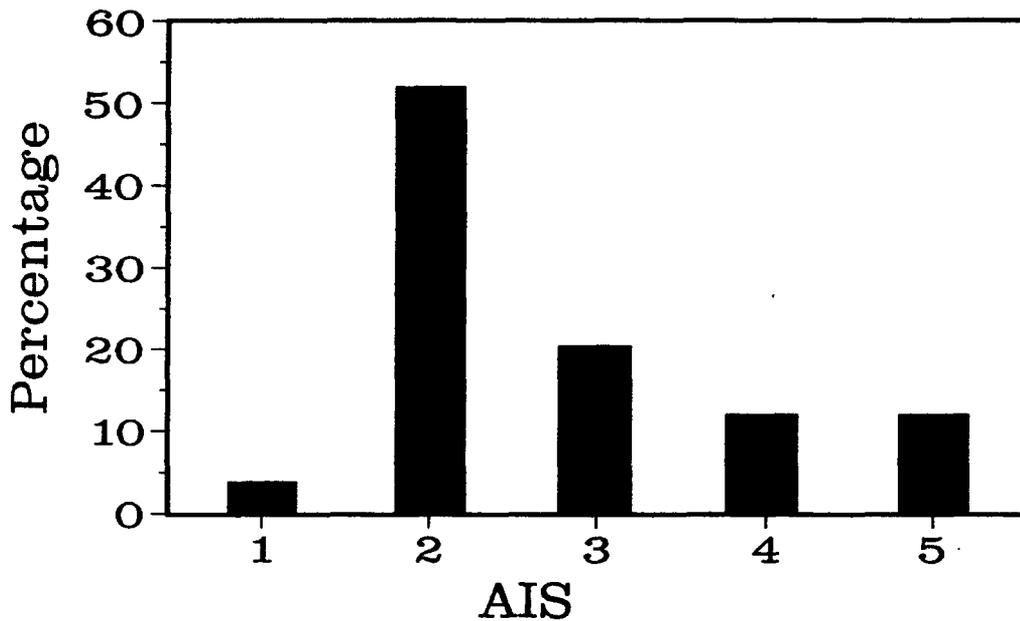
Unconsciousness or amnesia (retrograde or antegrade) were recorded only in 19 instances and all of these involved survivable or potentially survivable accidents. None resulted in a fatality. Periods of unconsciousness ranged from 1 minute to 96 hours and the period of amnesia ranged from 3 minutes to 48 hours. These data are shown in Figures 15 and 16. It was not possible to divide the period of amnesia into antegrade and retrograde types due to lack of precise detail on the DA Form 2937. The AIS distribution for those cases with recorded periods of unconsciousness or amnesia is shown in Figure 17.

Figure 17. AIS 1980 distribution for those cases with recorded periods of unconsciousness or amnesia.

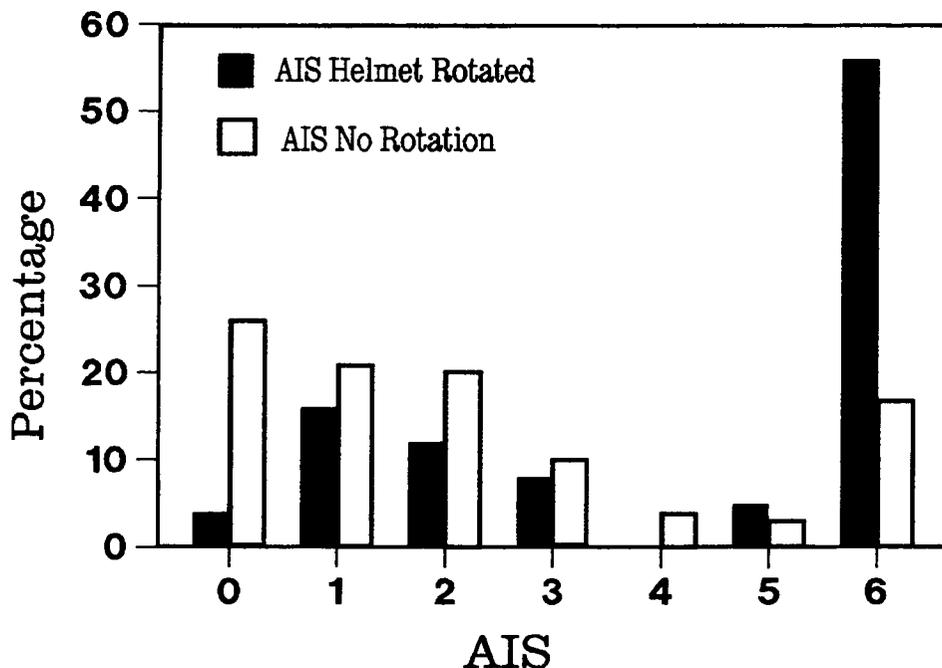
Figure 18 compares the AIS 1980 distribution of those helmets in which rotation or loss occurred and those cases in which the helmets are recorded as having been retained with little or no rotation.

Figure 18. AIS 1980 distribution related to helmet rotation.

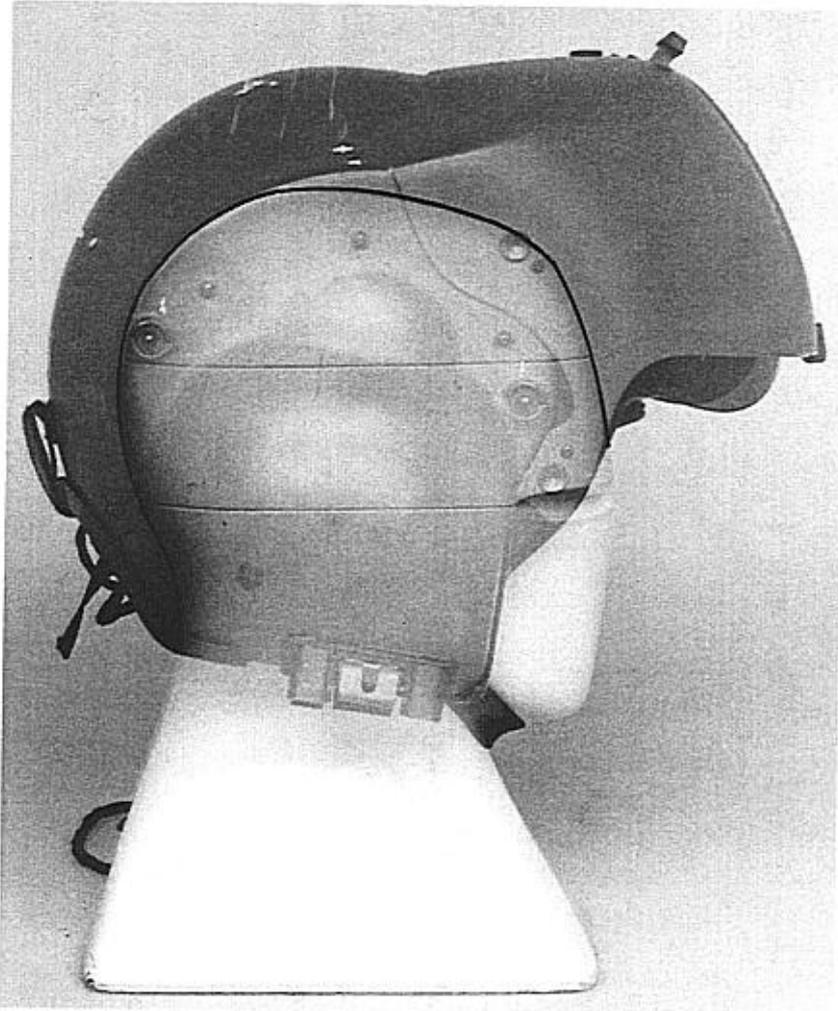
Figure 20 portrays the large increase in helmet volume, which has been the result of trying to optimize the performance of the visor in relation to the HMD unit. A recent accident investigated by USAARL demonstrated a blow to this visor cover could transmit the impact energy directly to a portion of the helmet, where there is no energy absorbing liner. The compressive force was estimated to be in the region of 1000 lbs. There is little doubt that the increased profile and strike range of this helmet were the cause of the injuries sustained in this case.

Figure 20. The large increase in potential strike envelope produced by the IHADSS helmet.

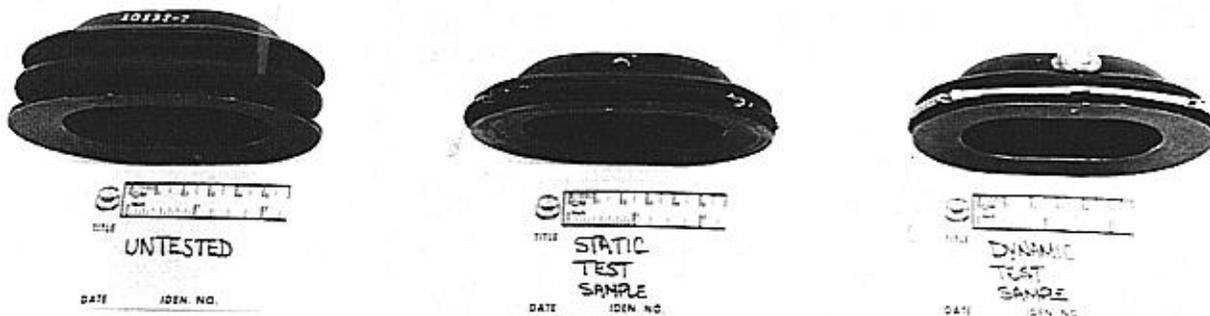
performed at USAARL have shown that the dynamic load required to fracture the standard earcups varies from approximately 750 lbs to crack the inner flange to over 5000 lbs to fracture the main body. Tolerance of humans to fracture in the temporo-parietal area is recorded as being as low as 400 lbs (Schneider and Nahum, 1972). A "crushable" earcup which would absorb energy during impact has been developed by USAARL under United States Army Contract DABT 01-79C-0250-1. The design is based on the requirement that the acoustical protection should equal or exceed that of the existing earcup and the crushing characteristics of the earcup should provide enhanced impact protection to the wearer's head. One such prototype earcup constructed of convoluted aluminum is shown in Figure 23. The specifications for the planned replacement helmet for the SPH-4, the Head Gear Unit No. 56 (HGU-56), requires the inclusion of an energy-absorbing "crushable" earcup. The reduction of force achieved by this method is a definite improvement and would surely contribute to injury reduction as indicated by Haley et al. (1983).

Figure 23. Convoluted aluminum earcups before and after static and dynamic testing.

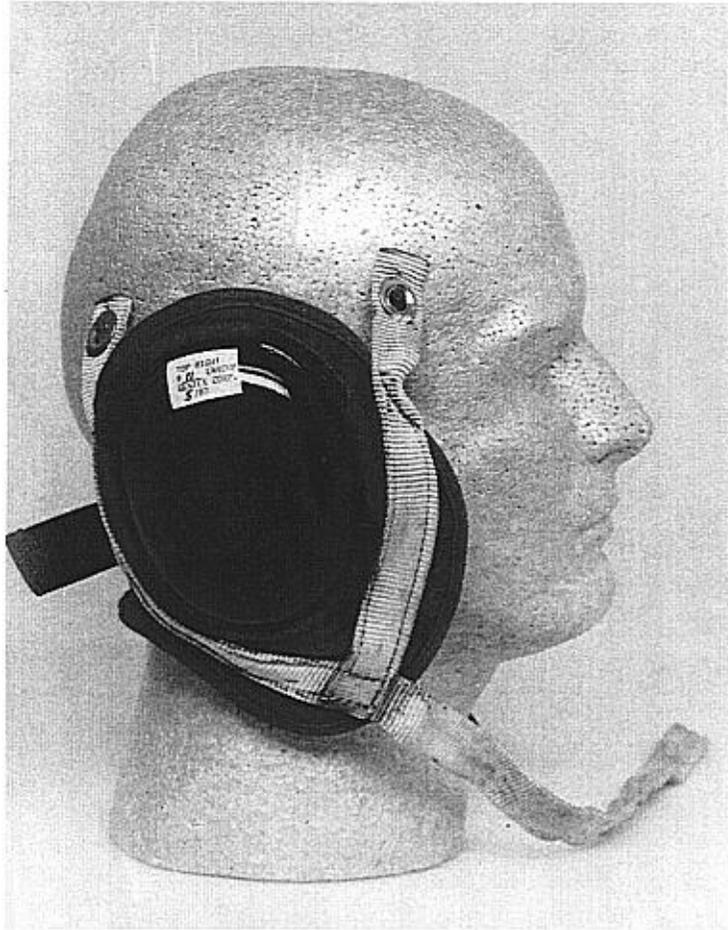
Figure 27. Reinforced retention system which eliminates the need for snap fasteners and retention tabs.

As already explained, part of the problem can be solved by the use of the TPL liner. However, the inherent difficulties associated with the elongation of the chinstrap and nape-ear cloth assembly still remain. One possible solution has been suggested by USAARL. This involves the use of a reinforced retention assembly. This modification increases the retention capability of the SPH-4 from a load of 280 lbs - 450 lbs, reduces helmet movement under simulated impact conditions by 45%, eliminates retention tab stitching failure, and distributes the loads over a greater area (Figure 27).

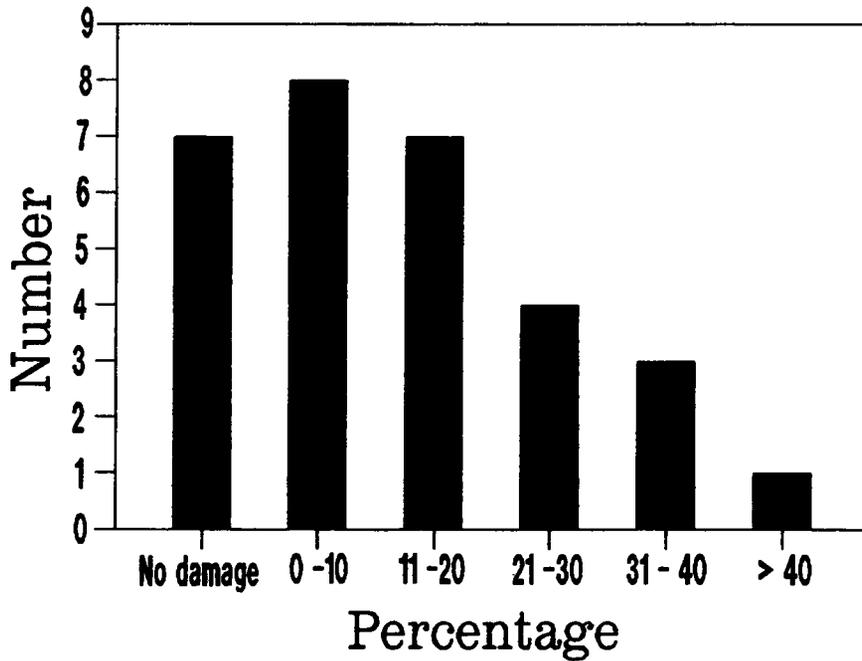
An analysis was carried out of the damage sustained by helmets when a period of unconsciousness or amnesia was recorded in the original records. There were 25 such cases and the percentage of foam compressed ranged from 0 to 50 percent. The distribution is shown in Figure 28. This data refers to all impacts and some helmets were struck on more than one occasion. As can be seen, the majority of helmets have little or no foam compression recorded; however, when one examines the site of the major impact, the majority (90 percent) involve either earcup, frontal damage, or the facial region. These are

the areas where foam is either deficient or totally lacking. These facts are illustrated in Table 14.

Figure 28. Percent foam compression in cases involving periods of unconsciousness or amnesia.
