MAJOR ORIENTATION-ERROR ACCIDENTS IN REGULAR ARMY UH-1

AIRCRAFT DURING FISCAL YEAR 1967: ACCIDENT FACTORS

W. Carroll Hixson, Jorma I. Niven, and Emil Spezia

October 1970

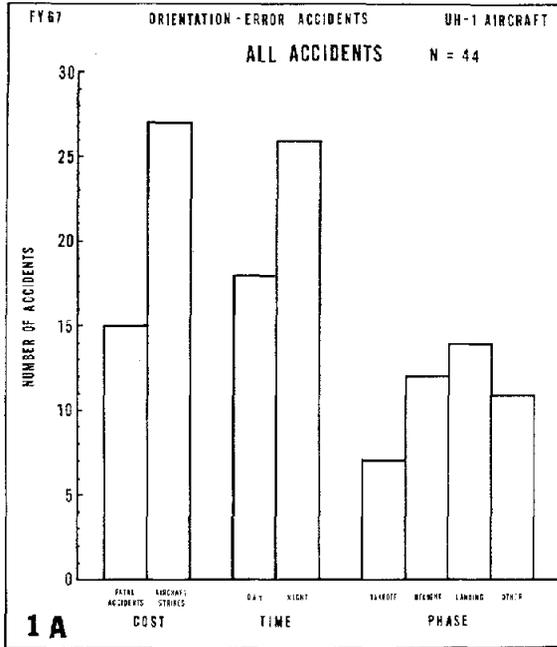
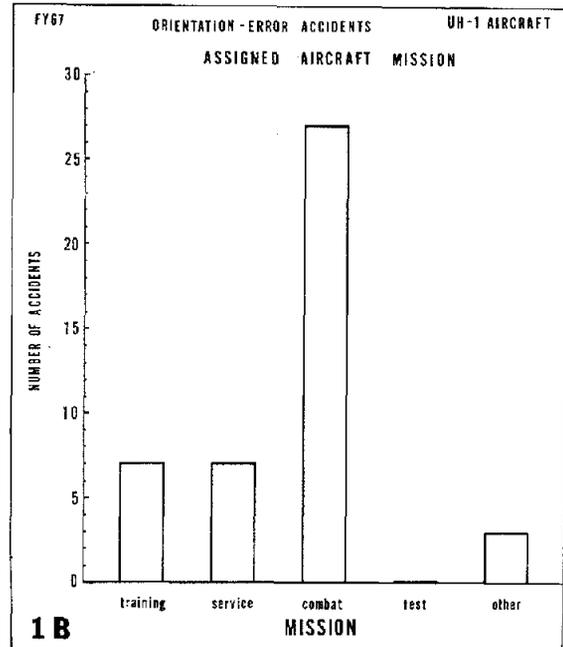
Figure 1

Major orientation-error accidents occurring in Regular Army UH-1 aircraft during fiscal year 1967. Number of fatal accidents, number of aircraft strikes, time of day of the accidents, and the flight phase in which the accident occurred (A); and types of missions assigned to the accident aircraft (B).

Before presenting the individual case-history data for these 44 accidents, a brief summary will be made of selected background information pertinent to the accidents as a whole. As indicated by the cost data in Figure 1A, the hazard of orientation-error accidents was considerable for that fiscal year. Some 34.1 percent of the accidents were fatal, while 61.4 resulted in a total loss of the aircraft. The time-of-day data show that the majority of the accidents (59.1 percent) occurred at night. In terms of the phase of flight in which the accident occurred, Figure 1A indicates that the greatest number of accidents took place while landing, the least during takeoff. It should be noted that the "other" phase classification used in this report denotes localized operations, such as reparking an aircraft, lifting a sling load, or moving an aircraft to a nearby refueling site. Though such operations may involve a takeoff, a short hovering flight, and a landing within the confines of a field, the takeoff classification is reserved solely for conventional outbounds or departures, the landing classification for inbounds, and the inflight classification for the intermediate phase.

The mission data presented in Figure 1B show that the majority (61.4 percent) of the accidents occurred on flights that had some form of combat-related mission assignment. This would be expected since 37 (84.1 percent) of the 44 accidents occurred in Vietnam. The reader is reminded that although a combat mission may have been assigned to the crew, the resulting mishap was an accident and not a loss attributable to direct enemy action.

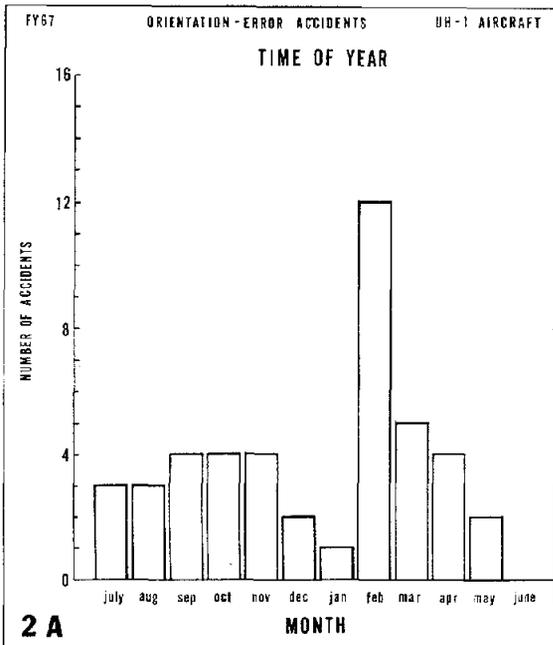
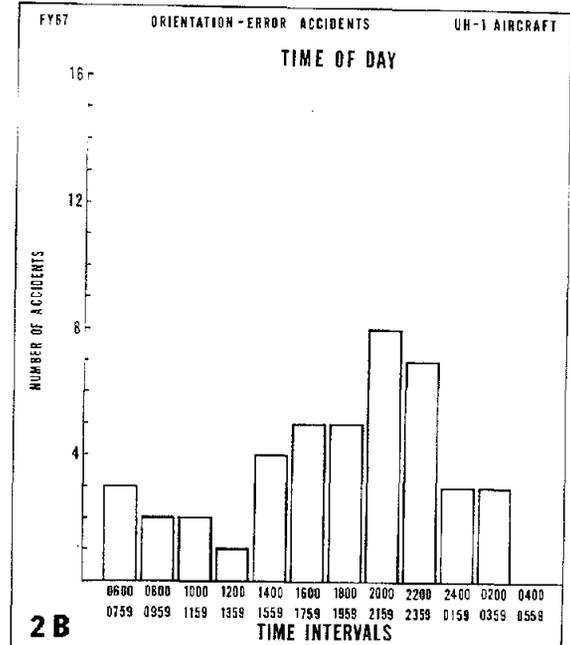
Figure 2

Number of orientation-error accidents as a function of the time of year (A) and the local time of day (B).

In Figure 2A a distribution is given of the number of accidents during each month of the fiscal year. Since the majority of the accidents occurred in Vietnam, the time-of-year incidence of accidents due to weather and dust peaked in that country's monsoon and dry seasons, respectively. Interpretation of these data beyond this point is restricted by

the month-to-month variations in the level of combat operations being conducted at a given time. Similarly, the daily variation in frequency of operations would affect interpretation of the hourly distribution data plotted in Figure 2B which shows accident incidence in 2-hour increments over a 24-hour period.

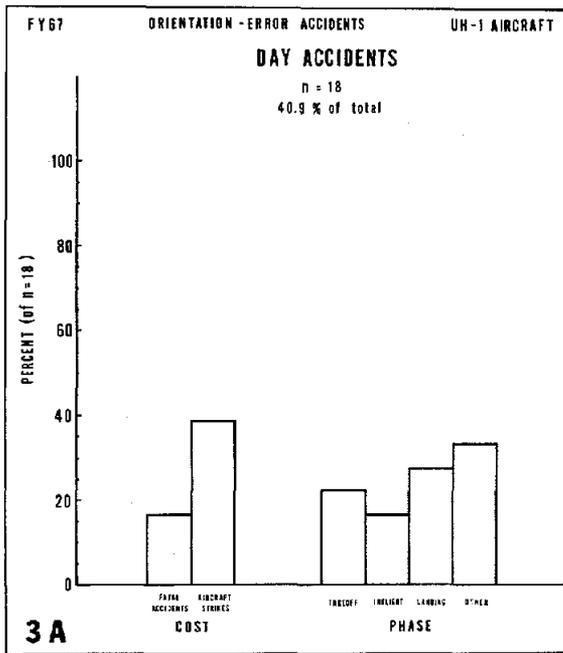
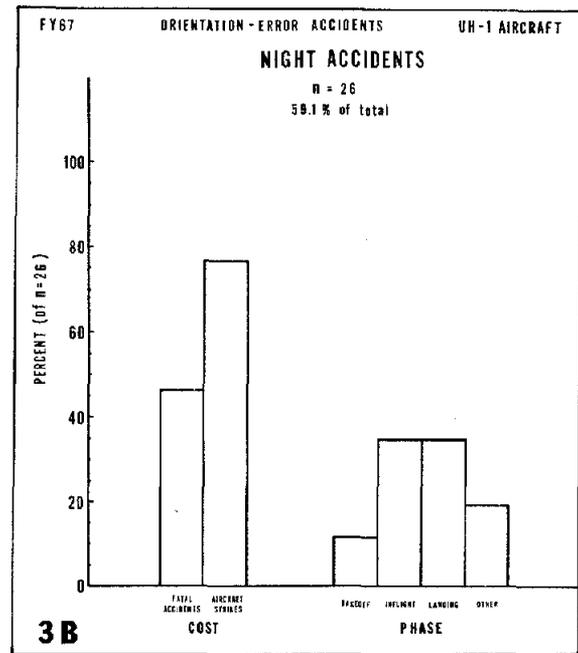
Figure 3

Comparison of percent incidence of fatal accidents, aircraft strikes, and flight phases for the 18 orientation-error accidents that occurred under daylight visibility conditions (A) and the 26 accidents that occurred under night visibility conditions (B). Note the considerably greater hazard of the night flights.

Additional data related to the time-of-day incidence of the accidents are presented in Figure 3. Statistics pertinent to the 18 accidents that occurred under daylight visibility conditions are plotted in Figure 3A. Similar data for the 26 night accidents are shown in Figure 3B. It is obvious that the cost of night accidents in terms of fatal accidents and aircraft strikes was considerably greater than the corresponding costs of daylight accidents. That is, 46.1 percent of the night accidents were fatal compared to only 16.7 percent of the daylight accidents; 76.9 percent of the night accidents resulted in aircraft strikes as compared to only 38.9 percent of the daylight accidents. In terms of the phase of flight for the night accidents, the inflight and landing phases had equal incidence, followed by the "other" and takeoff phases in that order. For the daylight accidents, the greatest incidence occurred in the "other" phase followed by the landing, takeoff, and inflight phases.

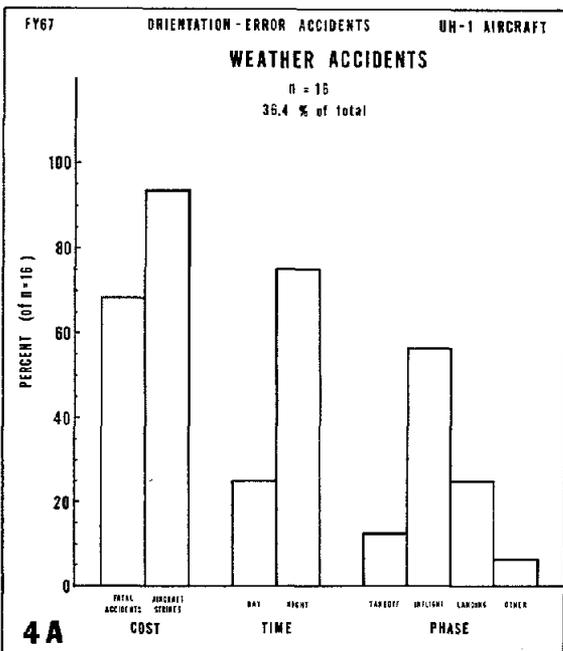
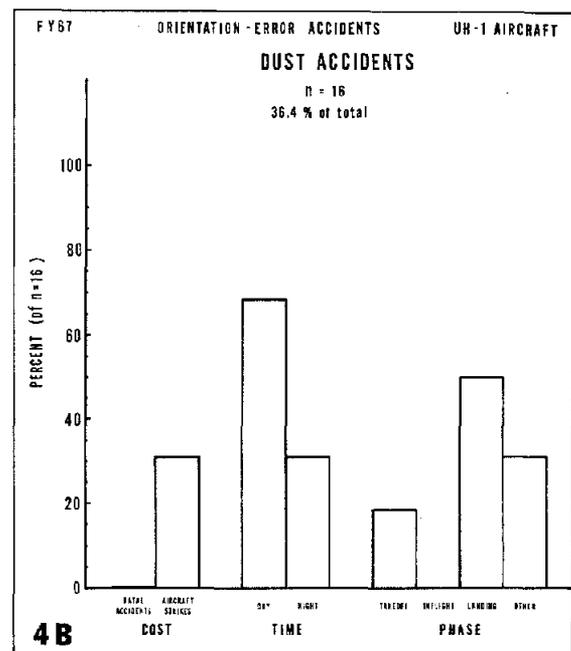
Figure 4

Comparison of percent incidence of fatal accidents, aircraft strikes, day/night accidents, and phases of flight for the 16 orientation-error accidents that involved poor weather (A), and the 16 accidents that involved rotor-raised ground dust or ashes (B). Note the high incidence of fatal accidents and aircraft strikes involved in the weather accidents.

Data pertaining to accidents involving degraded visibility due to weather and rotor-raised ground dust are presented in Figure 4. As denoted in Figure 4A, poor weather of one form or another was present in 16 (36.4 percent) of the 44 major orientation-error accidents. The hazard of these weather accidents was most significant since 68.7 percent of the accidents were fatal and 93.7 percent resulted in aircraft strikes. The majority (75 percent) of these accidents occurred at night. In terms of the phase of flight when the accident occurred, the inflight phase had the highest incidence (56.25 percent). When these weather accidents involved flight at night, the incidence of fatal accidents rose to 75 percent. Of the four daylight accidents, two were fatal.

As indicated in Figure 4B, degraded visibility due to rotor-raised ground dust or ashes was present in an additional 16 accidents. Though no fatalities resulted from these dust accidents, a considerable number (31.2 percent) involved the total loss or strike of the aircraft. Relative to the phase of flight, landing accidents had the greatest incidence (50.0 percent); as will be gained from reading the individual case history briefs which follow, these occurred at established heliports as well as at temporary field sites. It appears from a cursory scan of the orientation-error accidents occurring in subsequent fiscal years of this study that application of penepriime or similar surface coverings to minimize dust has decreased the incidence of this form of accident.

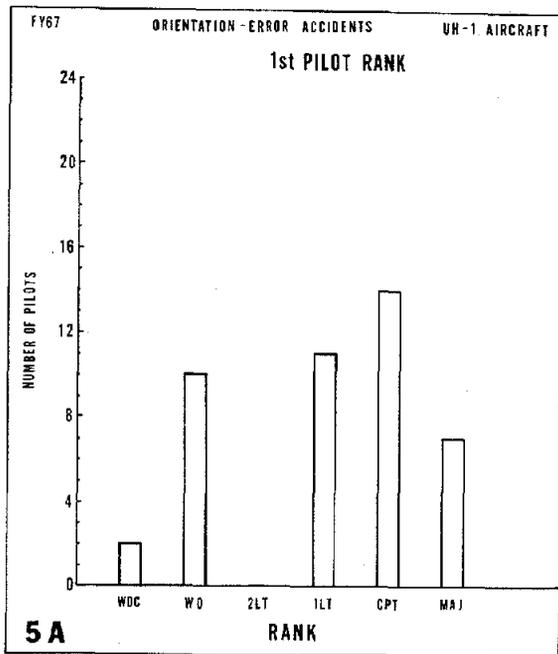
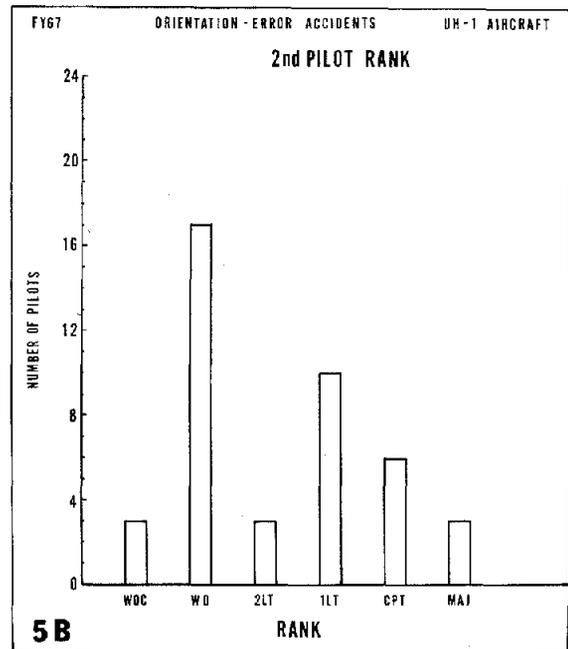
Figure 5

Distribution by rank of the 44 first pilots (A) and the 42 second pilots (B) involved in the orientation-error accidents. As explained in the text, the first pilot notation is used to describe the commanding aviator aboard the aircraft. In general, for Vietnam accidents, the first pilot is the "air commander" and the second pilot is the "pilot." For accidents occurring elsewhere, the first and second pilot notation usually corresponds to the conventional "pilot" and "copilot" designations, respectively.

In Figures 5 through 9, summary listings are made of various aviator-related background information. For each figure, a separate compilation is made for each of the two pilots normally aboard the UH-1 aircraft. The terms "first pilot" and "second pilot" have been arbitrarily selected to identify the commanding aviator (not necessarily the senior-ranked aviator) and his copilot, respectively. Outside of Vietnam, the first and second pilot notation corresponds to the conventional pilot (P) and copilot (CP) identification. In Vietnam, however, the two aviators are usually identified as the air commander (AC) and pilot (P); the air commander rating applies only after an aviator gains a certain

Data pertaining to the rank of the first and second pilots involved in the 44 orientation-error accidents are shown in Figures 5A and 5B, respectively. In the case of the 44 first pilots, there were almost as many individuals (21) with the rank of captain and above as there were of lower rank. As would be expected for the 42 second pilots (two accidents involved flights without a second pilot aboard) the median rank was lower, with 22 individuals having a rank of second lieutenant or above. The age distribution data, based on those whose ages were recorded, presented in Figure 6A for the 38 first pilots indicate a median of 27.8 years; Figure 6B data indicate a median of 24.9 years for 35 second pilots.

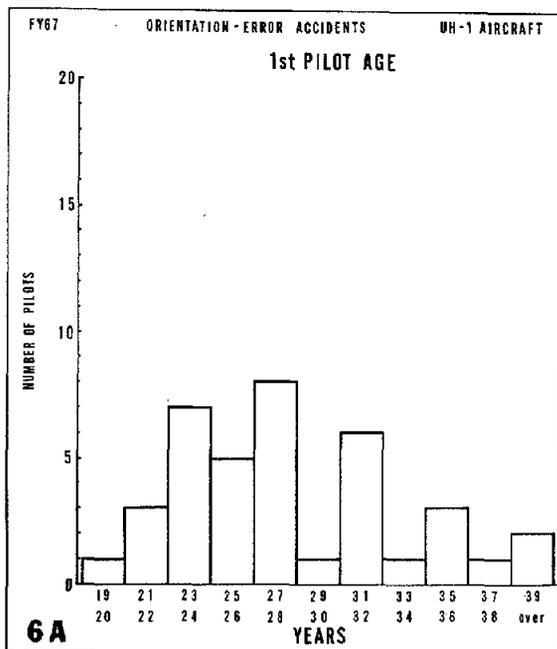
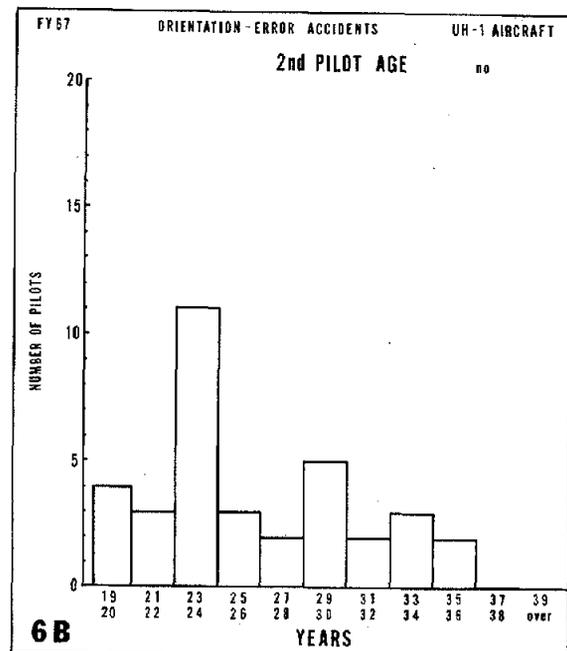
Figure 6

Age distribution of the first pilots (A) and second pilots (B). The median ages were approximately 27.8 years and 24.9 years, respectively.

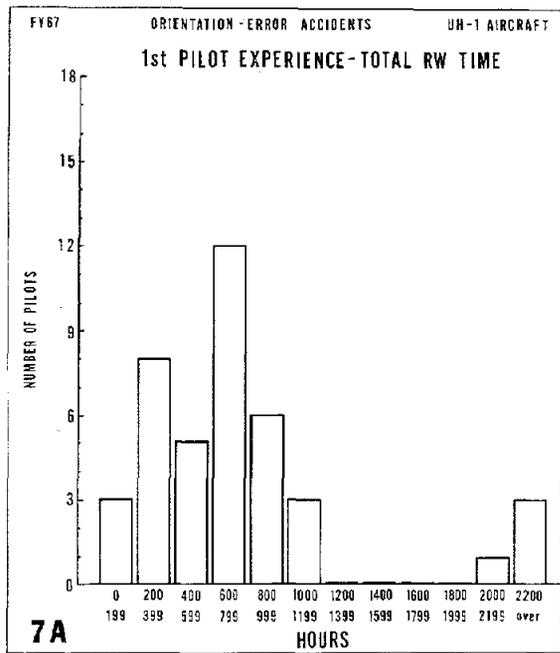
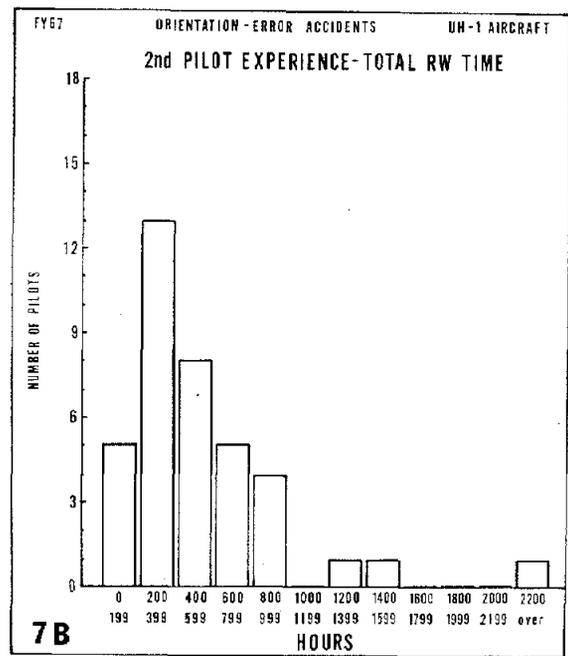
Figure 7

Distribution of total flight hours experience in military rotary-wing aircraft of the first pilots (A) and second pilots (B). The medians were approximately 675 hours and 425 hours, respectively. These data do not include any additional fixed-wing experience. (See Figure 10 for related FW and RW experience data.)

Aviator experience in terms of total flight hours both in all types of rotary-wing aircraft and in the UH-1 aircraft is described by Figures 7 and 8, respectively. The median

for the total recorded RW experience data, presented in Figure 7, was 675 hours for 41 first pilots and approximately 425 hours for 38 second pilots. The median times for total UH-1 experience were approximately 350 hours and 147.7 hours for the 42 first and 37 second pilots, respectively.

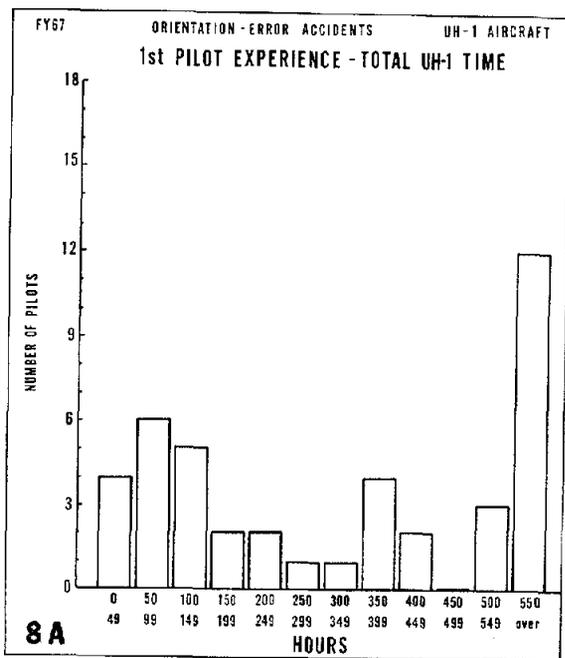
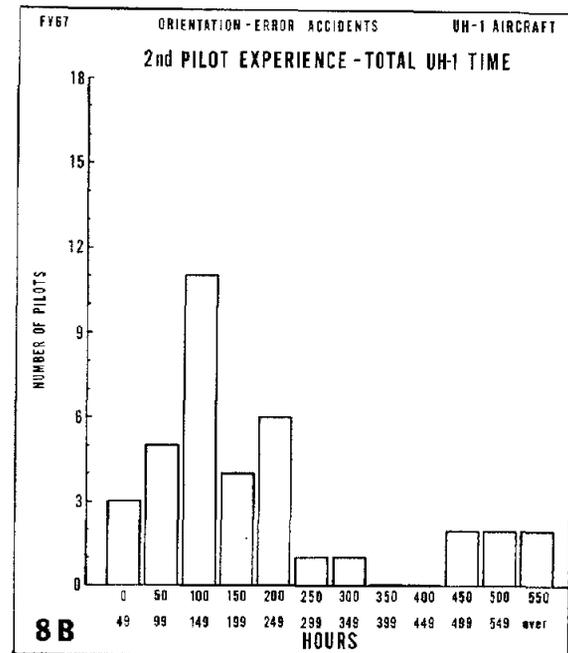
Figure 8

Distribution of total flight hours in the UH-1 aircraft of the first pilots (A) and second pilots (B). The median times were approximately 350 hours and 147.7 hours, respectively. (See Figure 10 for related UH-1 experience data.)

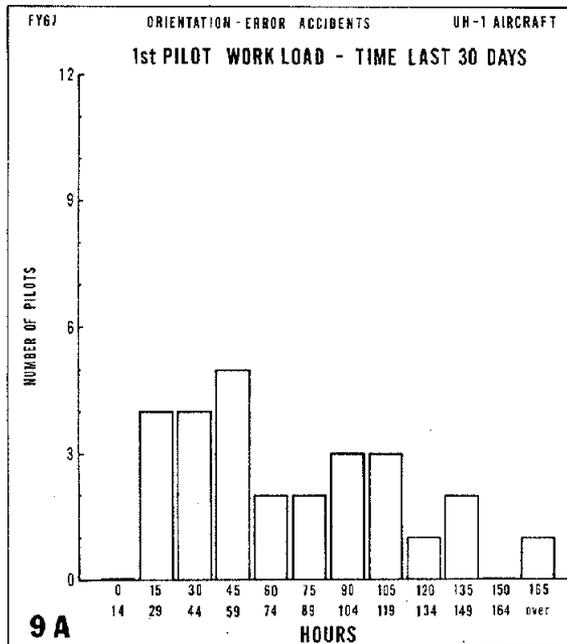
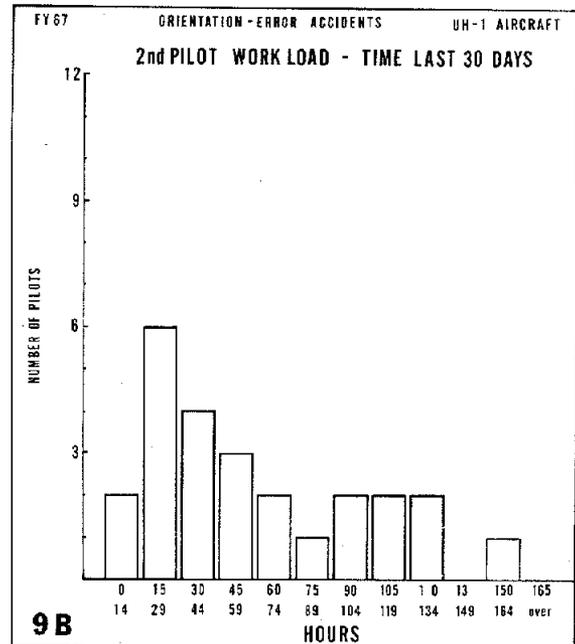
Figure 9

Distribution of pilot workload in terms of the total number of hours flown the 30 days preceding the accident by the first pilot (A) and the second pilot (B). The median workloads were 63.7 hours and 57.5 hours, respectively. (See Figure 11 for related fatigue listings.)

Work-load data concerned with the total number of hours flown by the aviators the 30 days preceding the accident are shown in Figure 9; specific hours data were available for only 27 of the first pilots and 25 of the second pilots. The median times were approximately 63.7 hours for the first pilots and 57.5 hours for the second pilots. Army regulations place 140 hours per 30-day interval as the official upper limit relative to pilot fatigue. After 90 hours, however, observation of the pilot by the air unit commander and flight surgeon is required.
