MAJOR ORIENTATION-ERROR ACCIDENTS IN REGULAR ARMY UH-1
AIRCRAFT DURING FISCAL YEAR 1969: ACCIDENT FACTORS

W. Carroll Hixson, Jorma I. Niven, and Emil Spezia

U. S. ARMY AEROMEDICAL RESEARCH LABORATORY
NAVAL AEROSPACE MEDICAL RESEARCH LABORATORY

October 1972

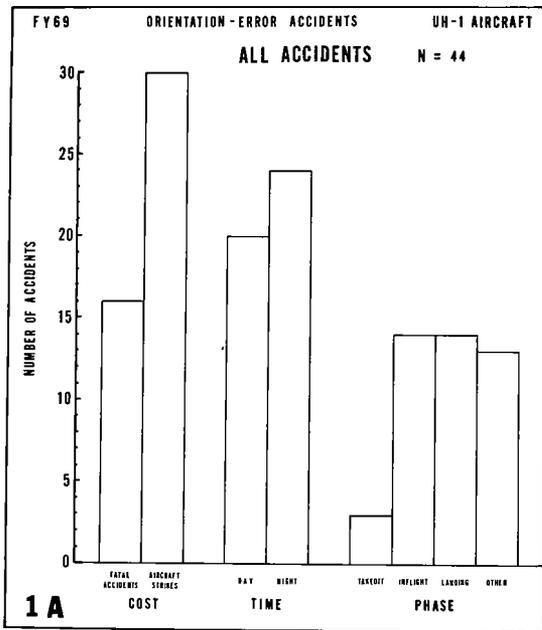
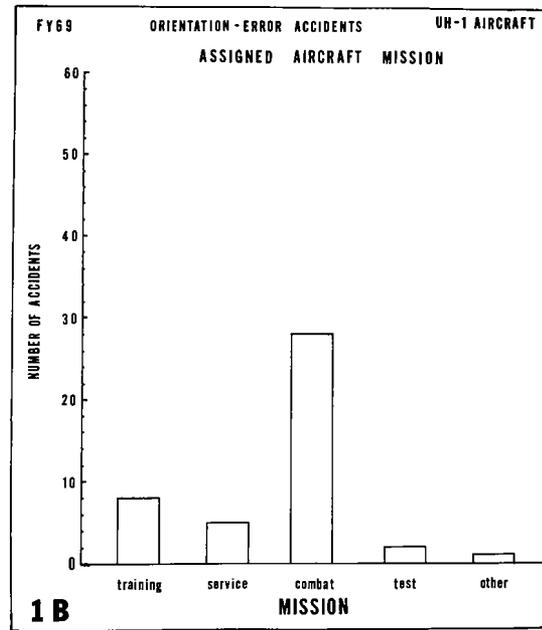
Figure 1

Major orientation-error accidents occurring in Regular Army UH-1 aircraft during fiscal year 1969. Number of fatal accidents, number of aircraft strikes, time of day of the accidents, and the flight phase in which the accident occurred (A); and types of missions assigned to the accident aircraft (B).

As indicated by the cost data presented in Figure 1A, the hazard of the orientation-error class of accidents was considerable for that fiscal year. Some 36.4 percent of the accidents were fatal, while 68.2 percent resulted in a total loss of the aircraft. The time-of-day data indicate that the incidence of accidents at night was slightly greater than the incidence during daylight. In terms of the phase of flight in which the accident occurred, 31.8 percent of the accidents occurred during the inflight phase, 31.8 percent during the landing phase, 29.5 percent during the "other" phase, and 6.8 percent during the takeoff phase. It should be noted that the "other" phase classification used in this report denotes localized operations, such as reparking an aircraft, lifting a sling load, or moving an aircraft to a nearby refueling site.

The mission data shown in Figure 1B indicate that the majority (63.6 percent) of the accidents occurred on flights that had some form of combat-related mission assignment. This would be expected since 37 (84.1 percent) of the accidents occurred in Vietnam. The reader is reminded that, although a combat mission may have been assigned to the crew, the resulting mishap was an accident and not a loss attributable to direct enemy action.

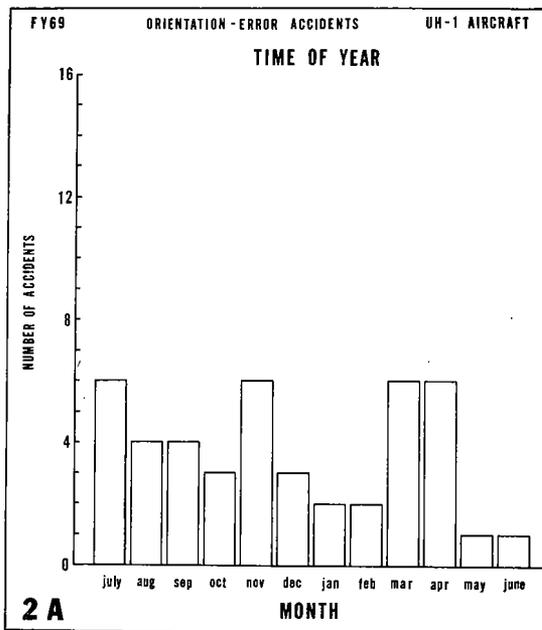
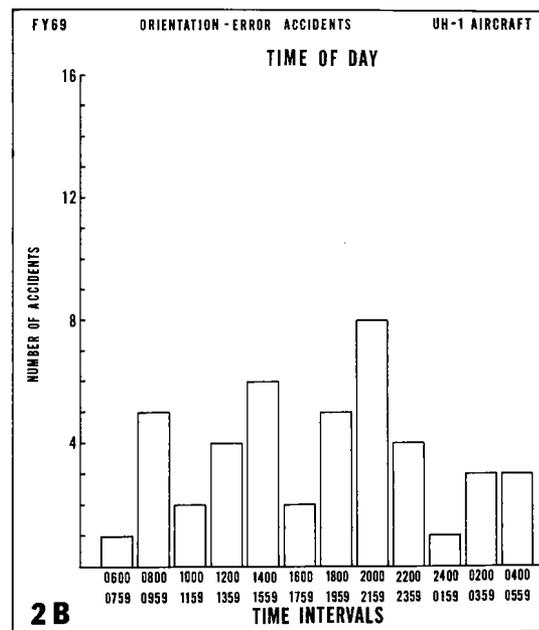
Figure 2

Number of orientation-error accidents as a function of the time of year (A) and the local time of day (B).

In Figure 2A a distribution is given of the number of accidents during each month of the fiscal year. Since the majority of the accidents occurred in Vietnam, the time-of-year incidence of accidents due to weather and dust peaked in that country's monsoon and dust seasons, respectively. Interpretation of these data beyond this point is restricted by the month-to-month variations in the level of combat operations being conducted at a given time. Similarly, the daily variation in frequency of operations would affect interpretation of the hourly distribution data plotted in Figure 2B, which shows accident incidence in 2-hour increments over a 24-hour period.

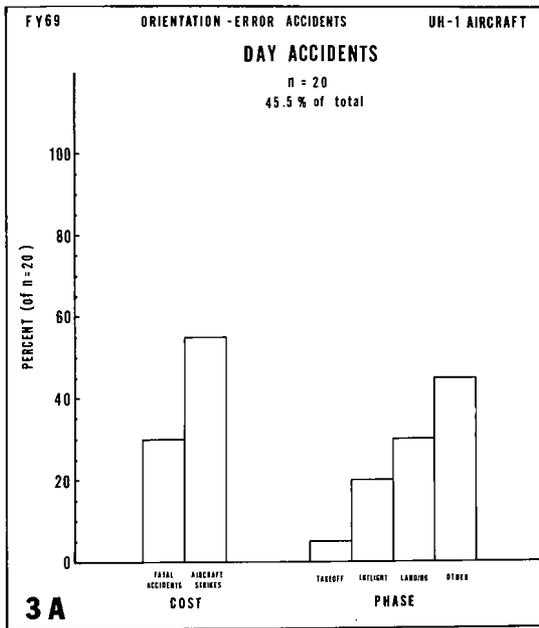
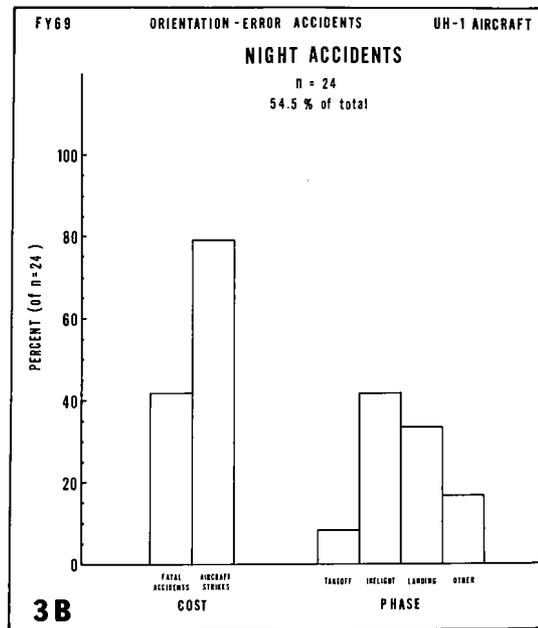
Figure 3

Comparison of percent incidence of fatal accidents, aircraft strikes, and flight phase for the 20 orientation-error accidents that occurred under daylight visibility conditions (A) and the 24 accidents that occurred under night visibility conditions (B). Note the considerably greater hazard of the night flights.

Additional data related to the time-of-day incidence of the orientation-error accidents are presented in Figure 3. Statistics pertaining to the 20 accidents that occurred under daylight visibility conditions are plotted in Figure 3A. Similar data for the 24

night accidents are shown in Figure 3B. It is obvious that the cost of night accidents in terms of fatal accidents and aircraft strikes was considerably greater than the corresponding costs for daylight accidents. That is, 41.7 percent of the night accidents were fatal as compared to only 30.0 percent of the daylight accidents; 79.2 percent of the night accidents resulted in aircraft strikes as compared to only 55.0 percent of the daylight accidents. In terms of the phase of flight for the night accidents, the greatest incidence occurred during the inflight phase (41.7 percent) followed by the landing, "other" and takeoff phases. For daylight accidents, incidence was greatest during the "other" phase (45.0 percent) followed by the landing, inflight, and takeoff phases.

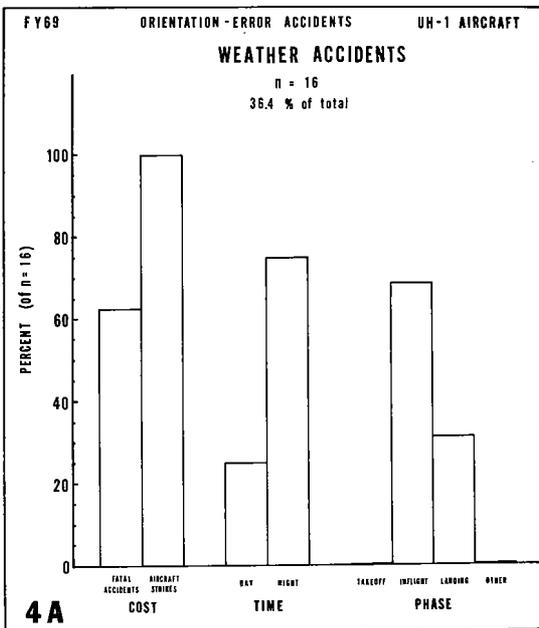
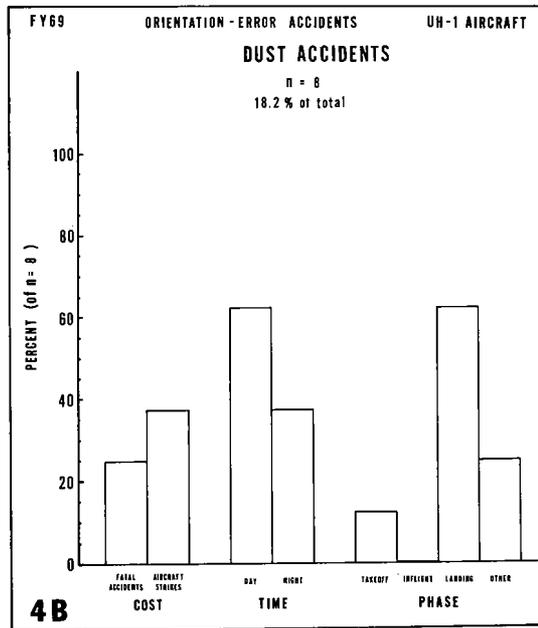
Figure 4

Comparison of percent incidence of fatal accidents, aircraft strikes, day/night accidents, and phases of flight for the 16 orientation-error accidents that involved poor weather (A), and the 8 accidents that involved rotor-raised ground dust or ashes (B). Note the high incidence of fatal accidents and aircraft strikes involved in the weather accidents.

Data pertaining to accidents involving degraded visibility due to weather and rotor-raised ground dust are presented in Figure 4. As denoted in Figure 4A, poor weather of one form or another was present in 16 (36.4 percent) of the 44 orientation-error accidents. The hazard of these weather accidents was most significant since 62.5 percent of the accidents were fatal and all resulted in aircraft strikes. A further significant feature was that the majority (75.0 percent) of the accidents occurred at night. Of the 12 accidents that occurred under these special conditions, i.e., visibility degraded both by weather and by darkness, 7 (58.3 percent) were fatal. Of the four weather accidents that occurred during daylight, three were fatal. With respect to the total of 10 fatal weather accidents, 7 (70.0 percent) of these occurred at night. In terms of the phase of flight when the accident occurred, the inflight phase had the greatest incidence (68.7 percent).

As indicated in Figure 4B, an additional 8 (18.2 percent) of the 44 orientation-error accidents involved degraded visibility due to rotor-raised ground dust. There were only 2 fatal accidents and 3 aircraft strikes in this classification. In contradistinction to the weather accident data, the majority (62.5 percent) of the dust accidents occurred under daylight visibility conditions. Relative to the phase of flight, landing accidents had the greatest incidence (62.5 percent) followed by the "other" and takeoff phases.

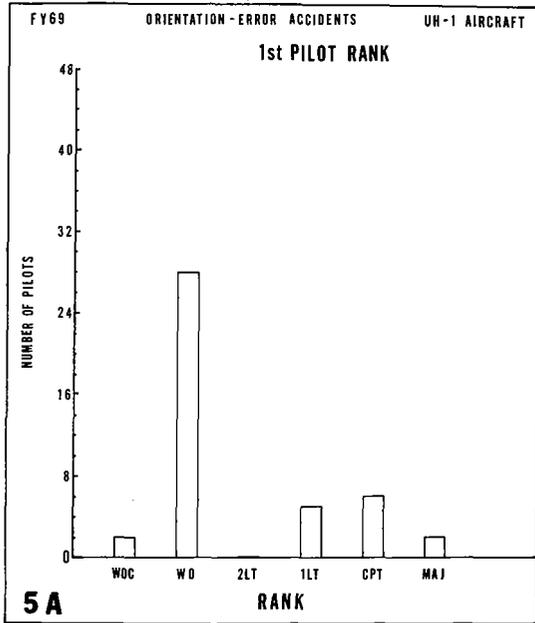
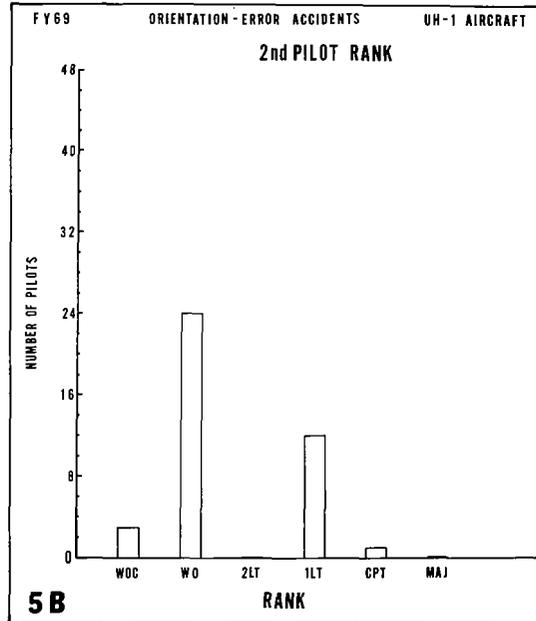
Figure 5

Distribution by rank of 43 first pilots (A) and 40 second pilots (B) involved in the orientation-error accidents. As explained in the text, the first pilot notation is used to describe the commanding aviator aboard the aircraft. In general, for Vietnam accidents, the first pilot is the "air commander" and the second pilot is the "pilot." For accidents occurring elsewhere, the first and second pilot notation usually corresponds to the conventional "pilot" and "copilot" designations, respectively.

Data pertaining to the military rank of the first and second pilots are shown in Figures 5A and 5B, respectively. Of the 43 first pilots for whom rank data were available, 13 (30.2 percent) individuals had a rank of second lieutenant or above. Similarly,

for 40 second pilots, 13 (32.5 percent) individuals had a rank of second lieutenant or above. The age distribution data presented in Figure 6A for 40 first pilots indicates a median of 23.7 years; the Figure 6B data indicate a median of 22.6 years for 36 second pilots.

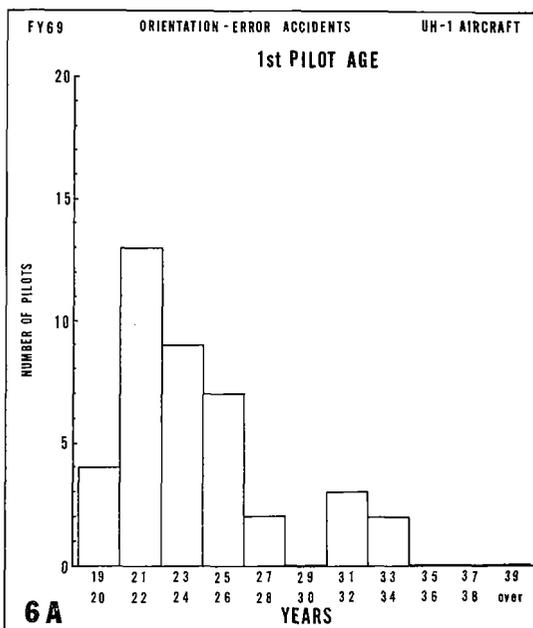
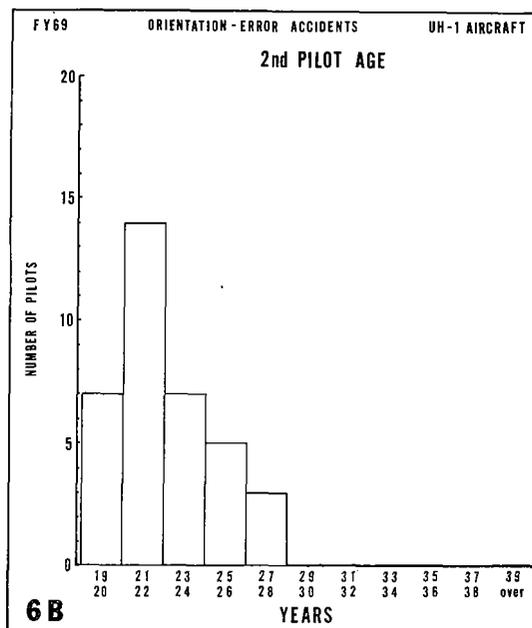
Figure 6

Age distribution of the first pilots (A) and second pilots (B). The median ages were approximately 23.7 years and 22.6 years, respectively.

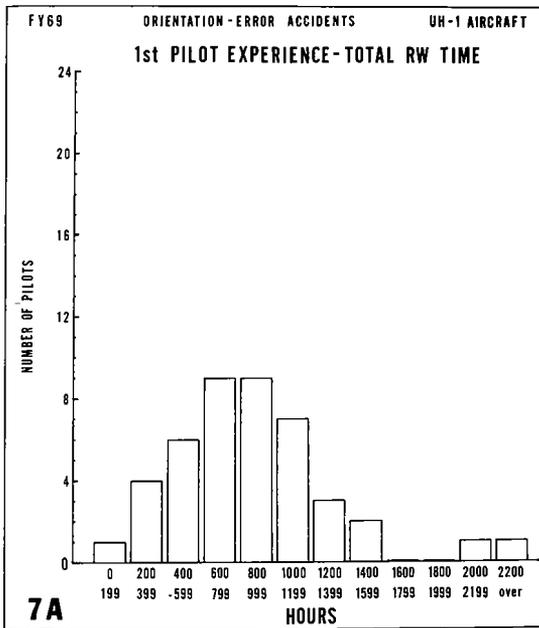
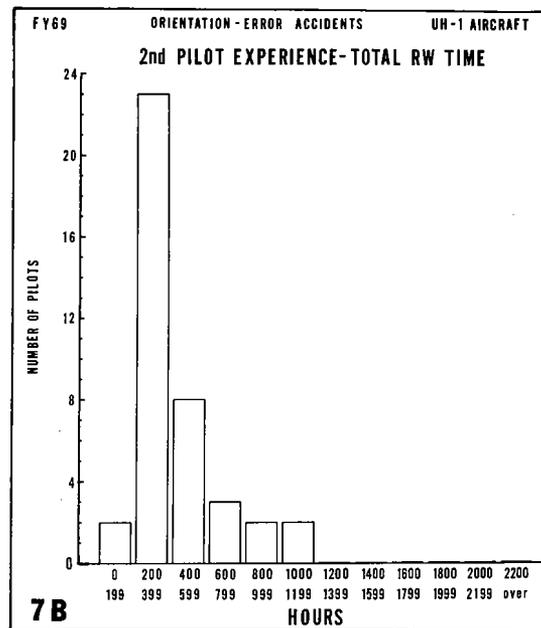
Distribution of total flight hours experience in military rotary-wing aircraft of the first pilots (A) and second pilots (B). The medians were approximately 833 hours and 356 hours, respectively. These data do not include any additional fixed-wing experience. (See Figure 10 for related FW and RW experience data.)

Aviator experience in terms of total flight hours both in all types of military rotary-wing (RW) aircraft and in the UH-1 aircraft is described by Figures 7 and 8, respectively. The median for the total recorded RW experience data presented in Figure 7 was 833 hours for 43 first pilots and approximately 356 hours for 40 second pilots. The median times for total UH-1 experience were approximately 417 hours and 125 hours for 42 first and 35 second pilots, respectively.

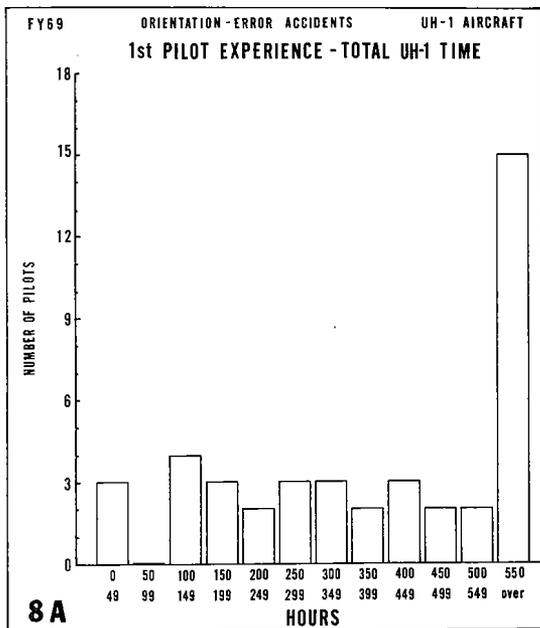
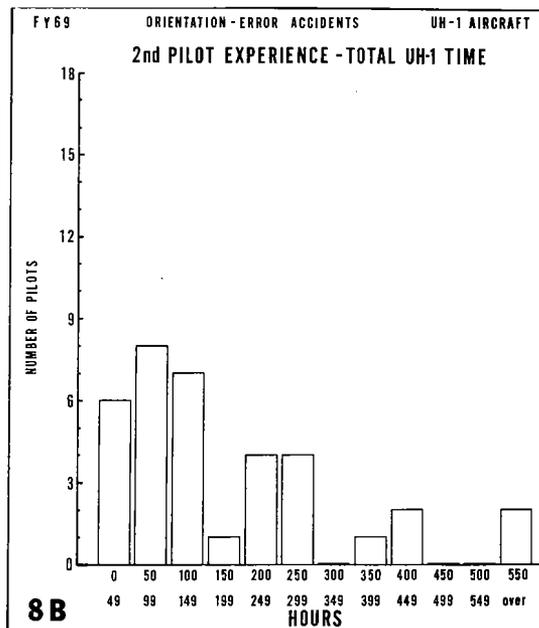
Figure 8

Distribution of total flight hours in the UH-1 aircraft of the first pilots (A) and second pilots (B). The median times were approximately 417 hours and 125 hours, respectively. (See Figure 10 for related UH-1 experience data.)

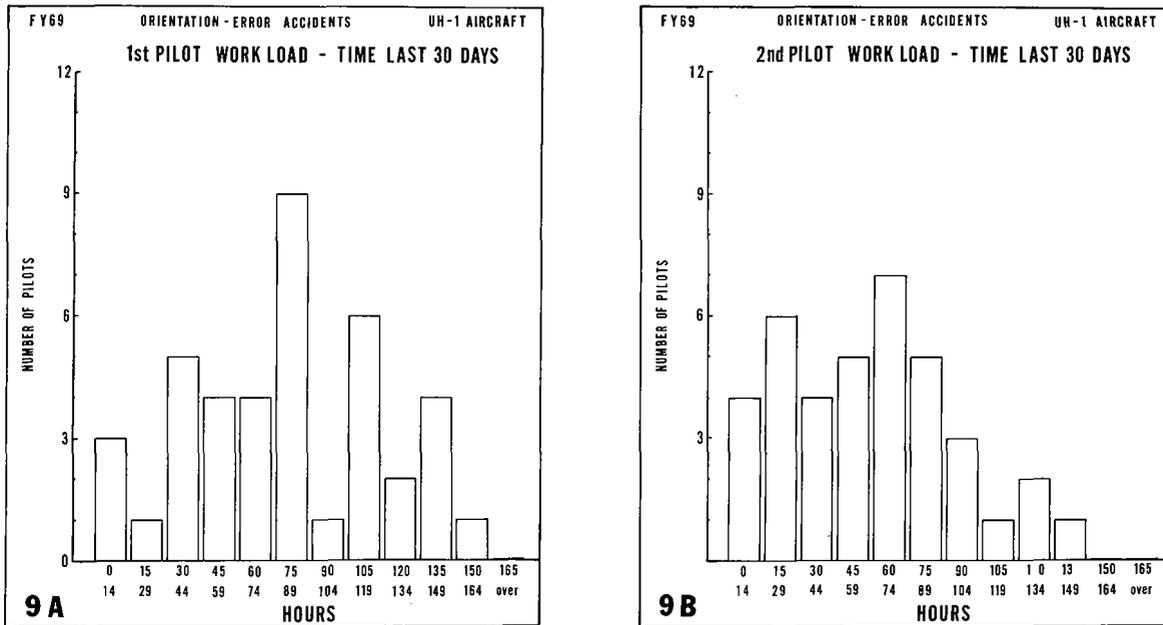
Figure 9

Distribution of pilot workload in terms of the total number of hours flown the 30 days preceding the accident by the first pilot (A) and the second pilot (B). The median workloads were 80 hours and 60 hours, respectively. (See Figure 10 for related fatigue listings.)

Work-load data concerned with the total number of hours flown by the aviators during the 30 days preceding the accident are shown in Figure 9; specific hours data were available for 40 first pilots and 38 second pilots. The median times were approximately 80 hours for the first pilots and 60 hours for the second pilots. Army regulations place 140 hours per 30-day interval as the official upper limit relative to pilot fatigue. After 90 hours, however, observation of the pilot by the air unit commander and flight surgeon is required.
