USAARL Report No. 95-9

**Evaluation of a Retrofit OH-58
Pilot's Seat to Prevent Back Injury**

**United States Army Aeromedical Research Laboratory
Fort Rucker, Alabama 36362-0577**

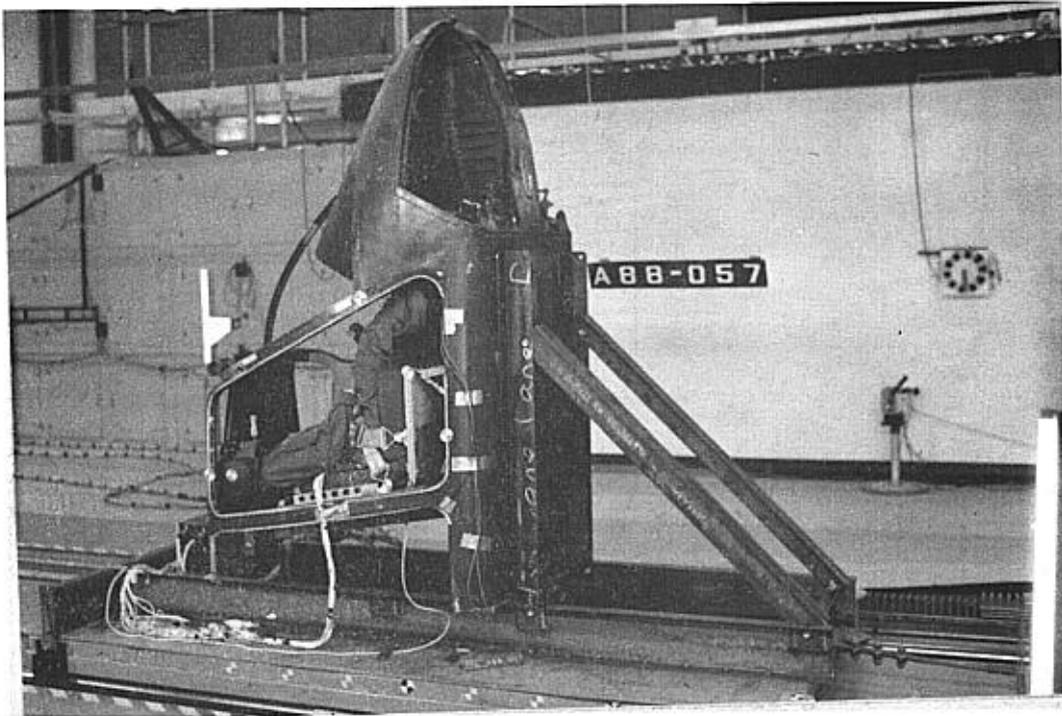
Figure 1. Civil Aeromedical Institute sled installed on acceleration track with OH-58 fuselage attached for pure vertical impact.

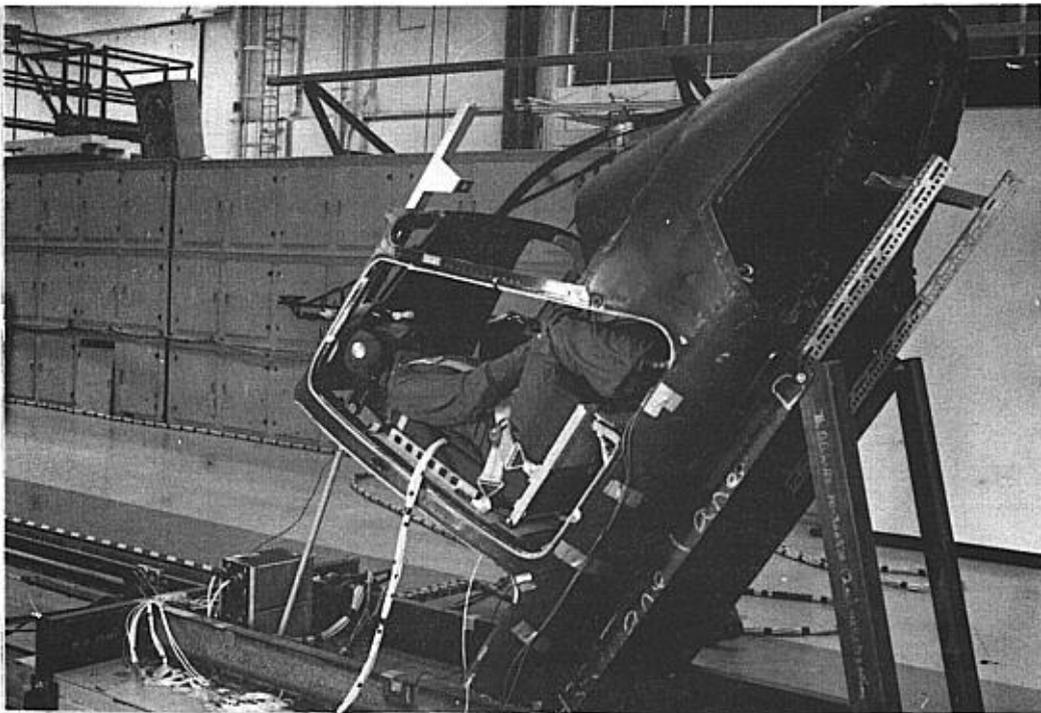
Figure 2. CAMI sled installed on track with OH-58 fuselage attached for impact at 34 degrees from vertical.

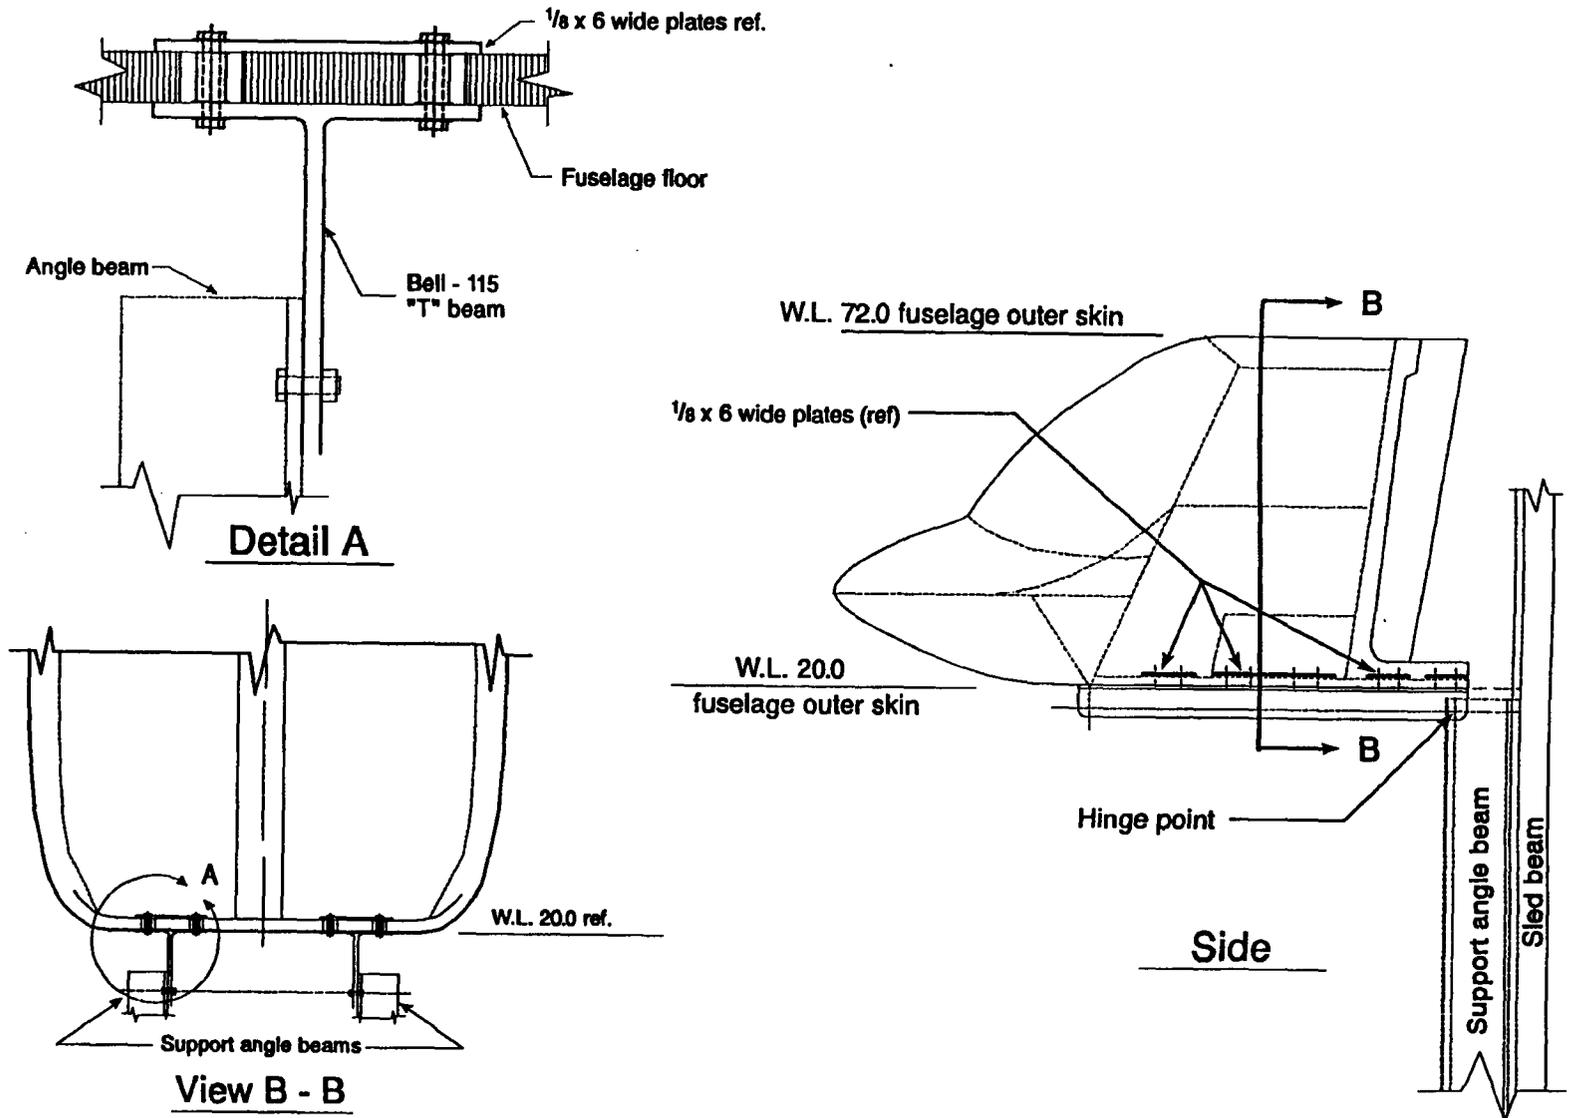
Figure 3. Fuselage attachment to CAMI sled (no scale).

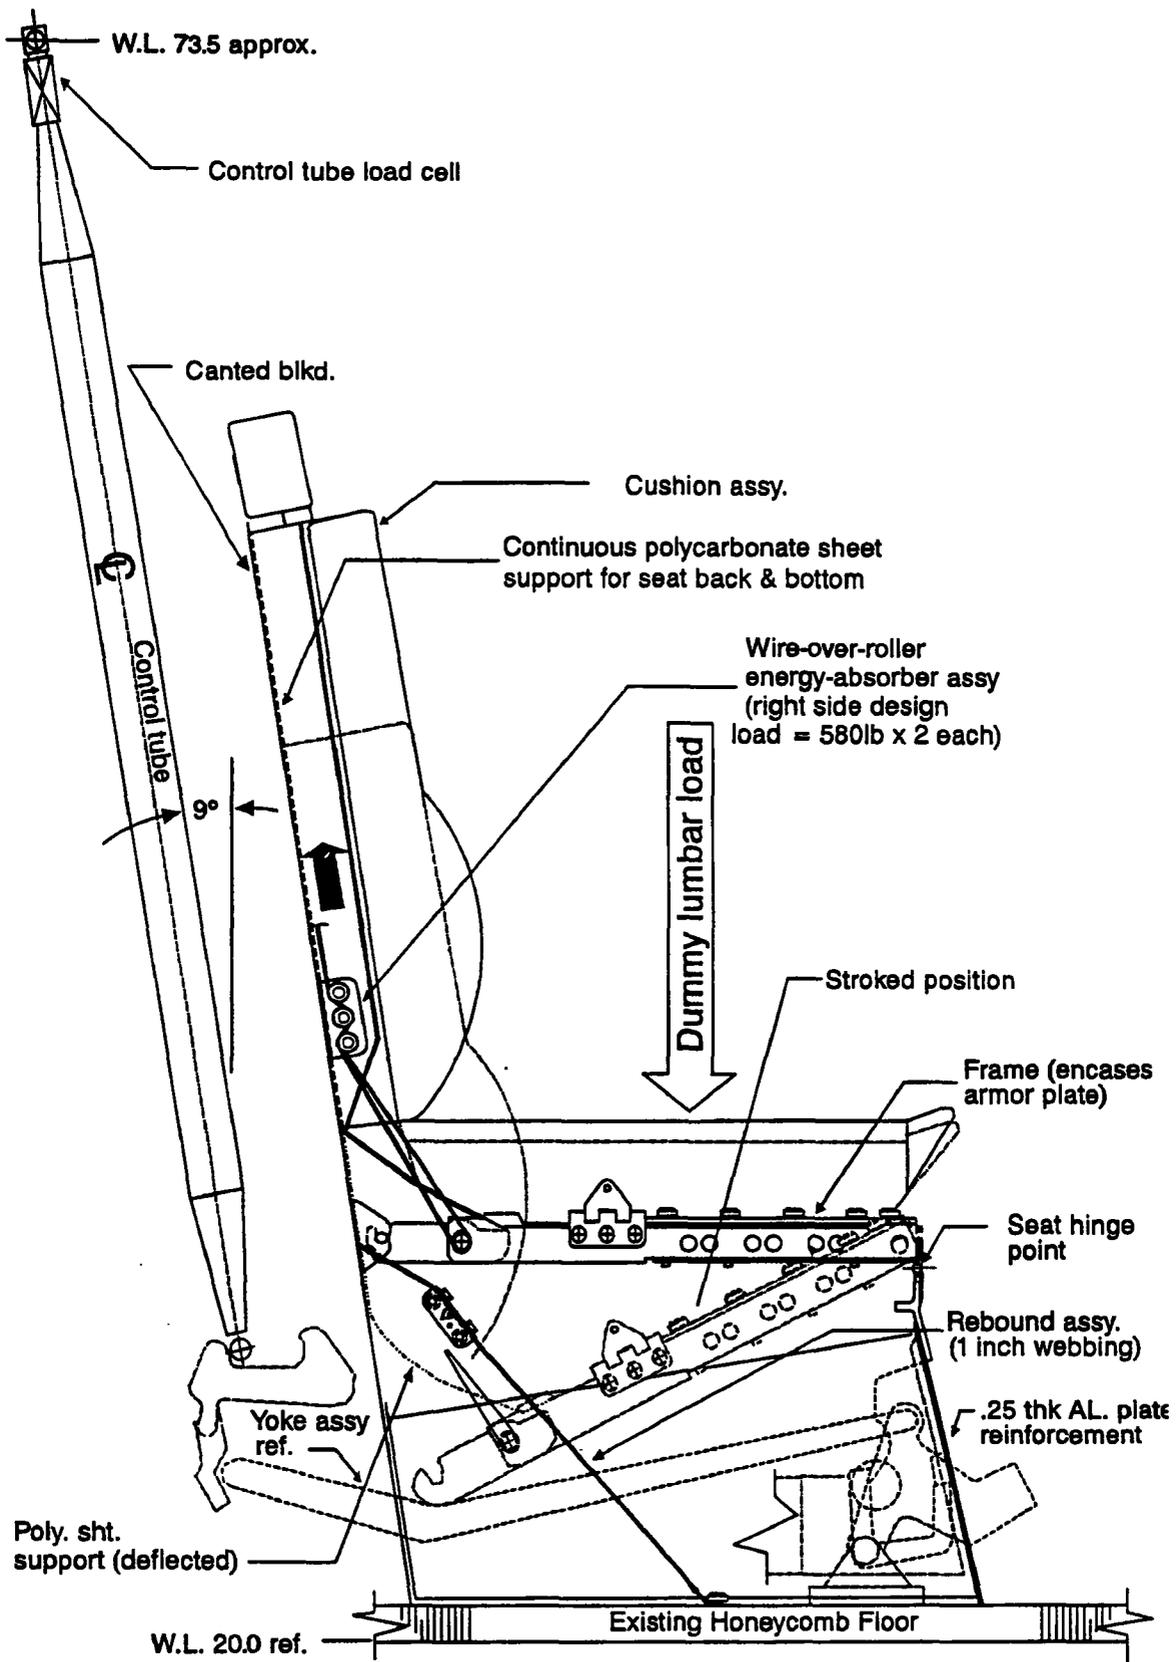
Figure 4. Profile of seat assembly, right seat shown.

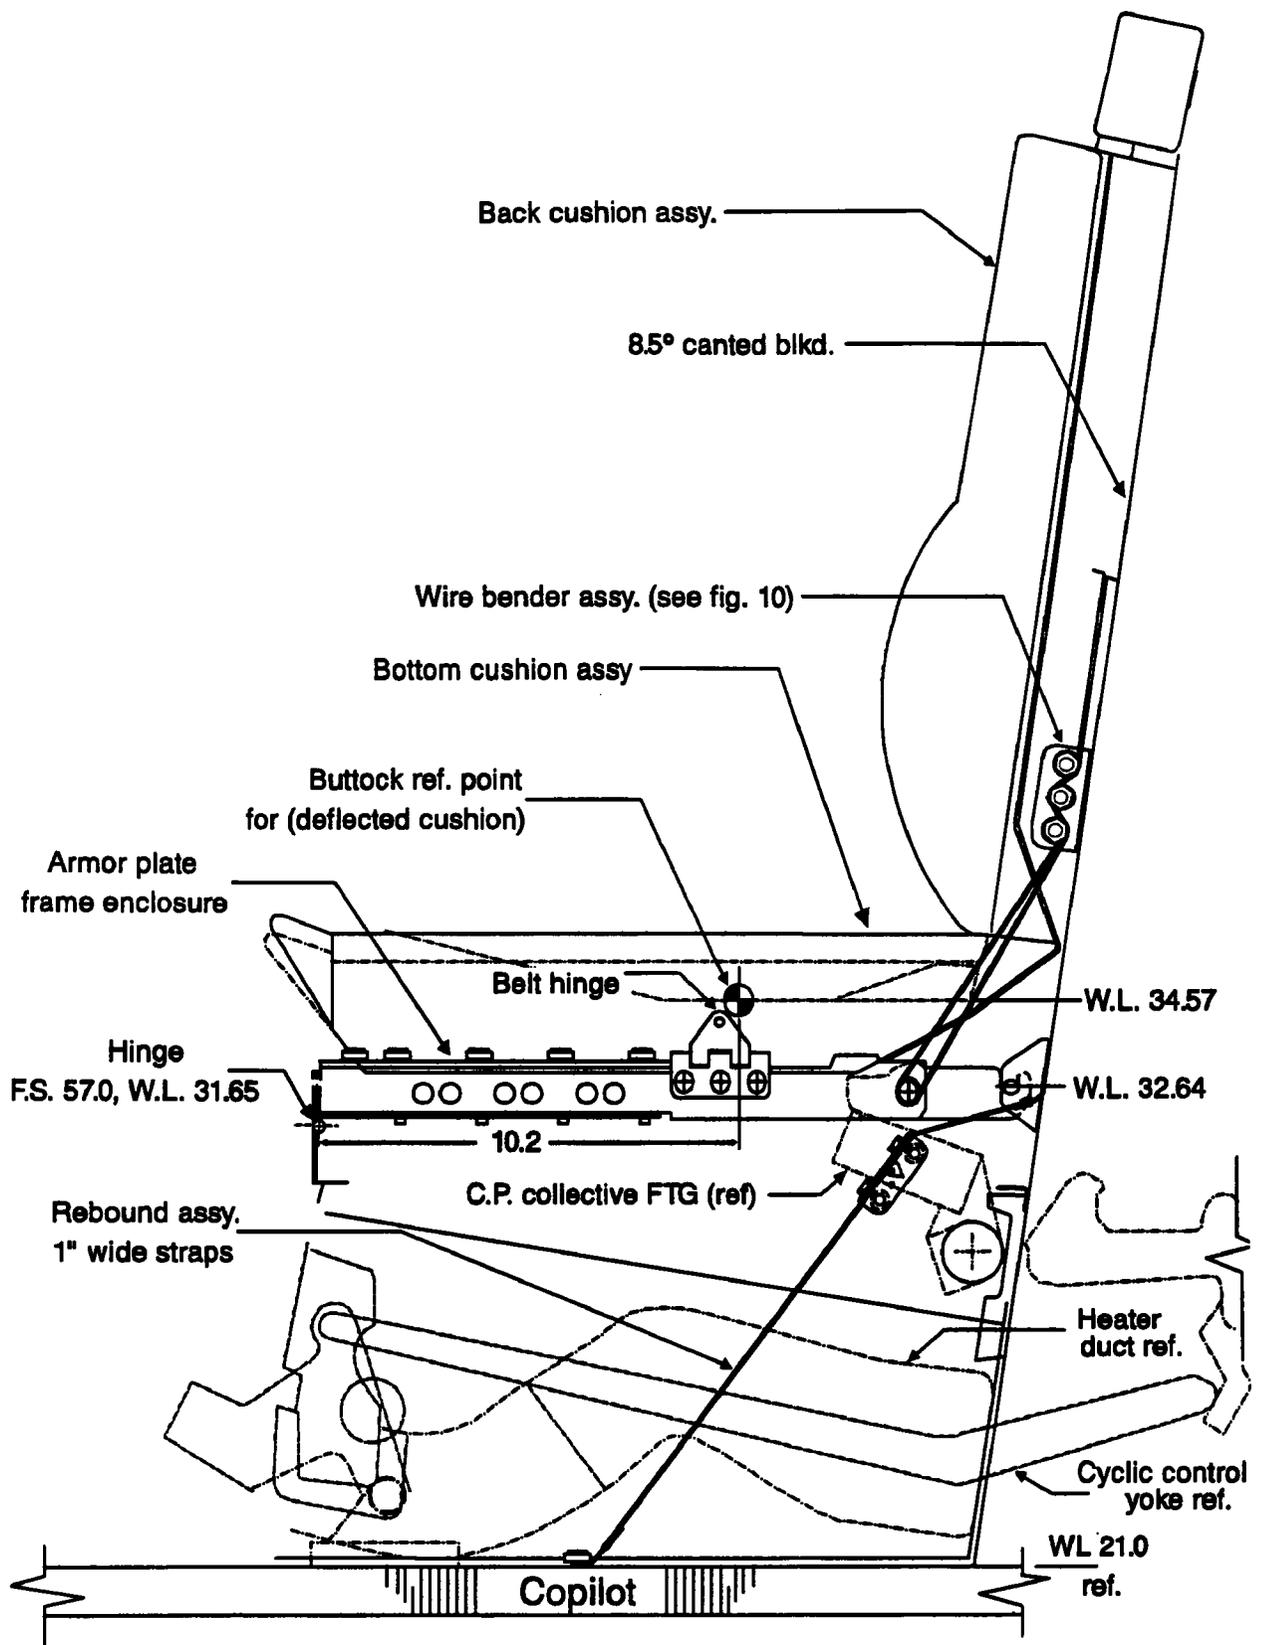
Figure 5. Profile of seat assembly, left side shown (note armor plate usage as a pivoting pan).

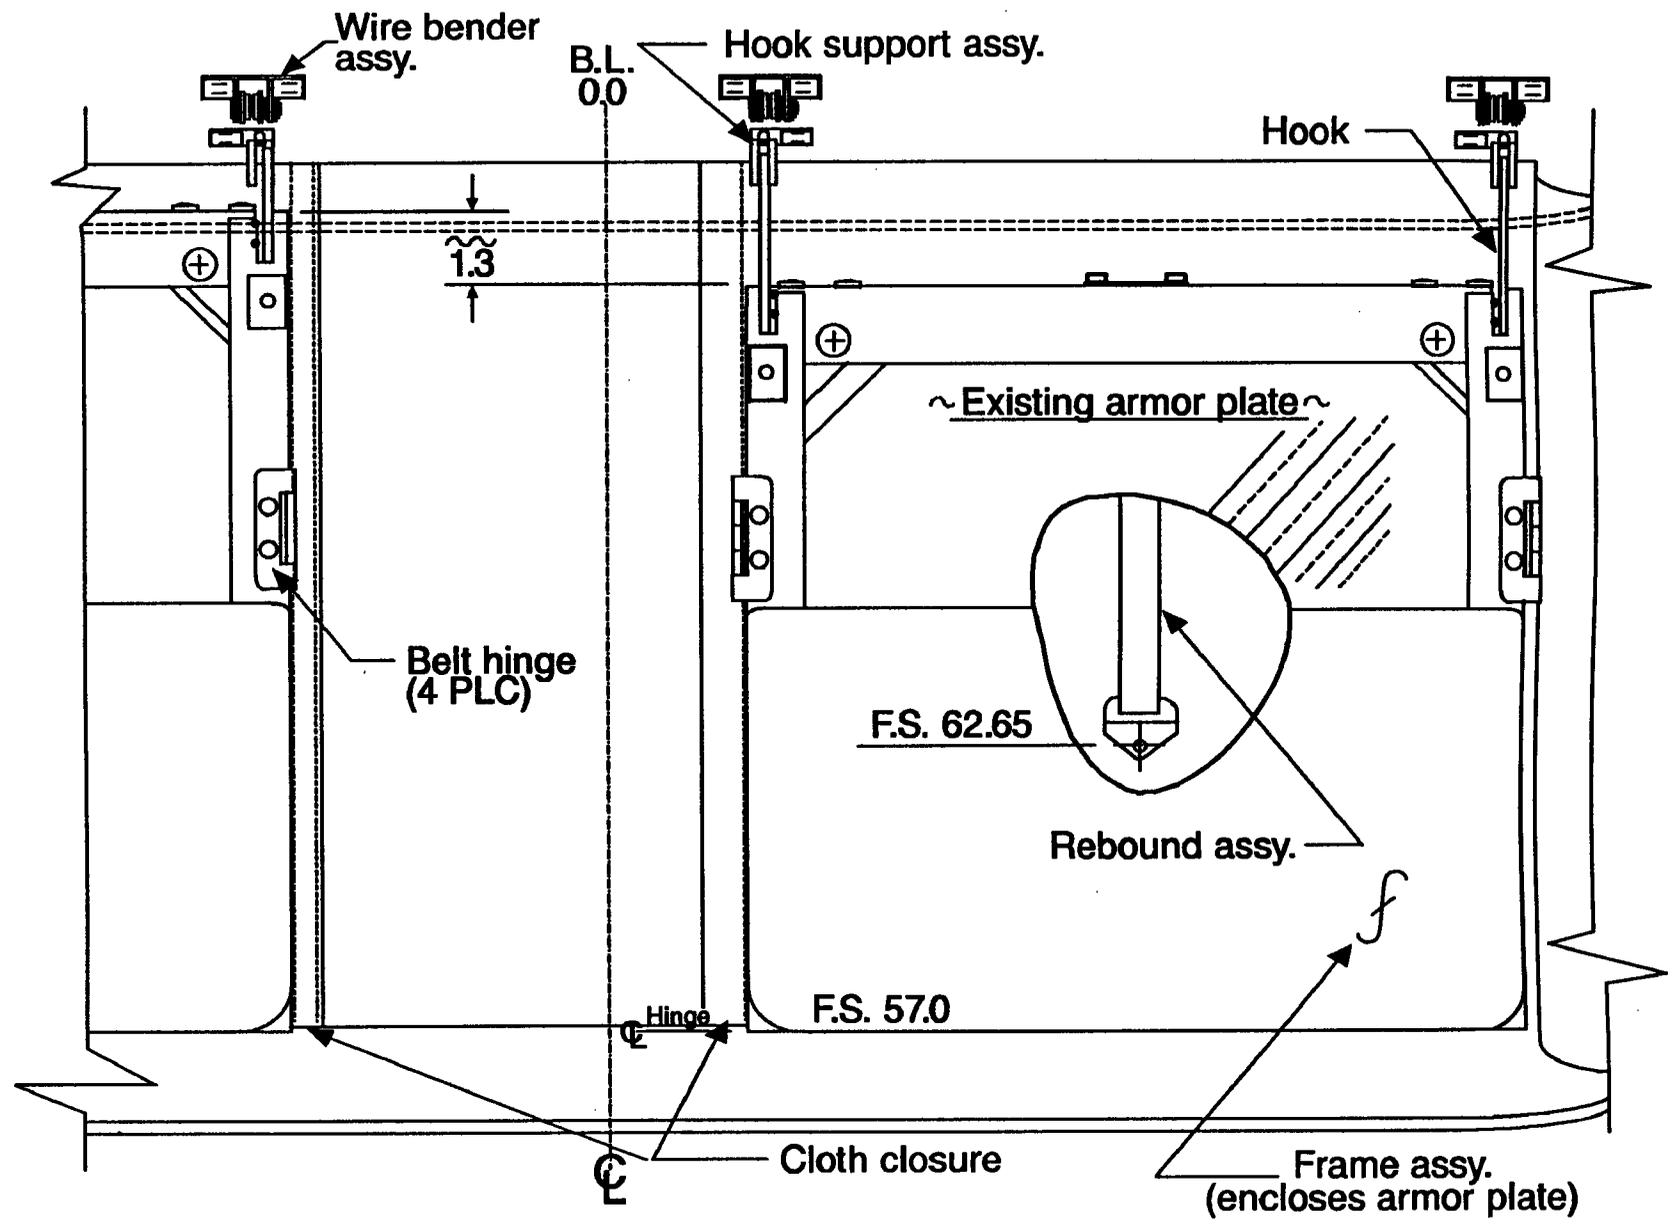
Figure 6. Frame assembly (armor encasement installation).

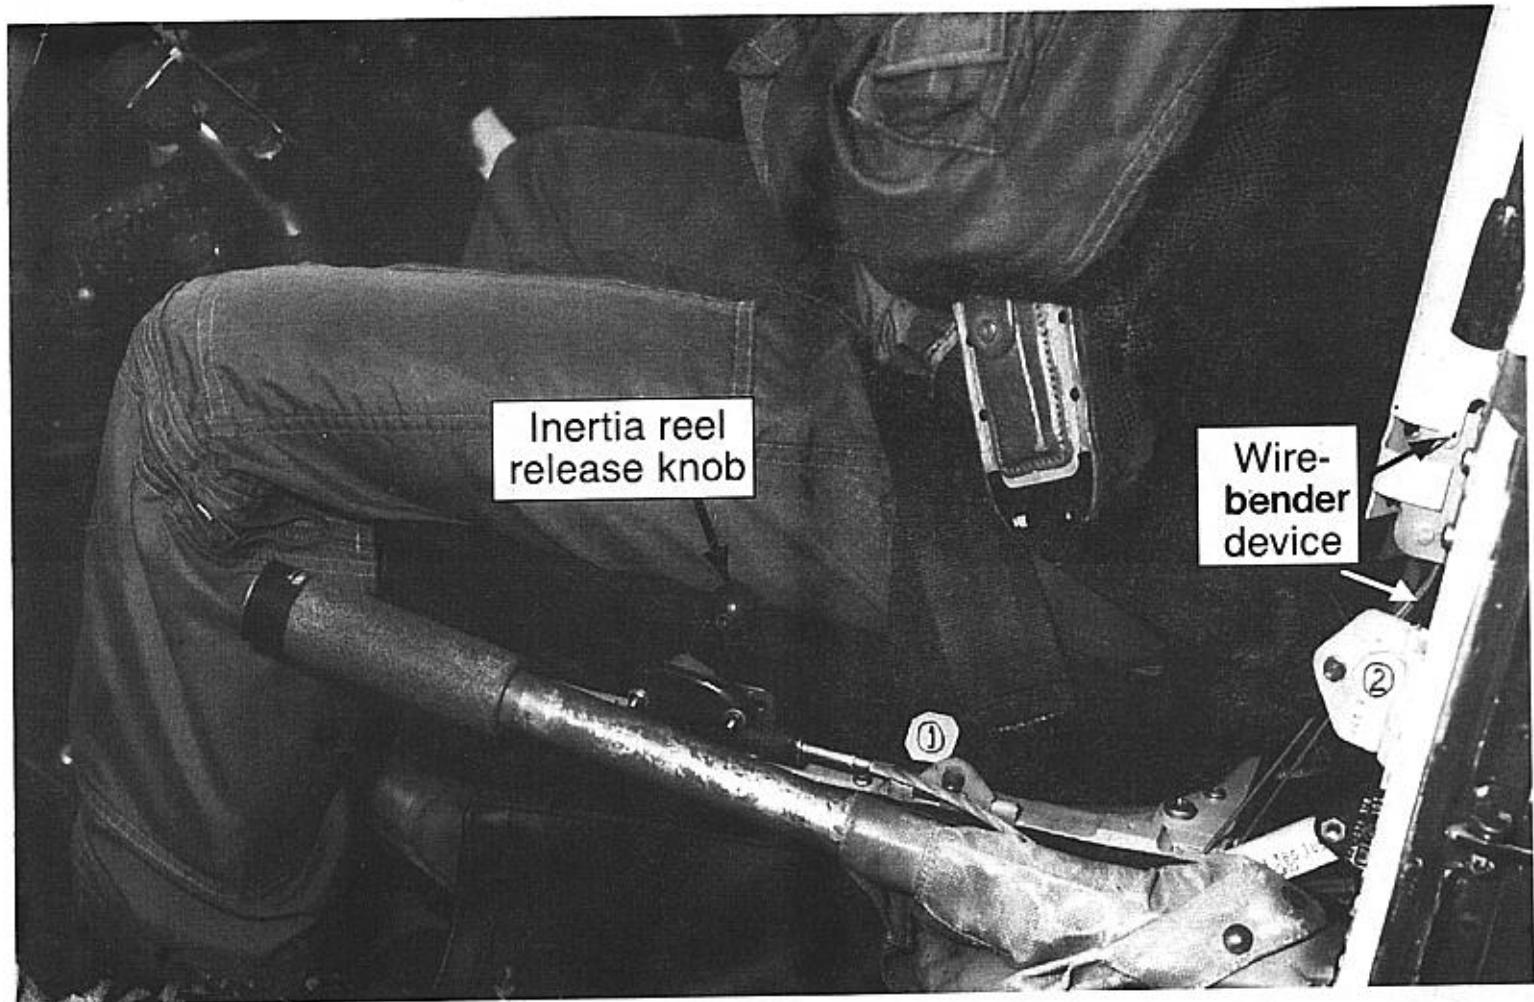
Figure 7. Five-point belt attachment to (1) armor plate frame, and (2) canted bulkhead. Shows cushion after 1-inch width reduction to improve access to reel knob.

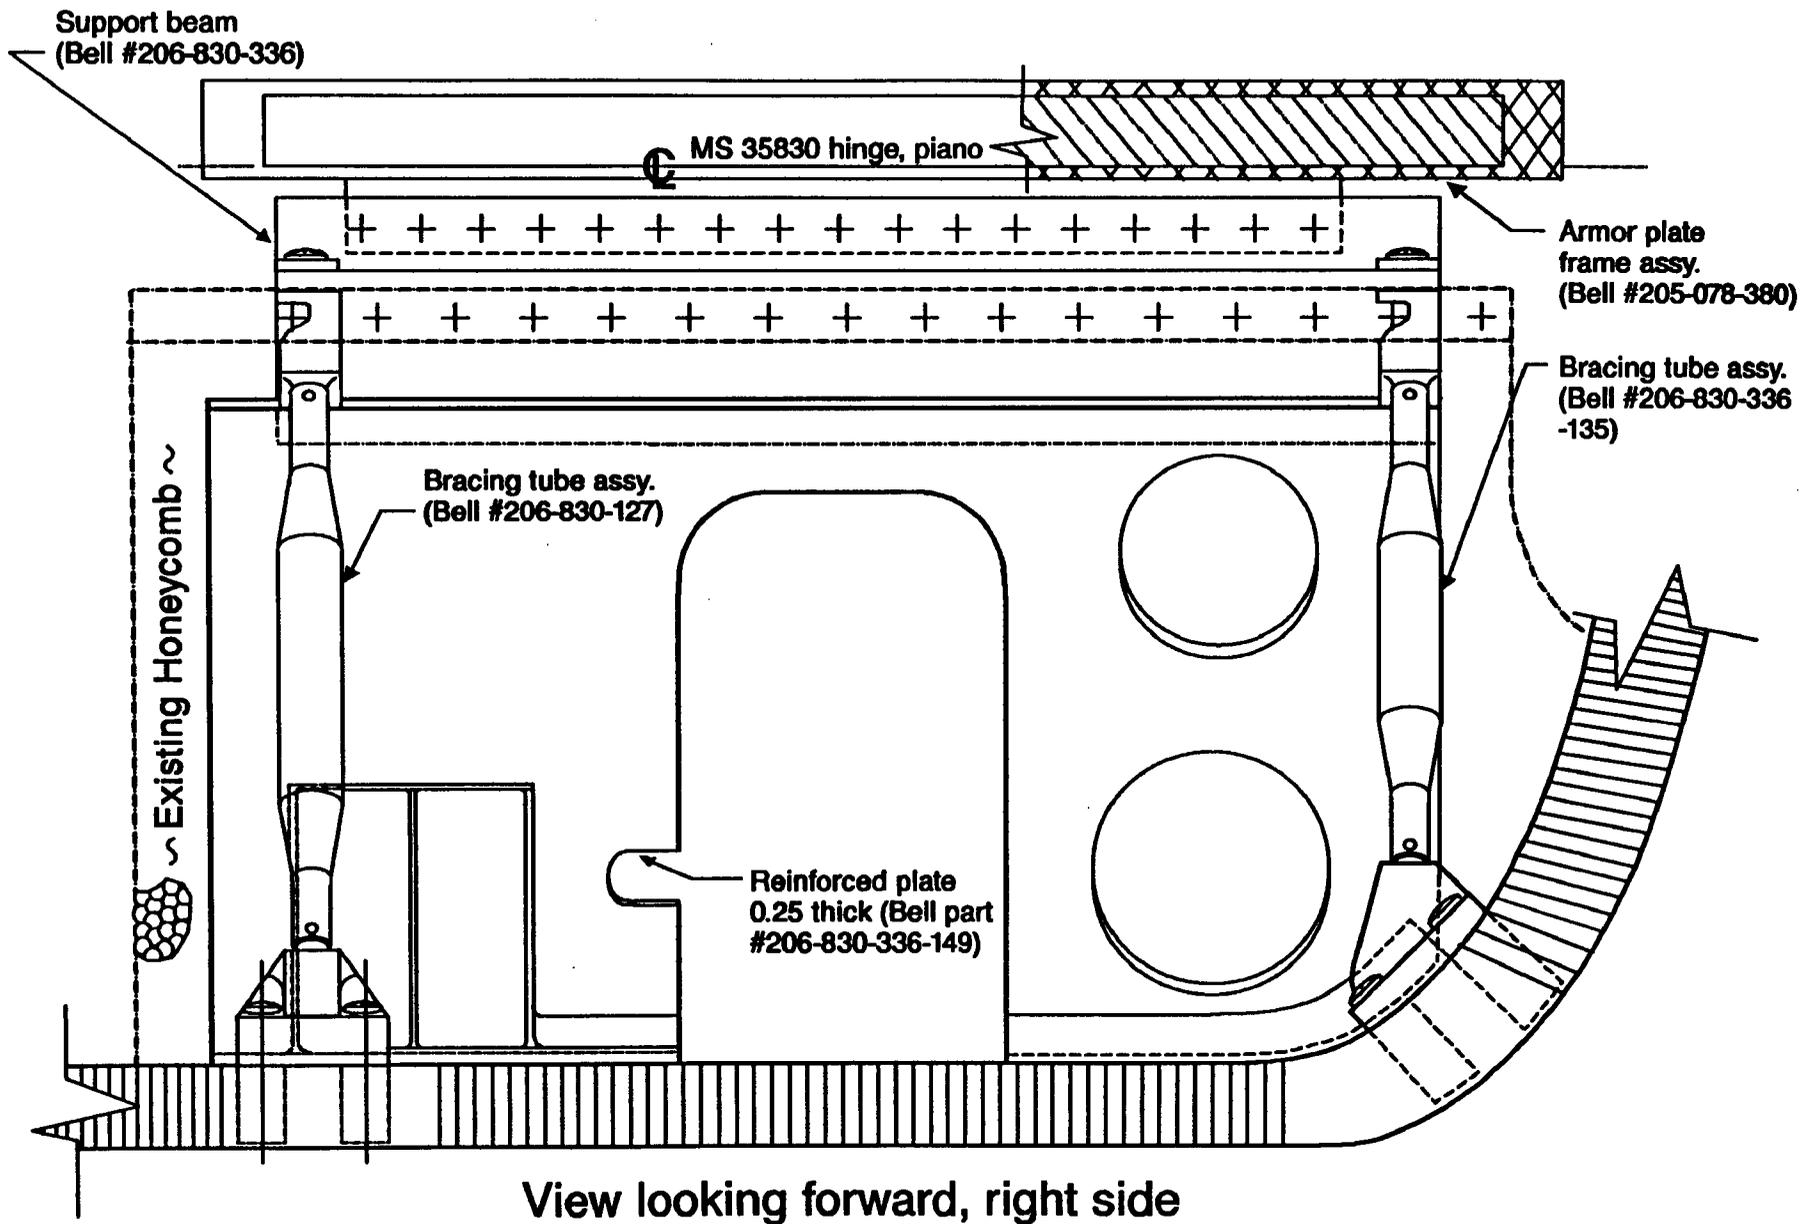
Figure 8a. Hinge line bulkhead for seat pan forward edge support (strain gages on bracing tubes not shown).

This dynamic test definitely revealed the need to use the braces for the front bulkhead support. The strain in these braces was converted to load as follows (refer to Figure 8 for strain gage locations): The axial unit strain e , in the absence of torsional strain (bending strains were cancelled by symmetric gage placement), is equal to the stress in the tube divided by the tube modulus of elasticity, i.e., $e = \frac{S}{E}$.

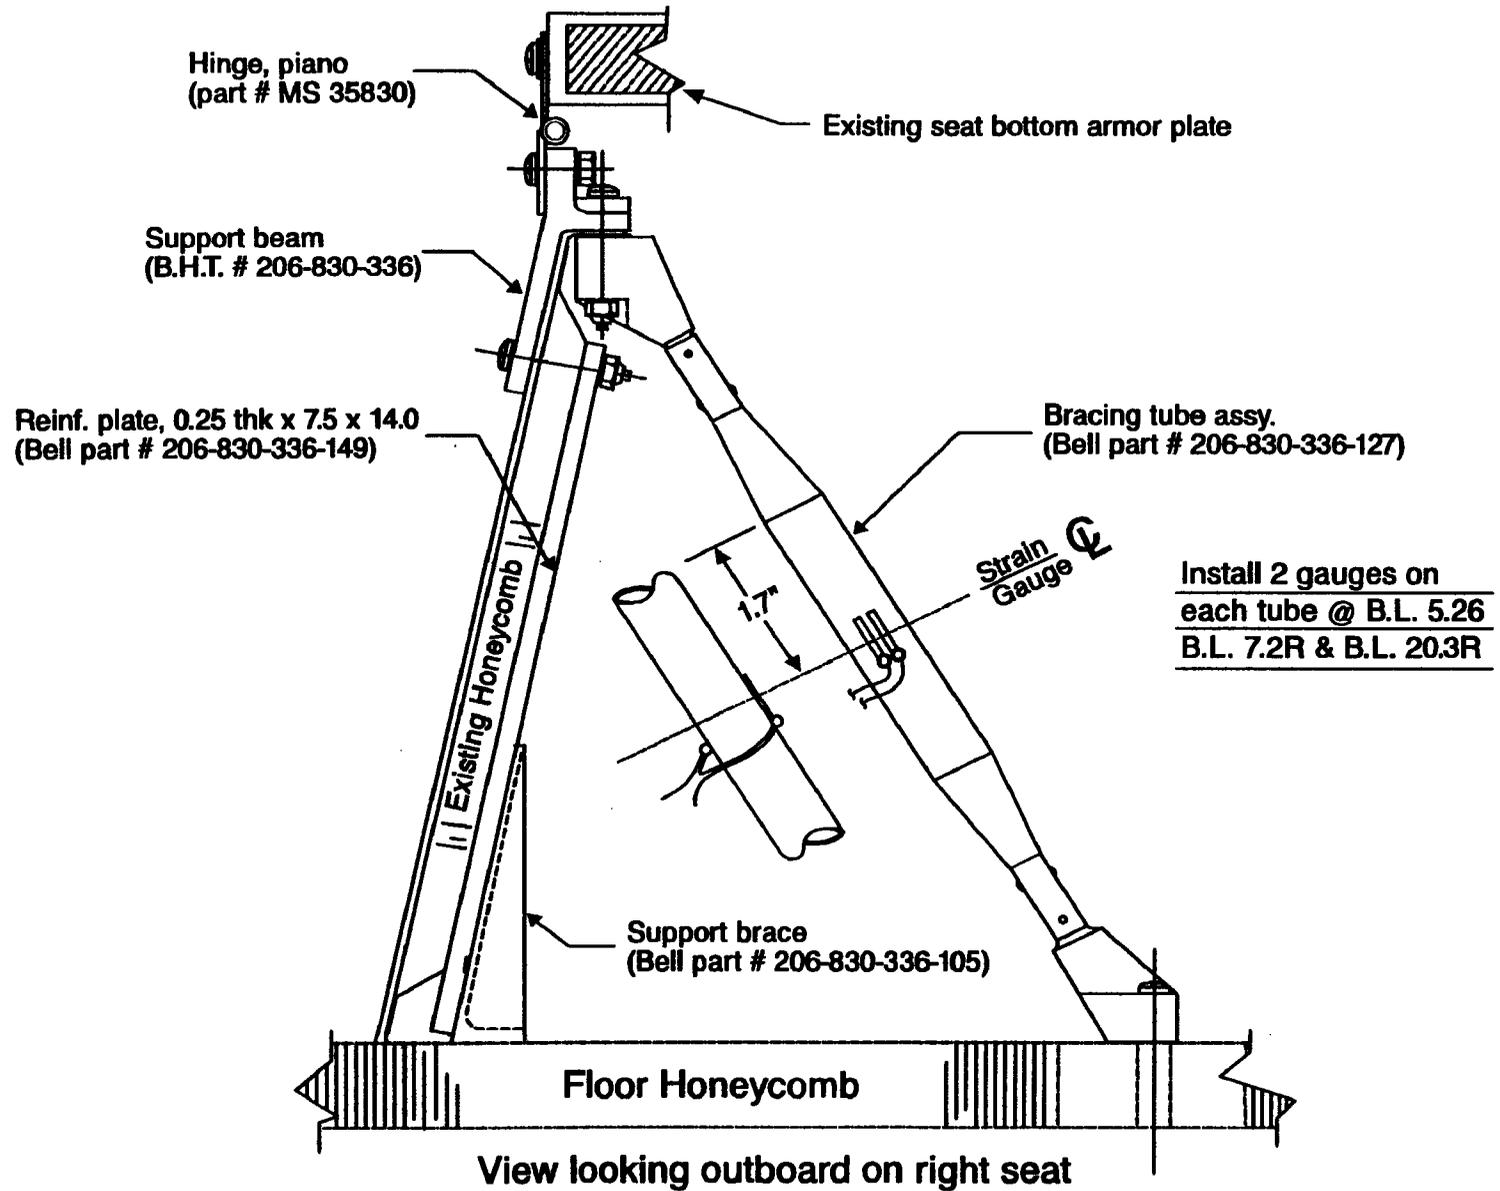
Figure 8b. Hinge line bulkhead for seat pan forward edge support (strain gage installation typical for three tubes).

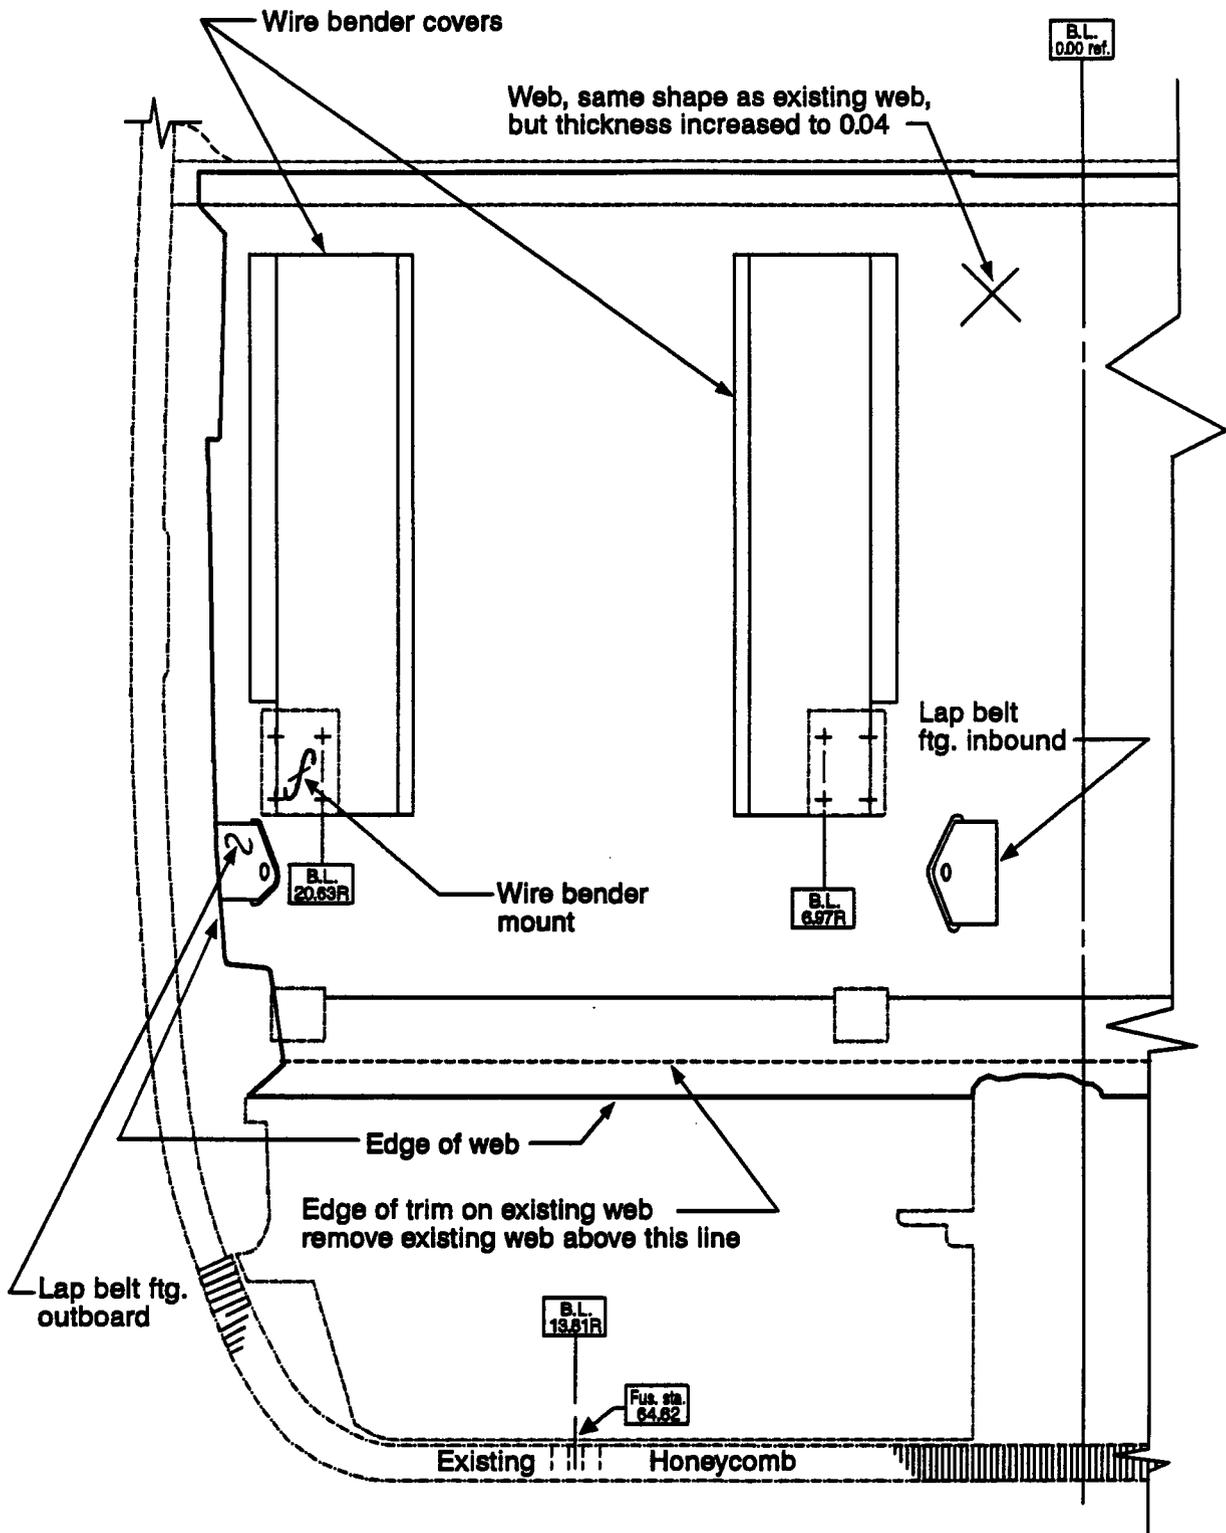
Figure 9. Seat mount bulkhead (view looking aft) (Bell drawing 206-830-335).

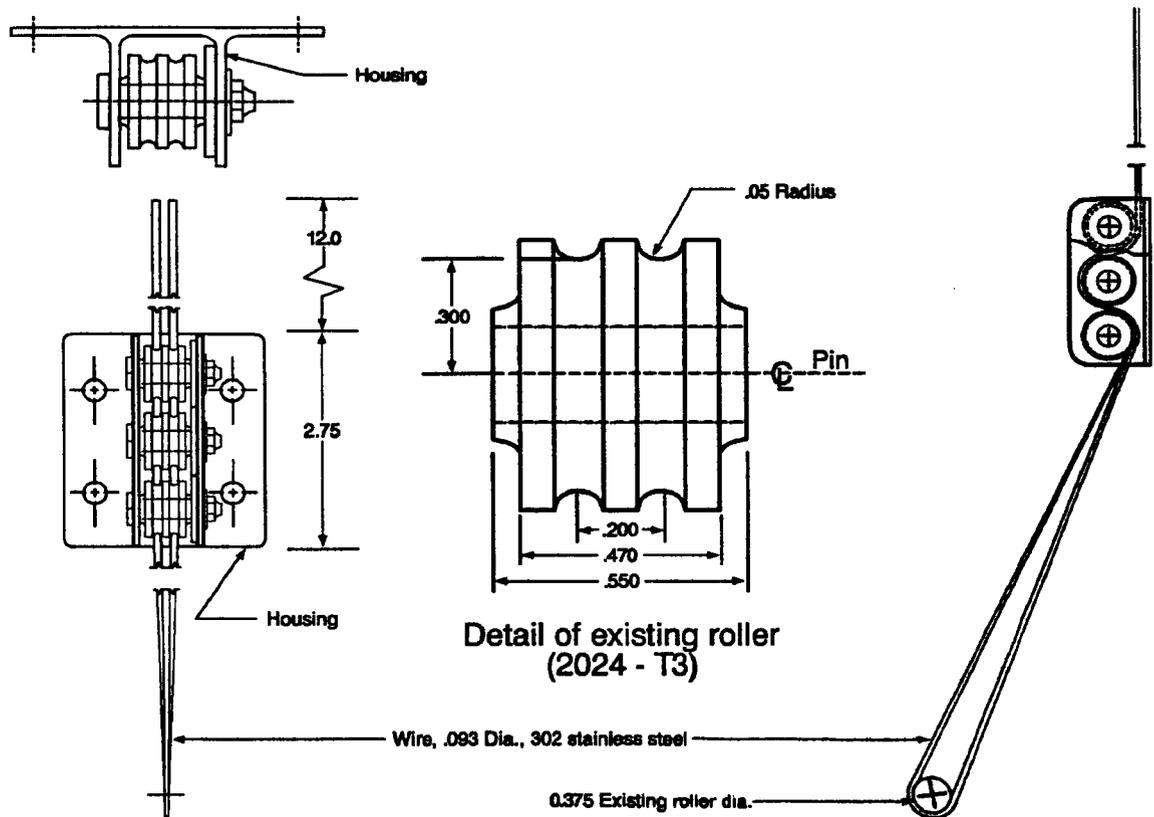
Figure 10a. Wire bending (load-limiting) device used to "limit" the force transmitted to the seated pilot.

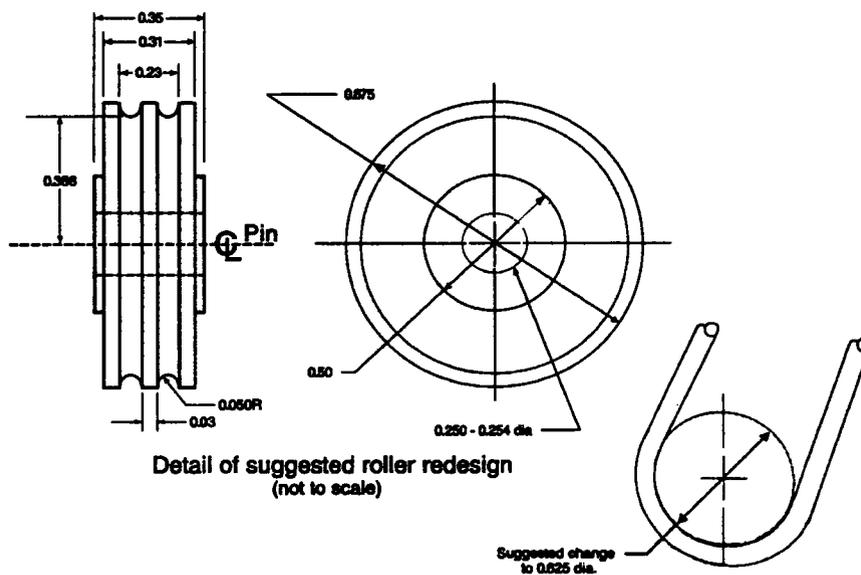
Figure 10b. Wire bending (load-limiting) device roller redesign.

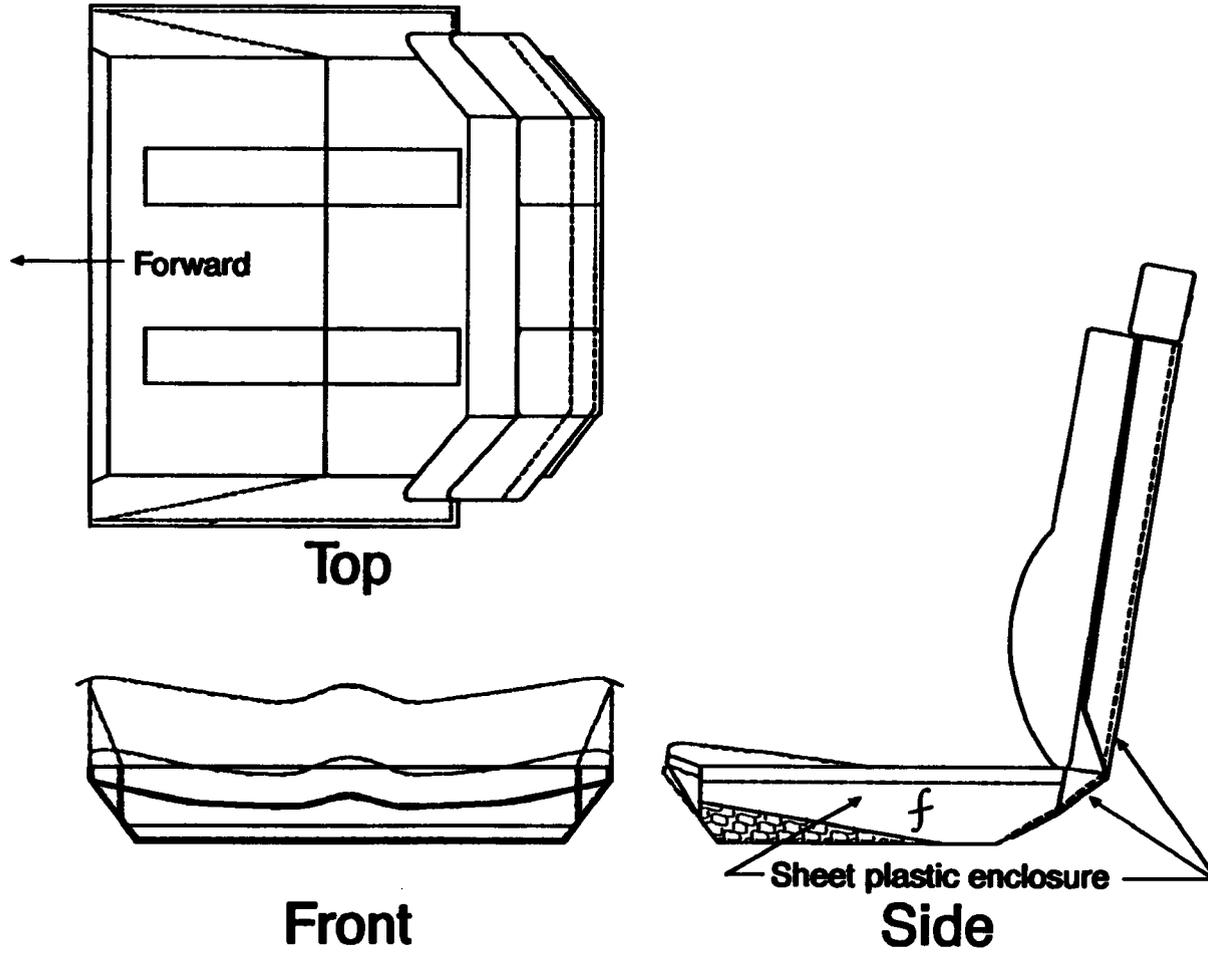
Figure 11. Integrated seat back and seat bottom cushion assembly (note contours at back and bottom).

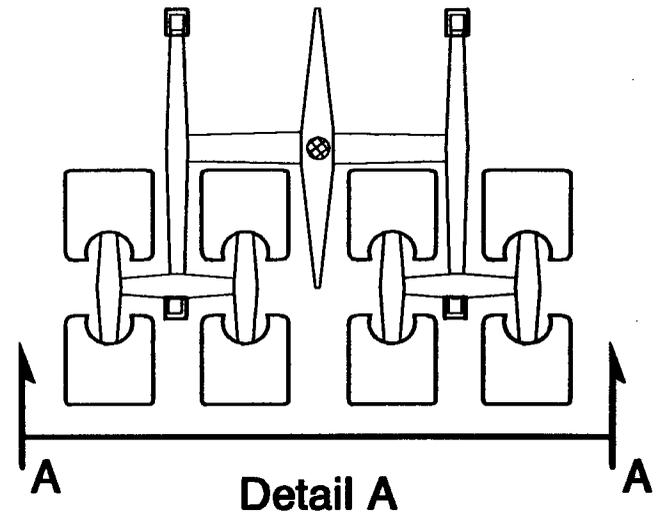
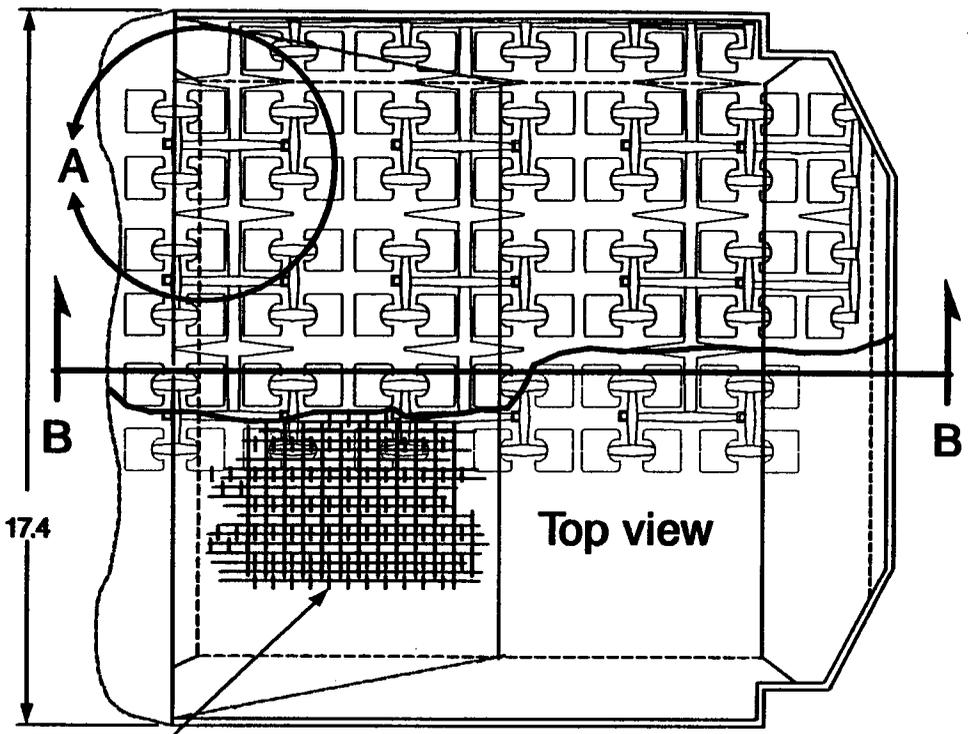
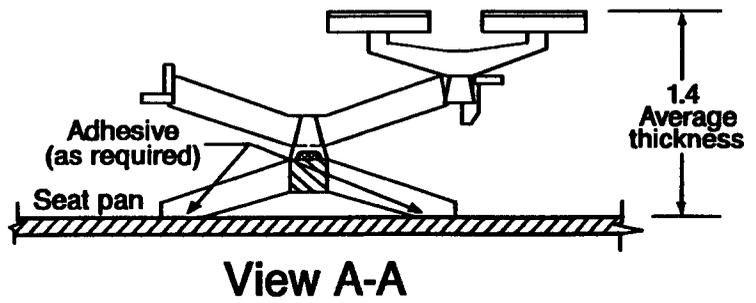
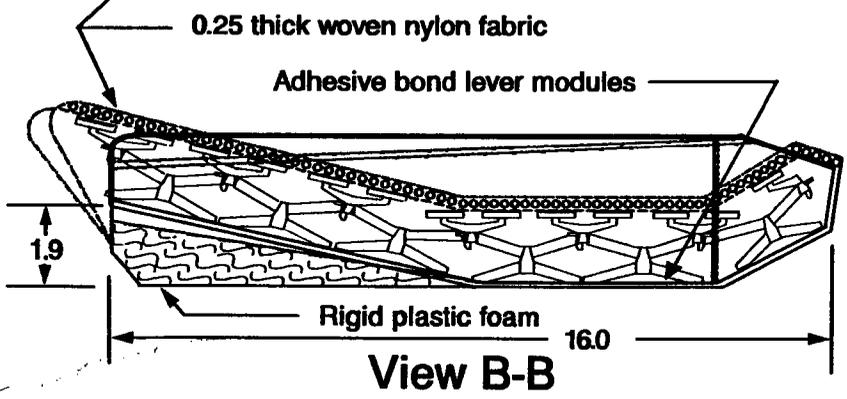
Detail A
Shows solid plastic lever modules,
modules only shown to simplify drawing

View A-A

Figure 12. Seat bottom support structure.

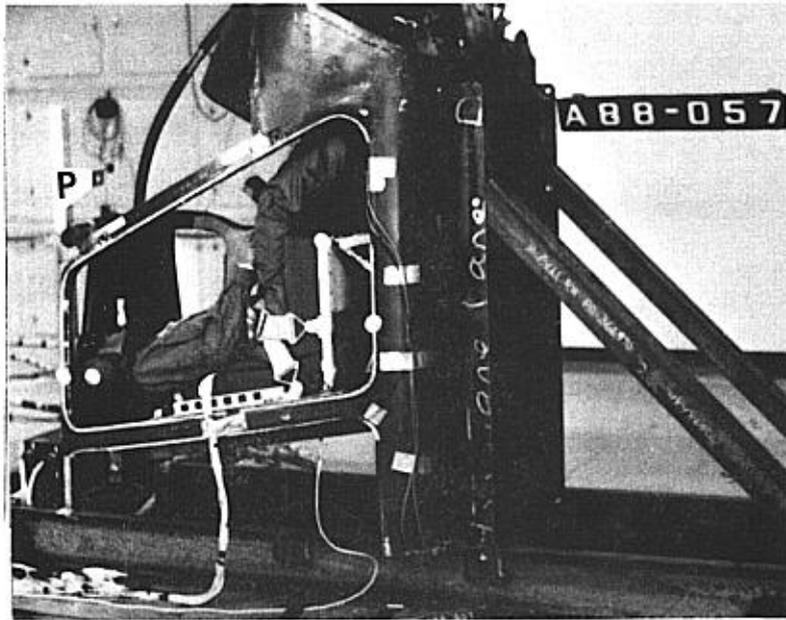
Figure 13. Test setup for pure vertical crash vector--test 88057 (the aluminum channel and bracket used later for pilot display unit tests shown with "P").

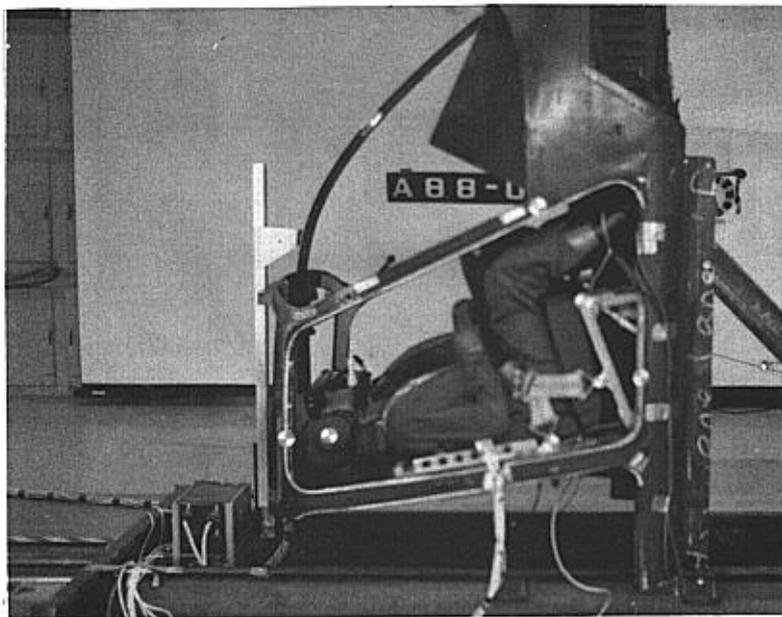
Figure 14. Posttest view of test 88057. (Note the stroked position of the bottom armor plate.)
