USAARL Report No. 95-9

**Evaluation of a Retrofit OH-58
Pilot's Seat to Prevent Back Injury**

**United States Army Aeromedical Research Laboratory
Fort Rucker, Alabama 36362-0577**

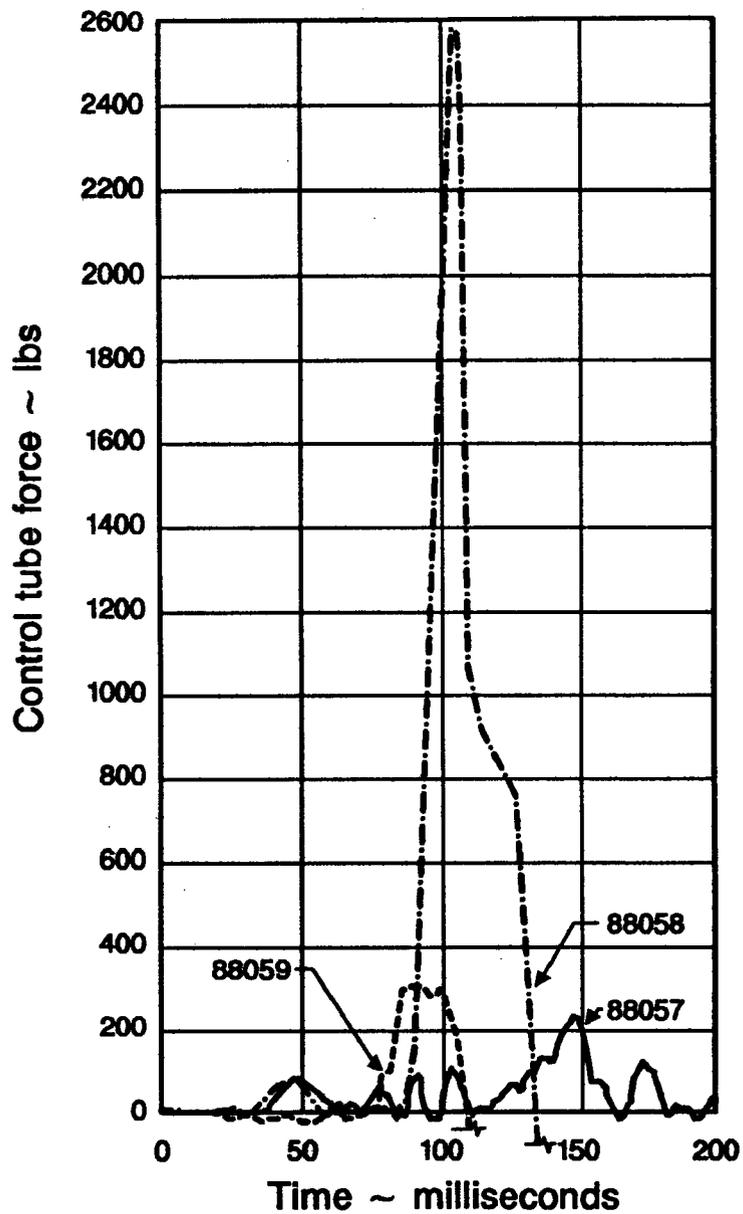
Figure 15. Load cell force measured due to impact of the pivoting seat pan with the under-seat control yoke (see Figures 4 and 23).

Reference to Figure 15 shows the control tube force increased about 1 ms sooner than in test 88057, probably due to the lesser stroke available before yoke contact as shown in Figure A5 in the 82-85 ms time frame. Figure A5 also shows the right seat dummy's lumbar load cell overshoot from 1100 to 2125 lb between 85 and 95 ms, and Figure A4 shows both vertical seat pan transducers producing values of 30 and 45 G at about 92 ms. The control tube force peaked at 2590 lb at 104 ms, and then returned to zero at 134 ms, just about the time the left seat lumbar G value reduced to zero.

The control yoke was impacted at 76 ms as seen in Figure 15, but the control tube load cell sustained only 300 lb at 85 ms; this force was caused by the left dummy deceleration peak of 53 G at 82 ms (Figure A-10). Figure A-9 shows the left seat stroked beyond 5 inches at 80 ms, but "overran," as discussed already. Evidence of the left armor plate impact with the control yoke is shown in Figures 23 and 24. The control yoke was deflected approximately 1.5-inch after impact by the left armor plate, but the right armor plate only touched the yoke with no significant force transfer.

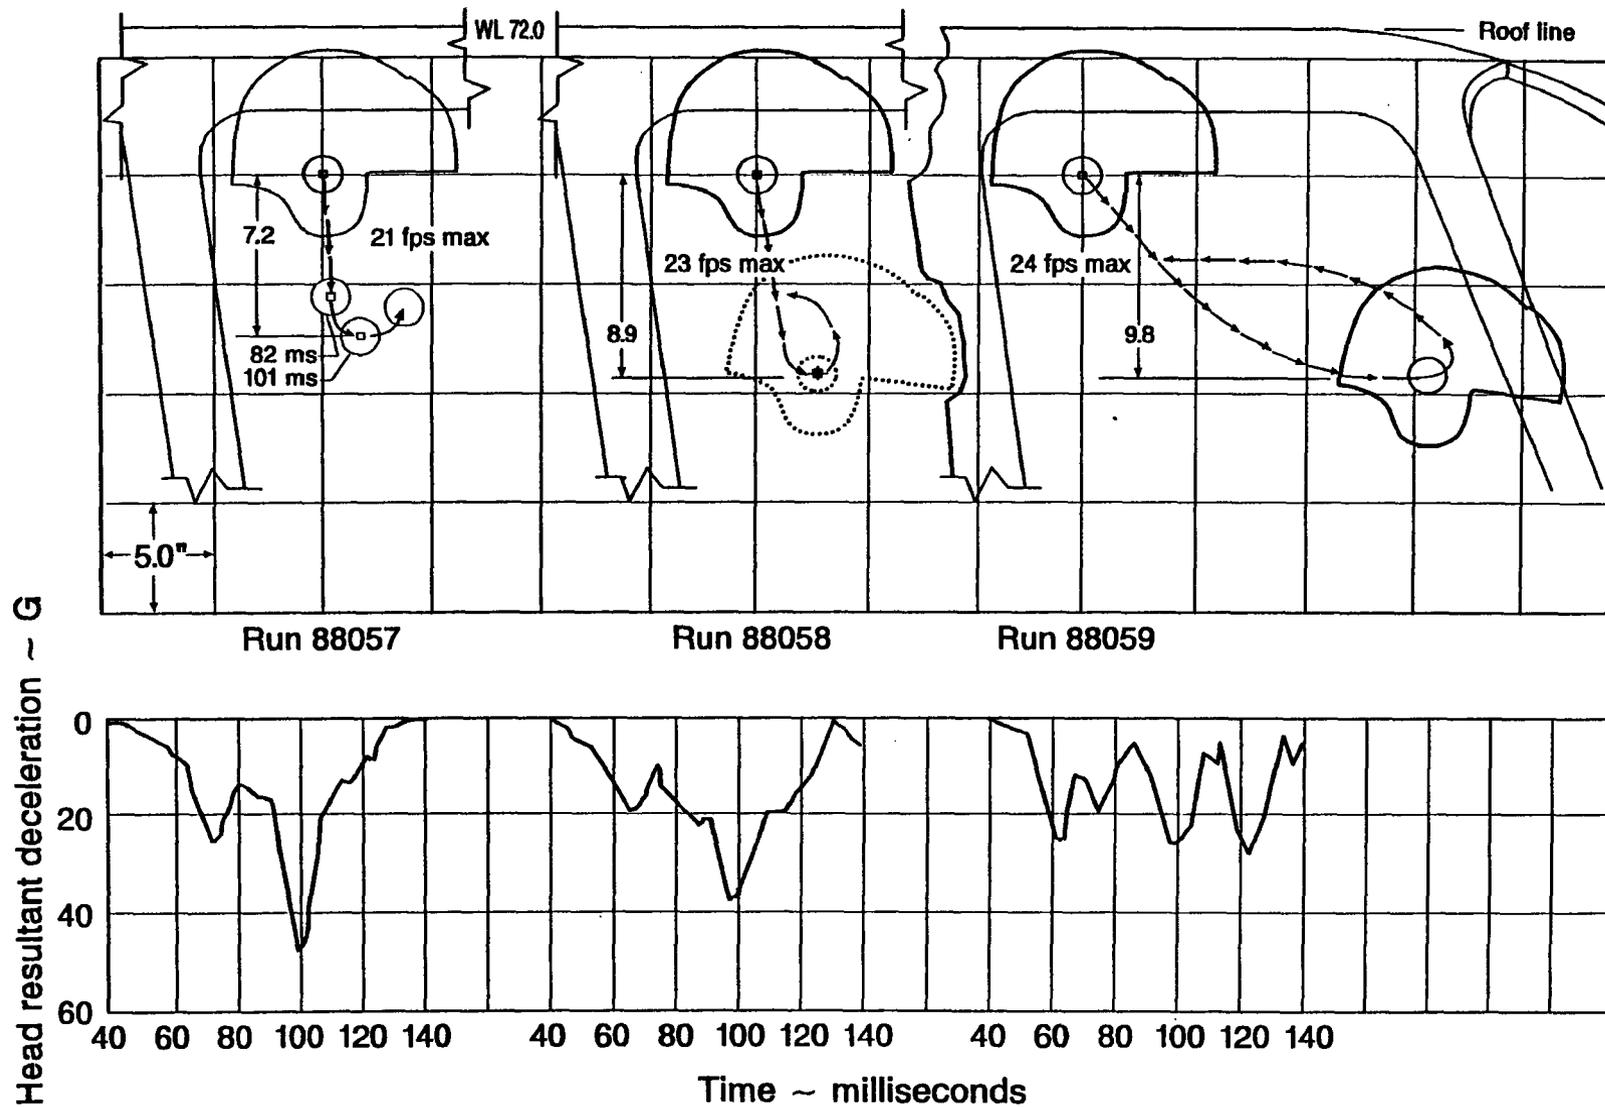
Figure 16. Measured helmet movement of right side dummy from film analysis and head deceleration (runs 88057, 88058, and 88059).

The movement of the helmeted head of the right dummy was analyzed from the two cameras on the right; the movement is illustrated to 1/8 scale in Figure 16. Note the 16-inch forward and 9.8-inch downward movement of the helmet even with a properly locked inertia reel, i.e., less than 3 inches strap movement from the reel.

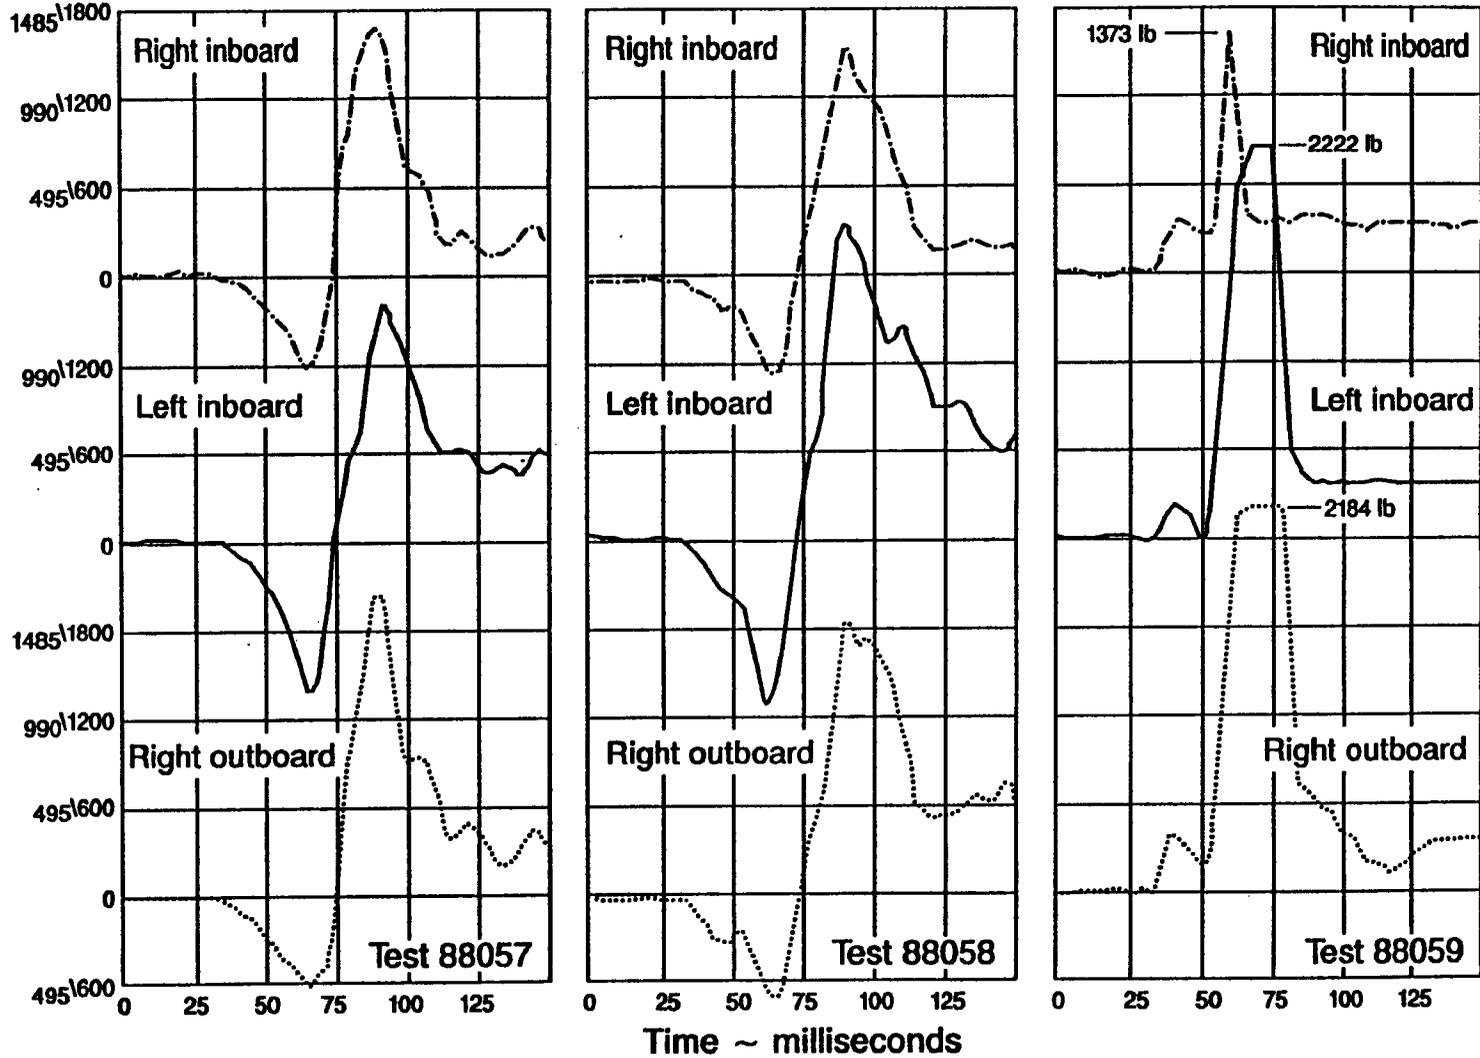
Figure 17. Measured axial strain in aluminum bracing tubes and calculated loads.

Thus, the above load is equal to each 600-microinch increment of strain in Figure 17 where all three bracing tube traces are shown on a common time base and all three tests are shown together. Observe the similarity of the load versus time variation of the three brace tubes; at 32 to 35 ms, all show a compressive load increasing to 500 lb each on the right seat, and 840 lb for the inboard brace of the left seat. The peak compressive load occurs exactly at 67 ms, then reduces to zero at exactly 74 ms, and continues to increase to a peak tensile load at 90 ms on the right seat with medium-size dummy and at 92 ms for the left large dummy. The 2-ms lag of the left seat also may be observed in the seat pan acceleration (Figure A1) in which the peak negative G of 20 and 22 G (left and right) begin to decrease at 103 and 101 ms. The right seat, right tube sustained 1735 lb compared to 1368 lb in the left; this difference would be expected since the center line of the right seat lap belt anchors is located about 0.7-inch outboard of the brace tube center line at BL 13.75R. The load in all three tubes reduces from their peak values to 500 lb or less at 117 ms; from 117 to 150 ms, the left seat sustains the load longer than does the right seat. This same extended time rebound force also is apparent in the left seat tube in the next two tests (88058 and 88059).

Since the anchorages did fail after sustaining this force for about 10 ms (Figure 17), we believe only a small strength increase would sustain the test loads. It is suggested the horizontal shear be carried through the honeycomb "bathtub" at the outboard edges of each seat and at the center console web. The cost and weight of a web structure should be lower than the separate bracing tubes.

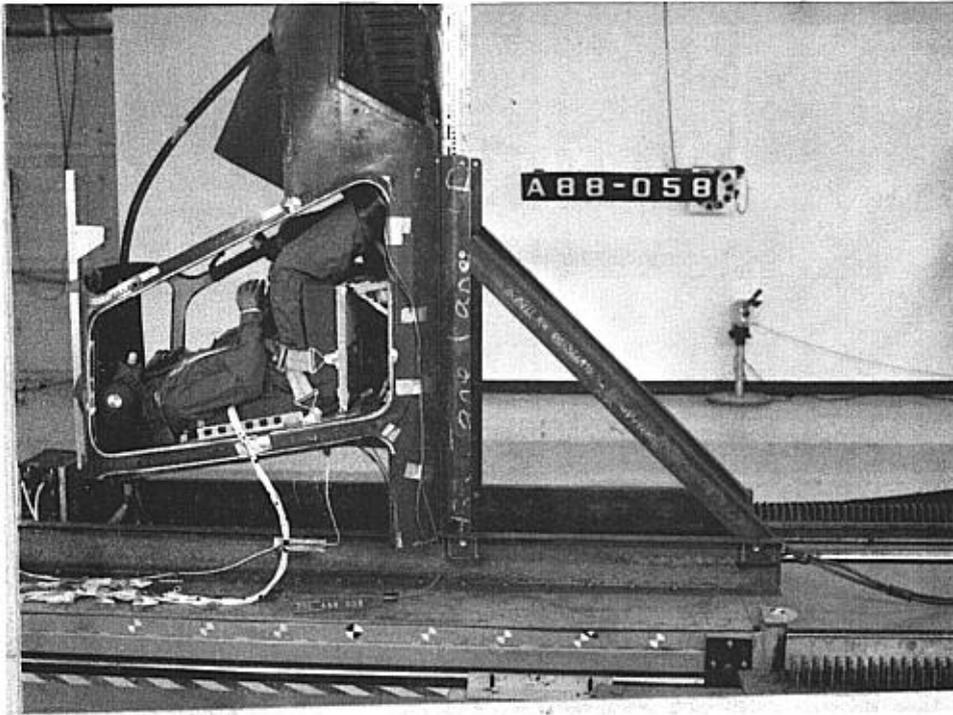
Figure 18. Pretest view of test 88058 (note added beams below nose to stiffen the fuselage).

The only difference in this test and test 88057 was the increased velocity to 29.6 fps from 26.5, and the collective control being placed in the "full down" position yielding about 1 inch less available stroke before under floor yoke contact. Pre- and posttest photographs from the right side are at Figures 18 and 19. A posttest view from the left side is at Figure 20. All transducer traces for the test are at Figures A4 through A7.

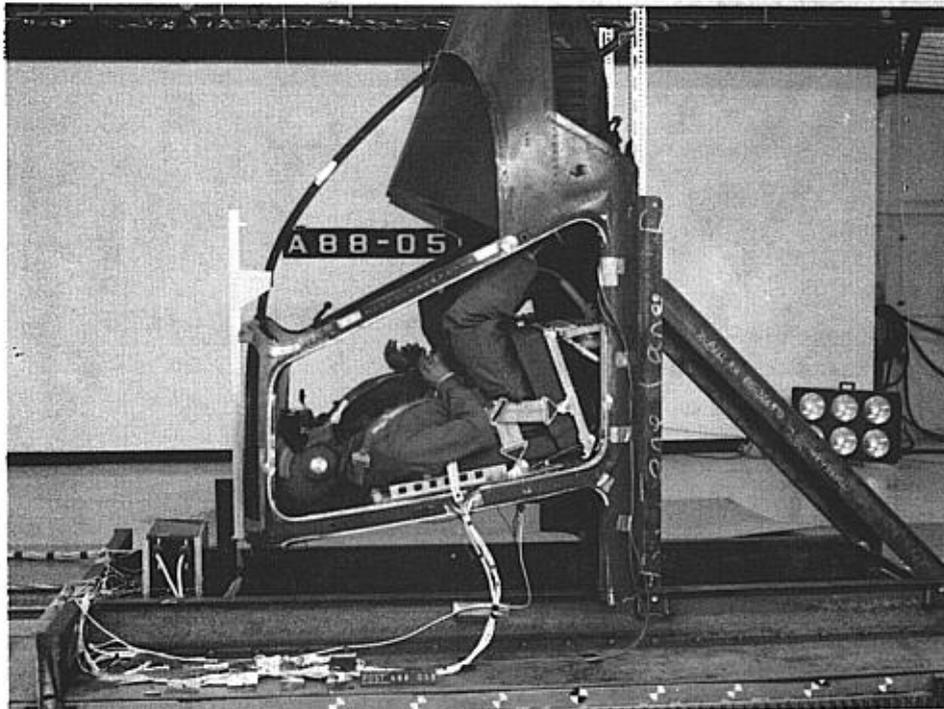
Figure 19. Posttest view of test 88058 (note the stroked position of the bottom armor plate).

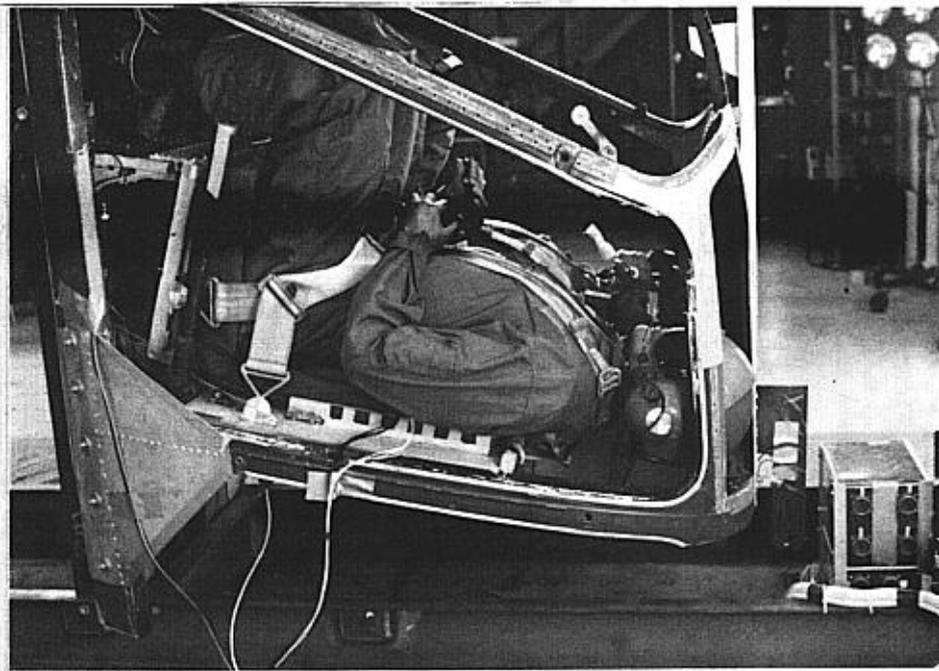
Figure 20. Posttest view of test 88058, showing 95th percentile VIP dummy (note the .05-inch thick aluminum sheet used to stabilize the floor-to-bulkhead joint, **and** the slack in the wire bender at point "W").

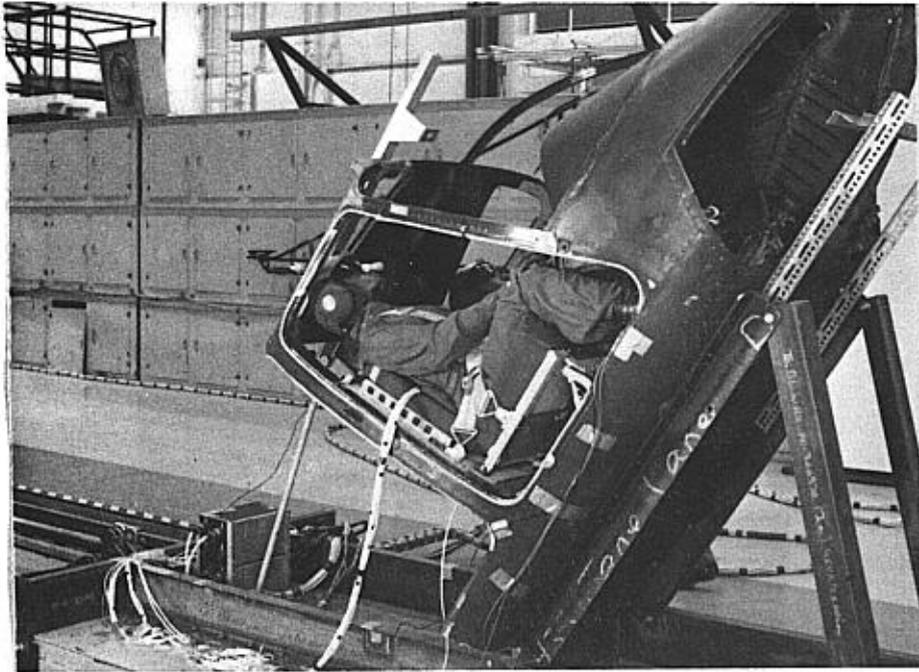
Figure 21. Pretest view of test 88059 (note the fuselage is pitched 56 degrees from vertical in lieu of 90 degrees).

Pre- and postimpact photographs are at Figures 21 and 22. The steel tube running from the sled to the fuselage ceiling is shown clearly in Figure 22. This tube was intended to prevent horizontal shear deformation in the fuselage due to the horizontal crash loads.

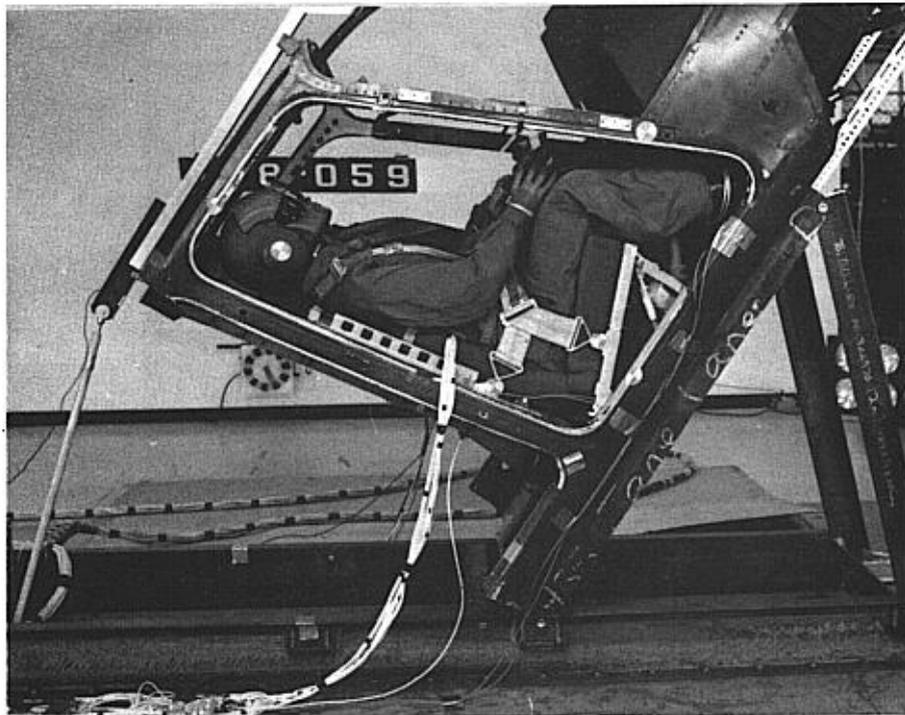
Figure 22. Posttest view of test 88059 (note slack wire bender device).

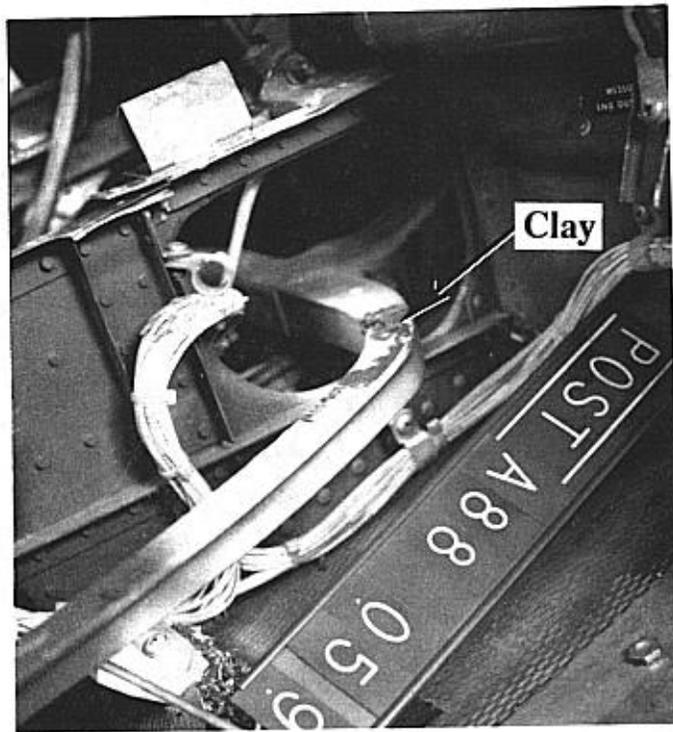
Figure 23. Modeler's clay on underfloor yoke revealing the impact point of the left armor plate (note failure of BL 5.21 brace tube anchorage).

The recorded transducer traces may be reviewed at Figures A-8 through A-11. The seat leading edge bulkhead braces at BL 17.5L, 5.2L, 7.2R, and 20.3R were torn free from their anchorages to the cockpit floor. The failures of these anchorages in the honeycomb floor were photographed and are shown in Figures 23 through 29. The stresses and corresponding loads in the three tubular braces are presented in Figure 17. The brace loads in this test are compared to those from the two pure vertical tests. Note an initial compressive load, due to the downward impact, did not occur in this test, and some tensile load appeared at 34 ms about the same time that the armor plate accelerometers showed deceleration (Figure A-8). The chest X deceleration of the right dummy (Figure A-8) peaked at 24 G, reflecting dynamic overshoot from the 34 G peak sled value acting at 34 degrees from the z-axis. The chest z-value, on the other hand, peaked at only 6 G, a value apparently incompatible with the known 12 G input to the buttocks as indicated by the 1300-lb load shown in Figure A-9. The same chest z-value was correspondingly too low in Figures A-1 and A-4 for tests 88057 and 88058, respectively. The chest z accelerometer appeared to have been inadvertently plugged into the y-axis chest accelerometer. This conclusion is based on the fact that the transducer also read very low negative and positive G in later PDU tests (runs 88060, 88061, and 88062), but when the cockpit was yawed 15 degrees for tests 063 and 064, the z-axis transducer came alive and displayed values of 10 to 15 G as would be expected for the y component. Thus, the chest z values shown are assumed to be chest y values.

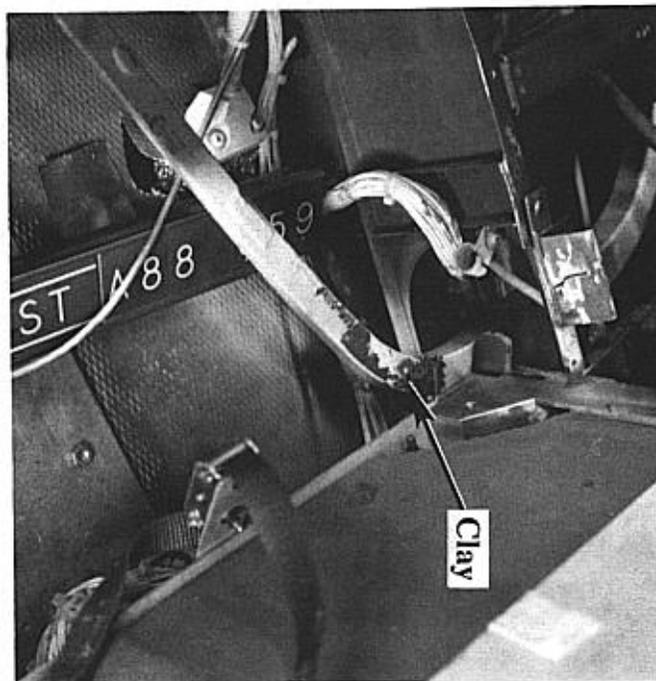
Figure 24. Underfloor yoke impact at bottom armor plate rear edge.

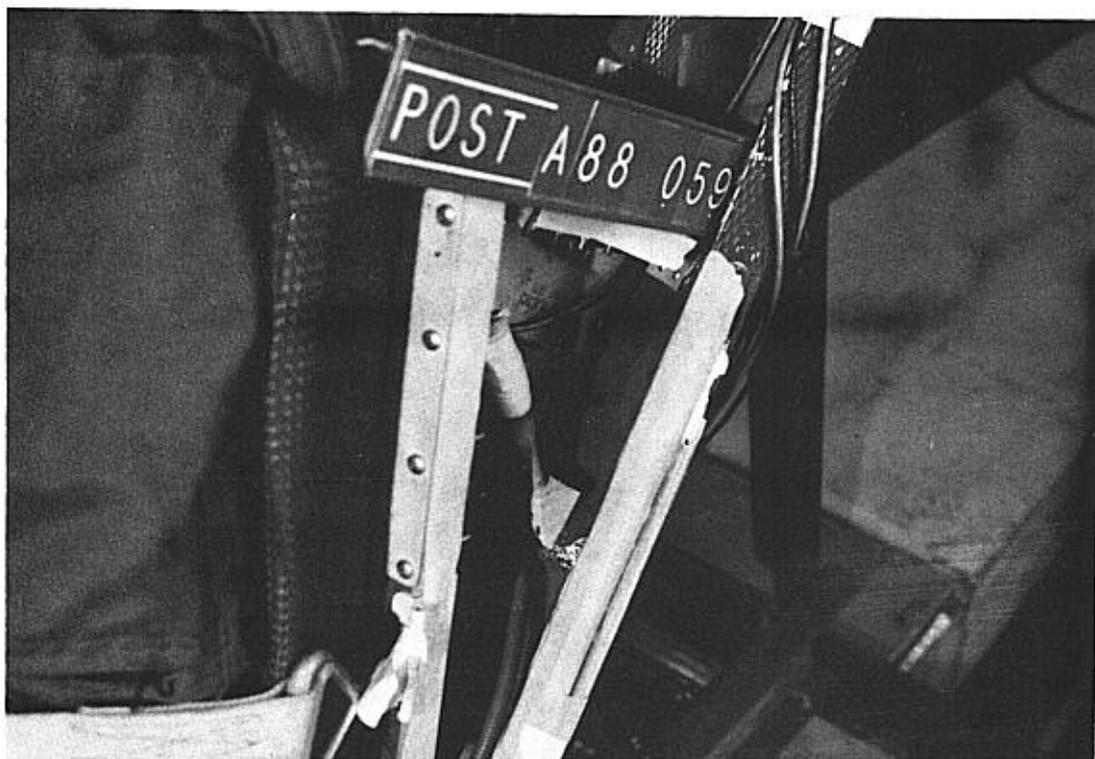
Figure 25. Failure of BL 20.3 right outboard brace tube anchorage to floor.

The failures of all four brace attachments to the "bathtub" honeycomb floor are depicted in Figures 25-29.

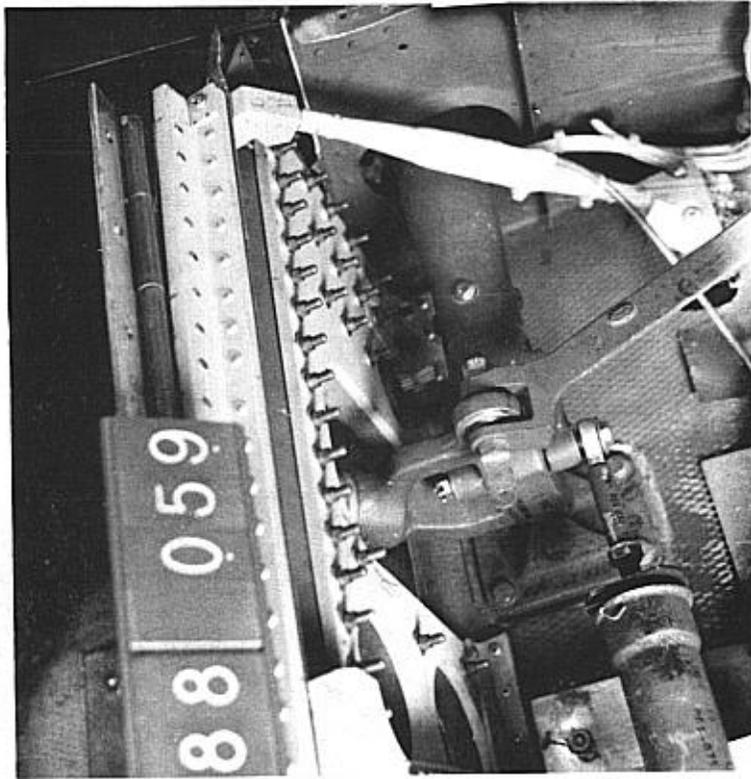
Figure 26. **Postmortem view of BL 17.5 left brace and BL 5.2 left brace tube (note slight separation of M535830 hinge at inboard edge).**

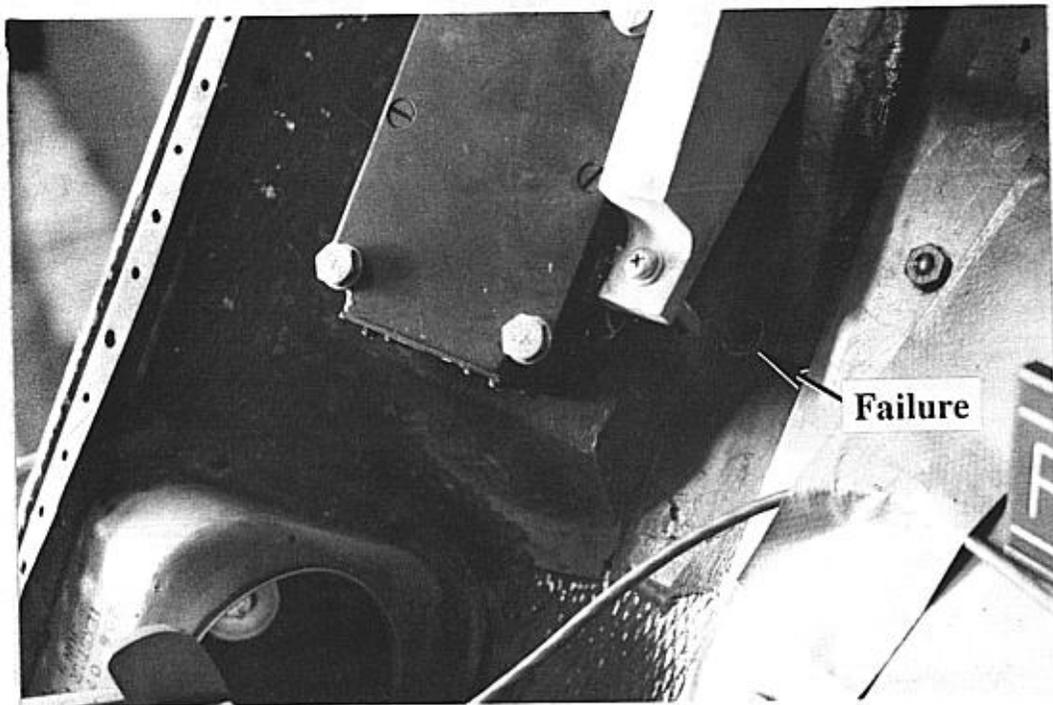
Figure 27. **Failure of BL 17.5 left brace anchorage to floor.**

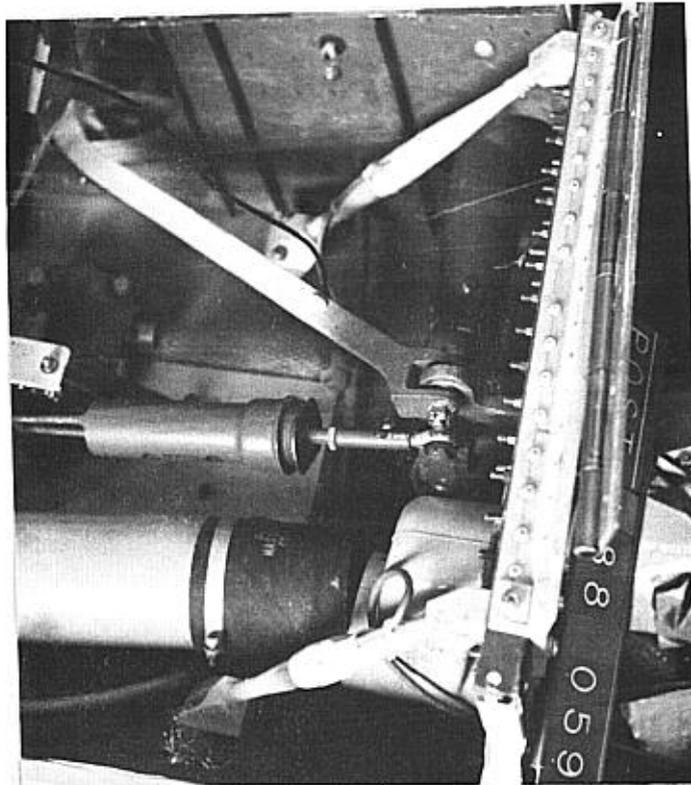
Figure 28. View of right seat area after removal of armor plate at hinge (note separation of M535830 at bottom of photograph).

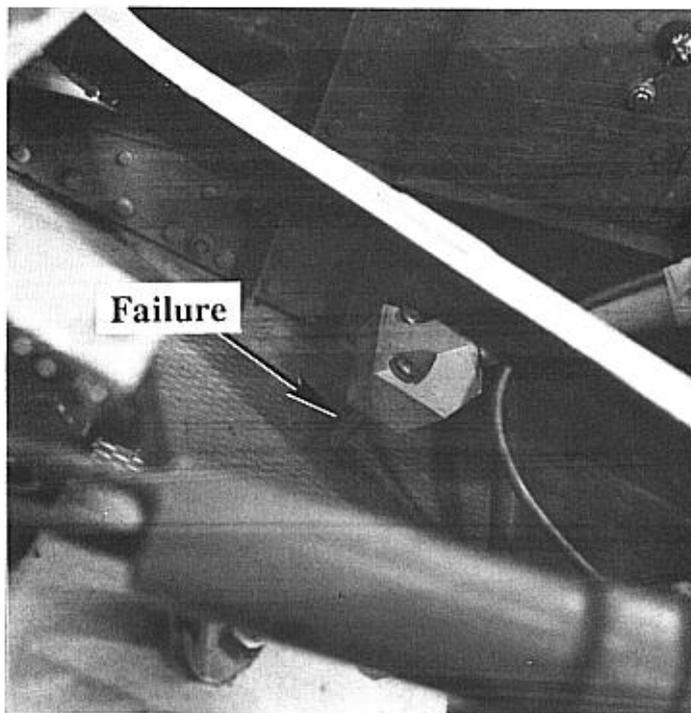
Figure 29. Closeup view of BL 7.2 right anchorage failure at 1373 lb.

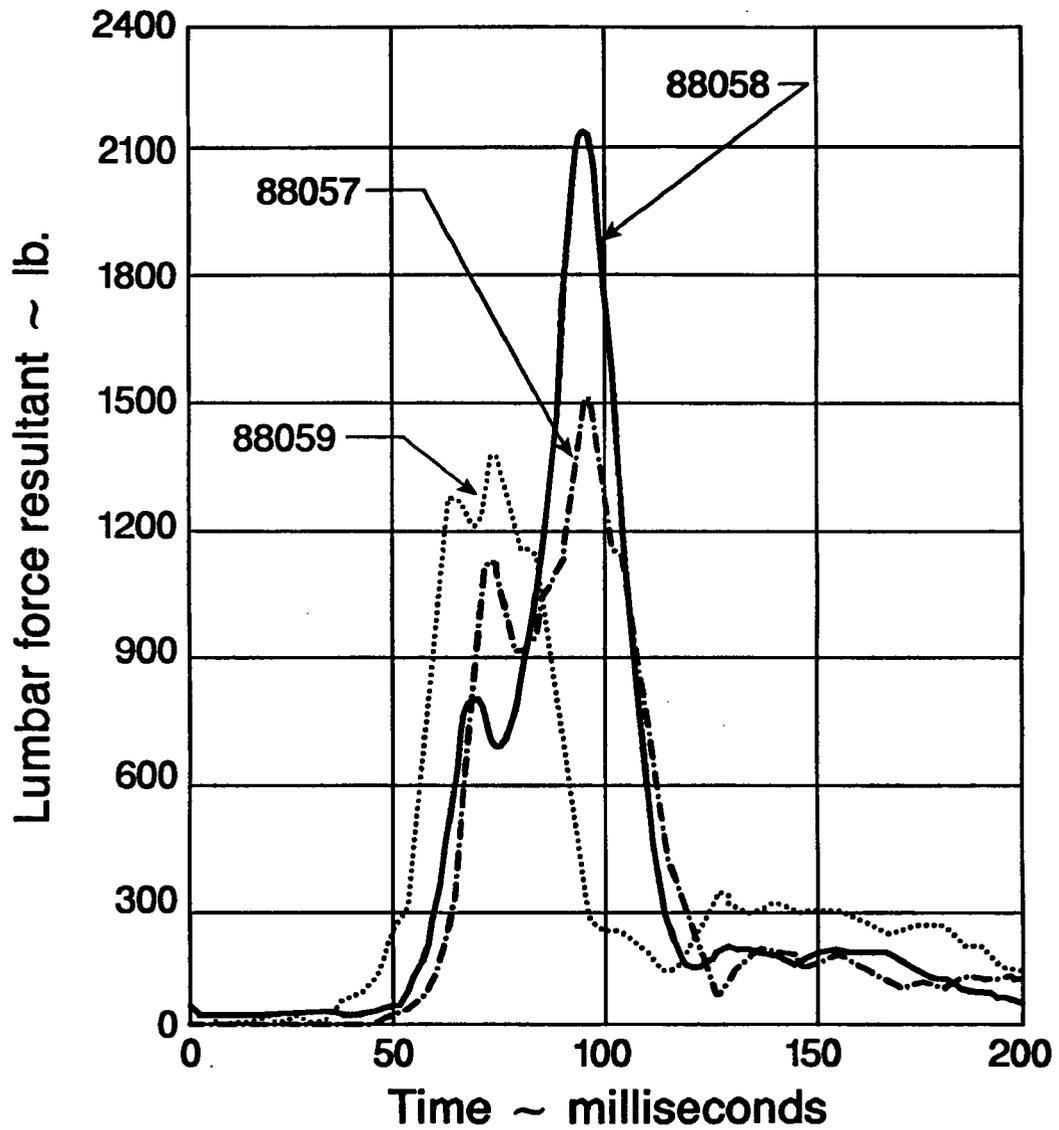
Figure 30. Calculated resultant of X, Y, and Z lumbar load cell vectors in right dummy.

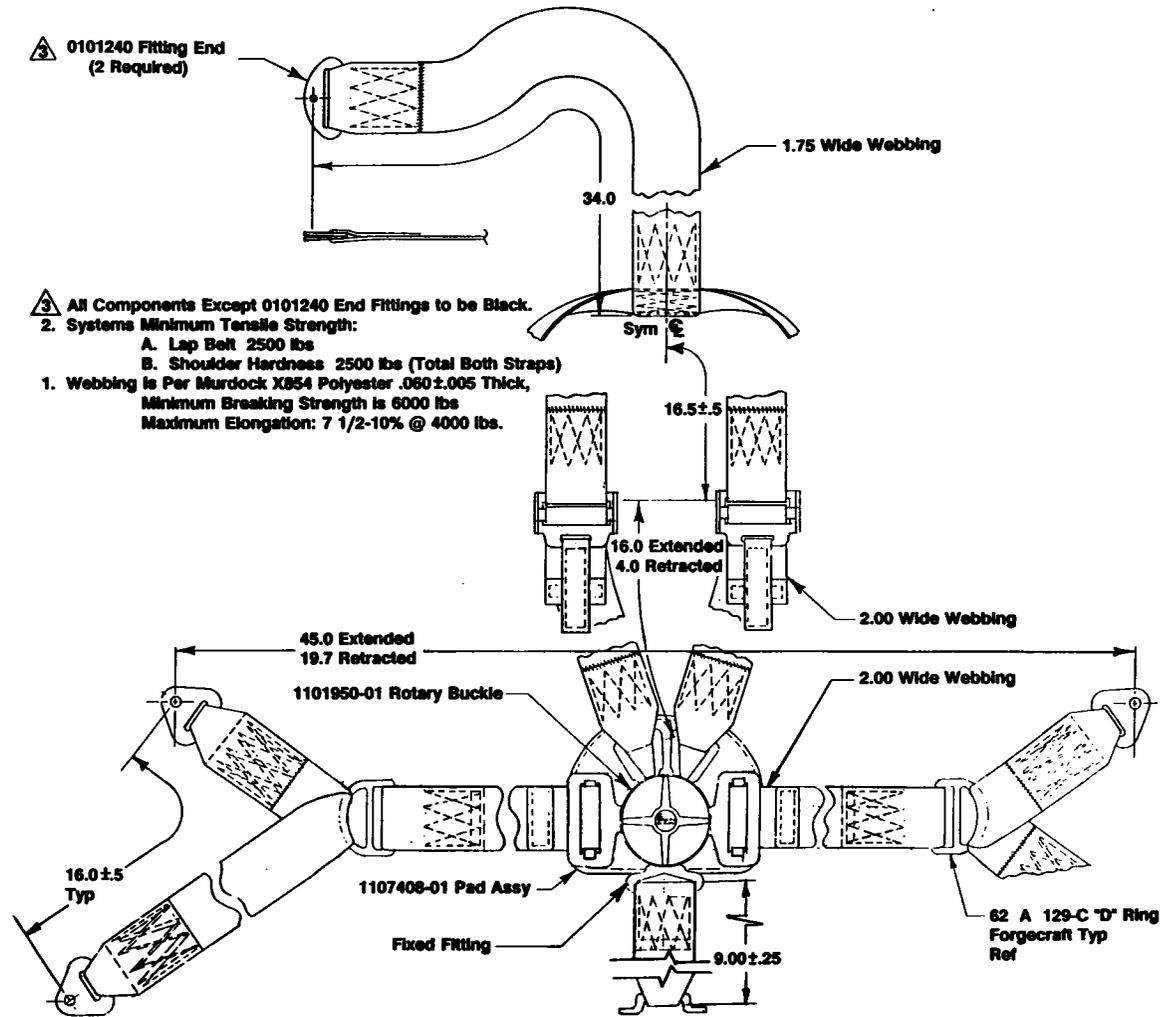
Figure 31. Five-point restraint harness proposal (Pacific Scientific Company, or equivalent).

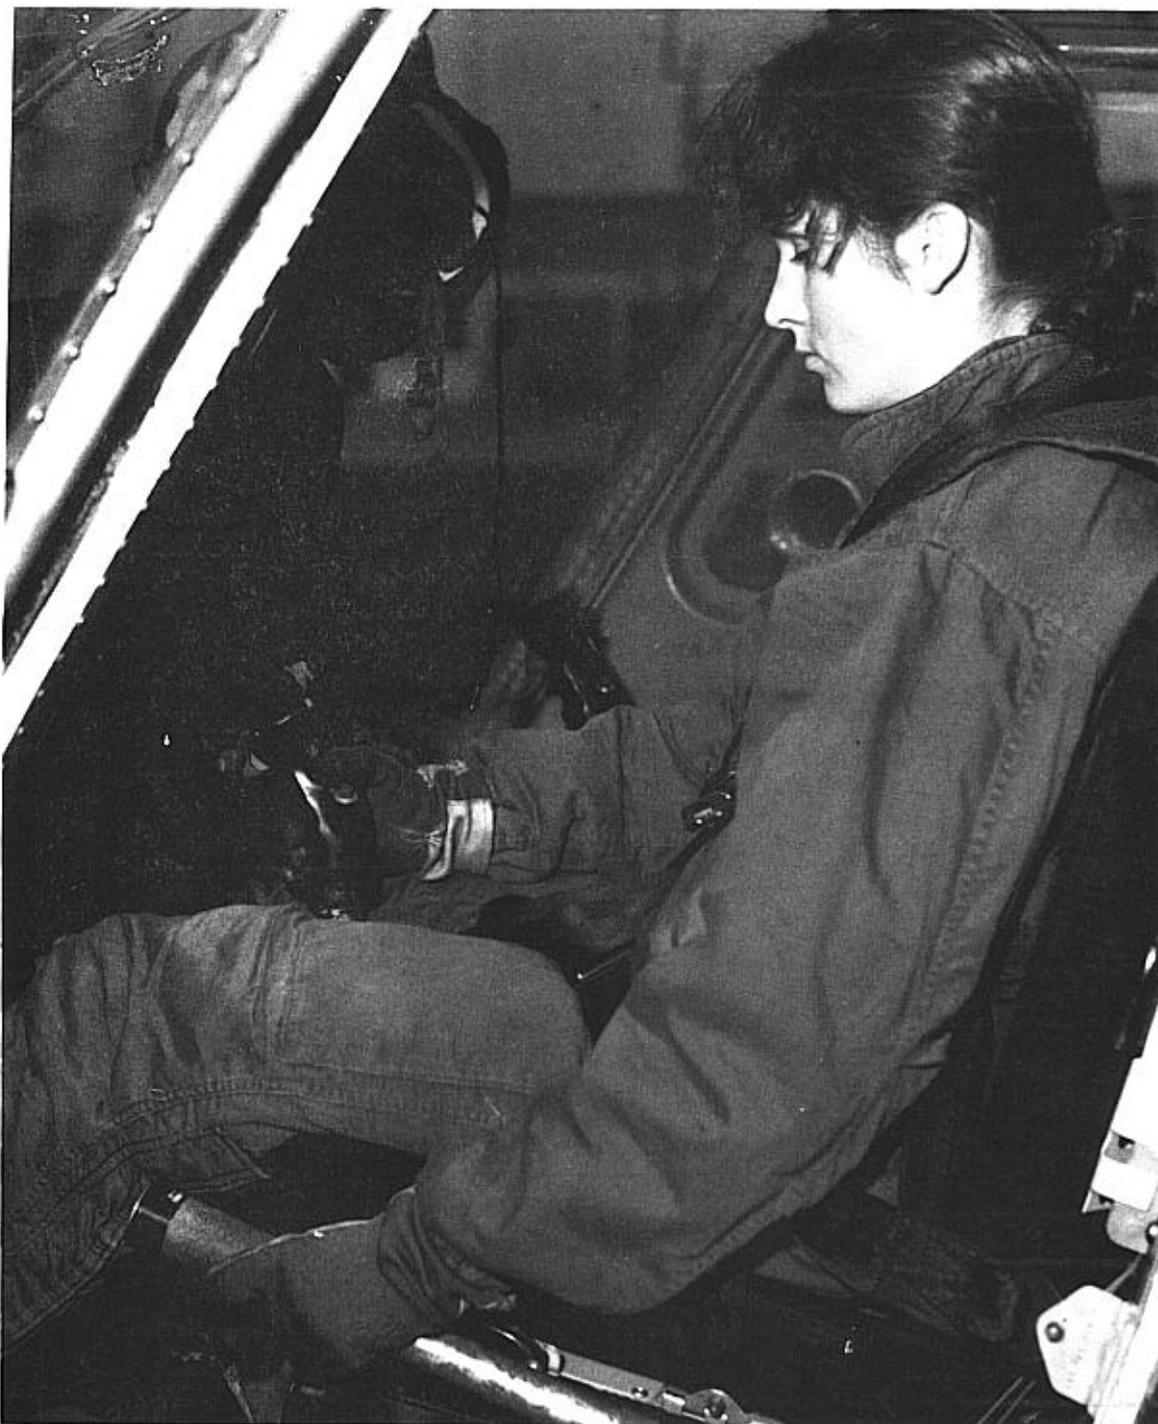
Figure 32. View of small female pilot in serial 71-20778 with five-point harness and seat pan BRP at 0.97 inch below sled test value (note collective in lowest position).

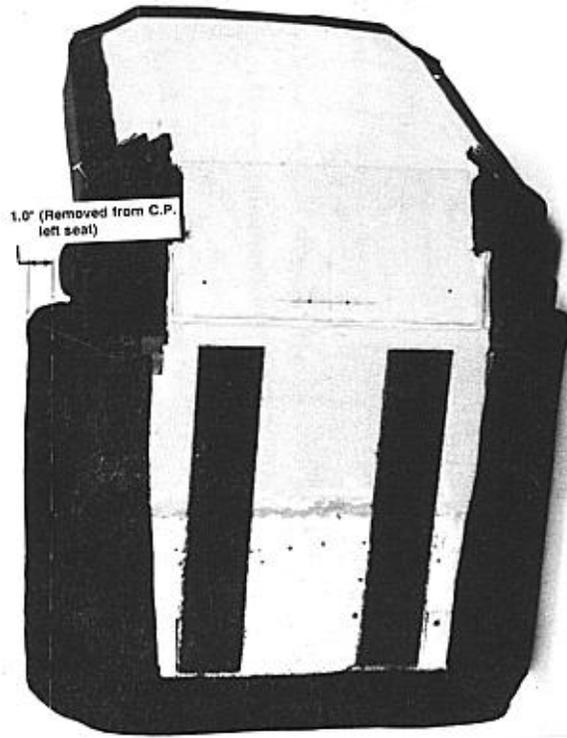
Figure 33. View of seat back and bottom assembly in serial 70-20778.

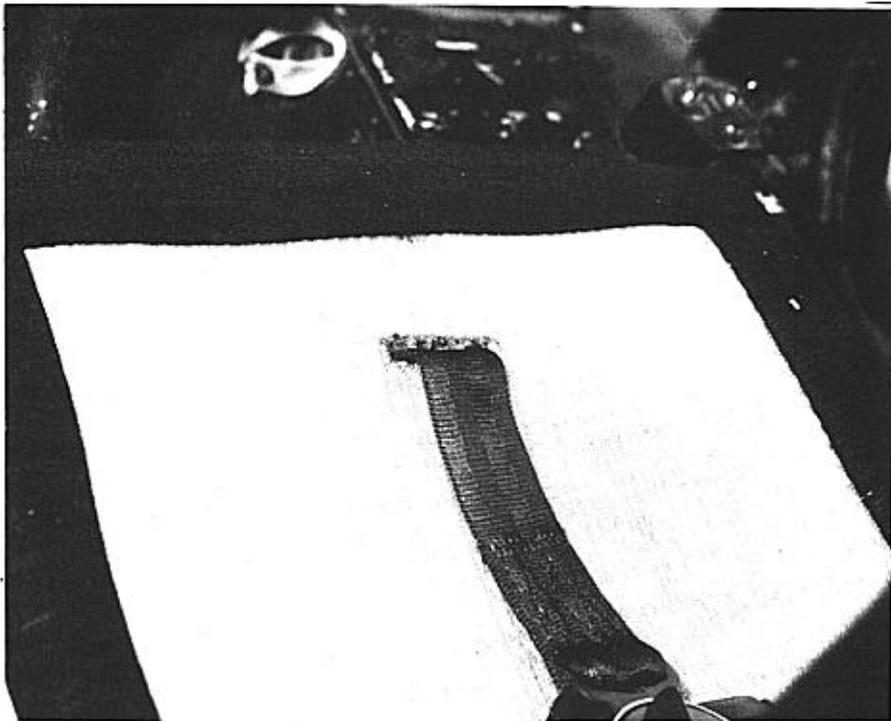
Figure 34. View of tiedown strap exiting hole in seat bottom cushion.

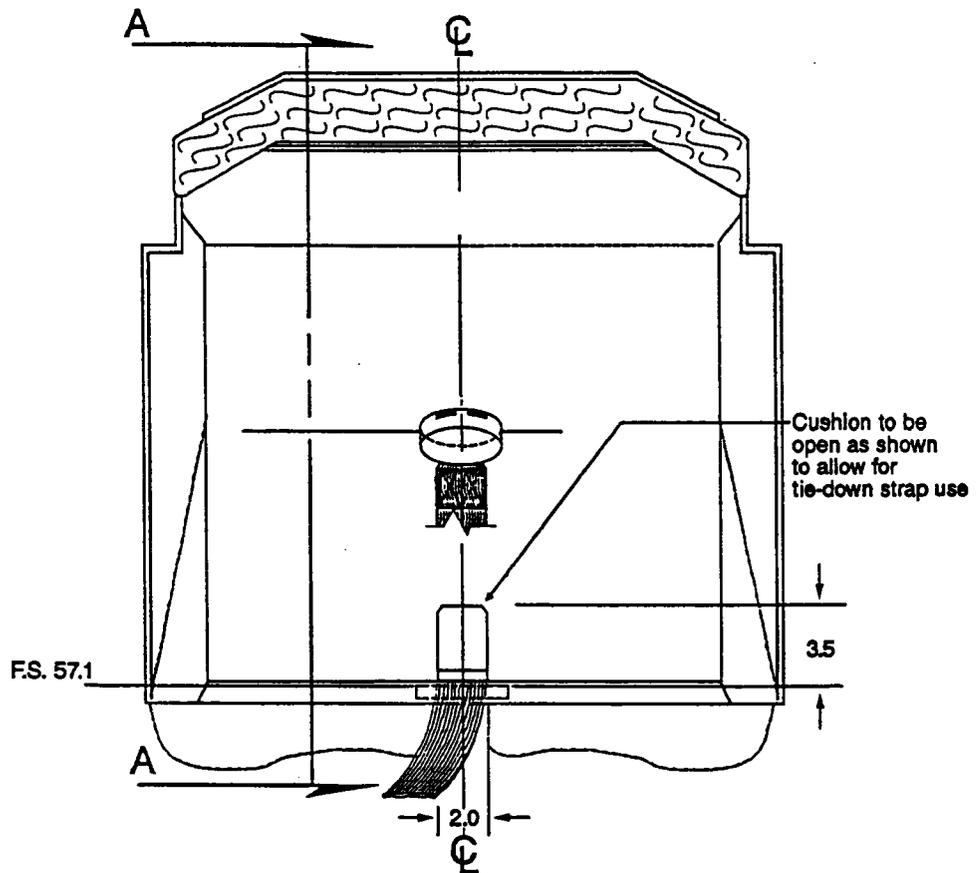
Figure 35. Location of tiedown strap for five-point harness (the 11.0-inch length shown agrees with the 9.0 inch webbing length shown in Figure 31).

- c. The TECOM flight evaluation used 10 pilots varying in sitting height from a small female (less than 1 percentile male sitting height), as shown in Figure 32, to a large male (over 95 percentile sitting height), based on the current pilot population). No significant problems were noted after (1) the shoulder strap was shortened, (2) the reel lock-unlock knob accessibility was improved by elevating the knob by 3/4 inch and reducing the width of the bottom cushion, and (3) the 5-point harness tie-down strap was routed through a hole in the cushion from an anchorage point on the armor plate forward edge, Figures 34 and 35.

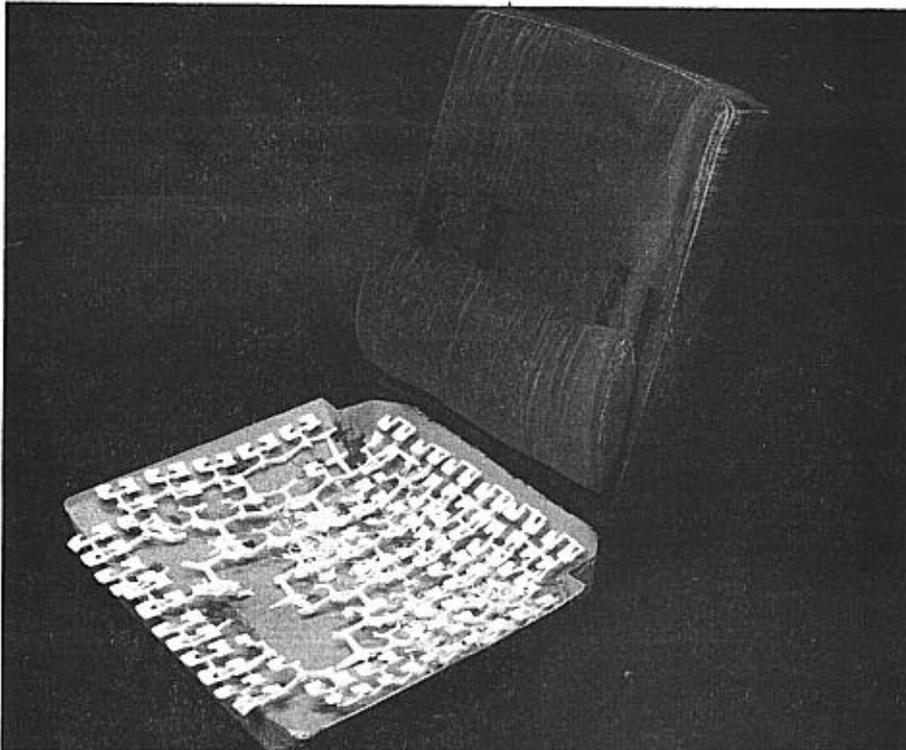
Figure 36a. Copilot seat bottom and back cushions after removal of PREQUAL™ cover after 20 months and 100 flight hours in JOH-58A (Ser 71-20778).

After the TECOM evaluation was completed, the JOH-58A aircraft was returned to USAARL and this aircraft with the prototype crashworthy seats installed has continued to fly to the present. The left (copilot) seat still has the 5-point harness and the Pacific Scientific dual mode (1.5 G lock) inertia reel while the right seat includes the standard 4-point harness. The seats have continued to fulfill their function without complaint from the pilot users with one exception. The bottom "cushion" consisting of 30 plastic lever modules called PREQUAL™* and a ¼-in thick porous cover called SPACEFABRIC™*, degraded after approximately 20 months exposure at Fort Rucker, Alabama. Specifically, the SPACEFABRIC™ became threadbare and started unraveling, and the PREQUAL™ lost elasticity and the individual lever beams completely disintegrated, as shown in Figures 36a and b. The disintegration was far worse on the left seat, the side of the aircraft exposed to the sun most of the day during parking. We conclude the sunlight exposure probably had a greater degrading effect than did the heat since both left and right cushions received nearly equal heat in the closed cockpit. In BHT report 699-099-286, paragraph 3.2, the text indicated the PREQUAL™ levers were in use in the AH-1S helicopter on the SAVIM seats; thus, the longevity and wearability of the PREQUAL™ cushions with a sheepskin cover should be evaluated prior to production consideration for the OH-58.

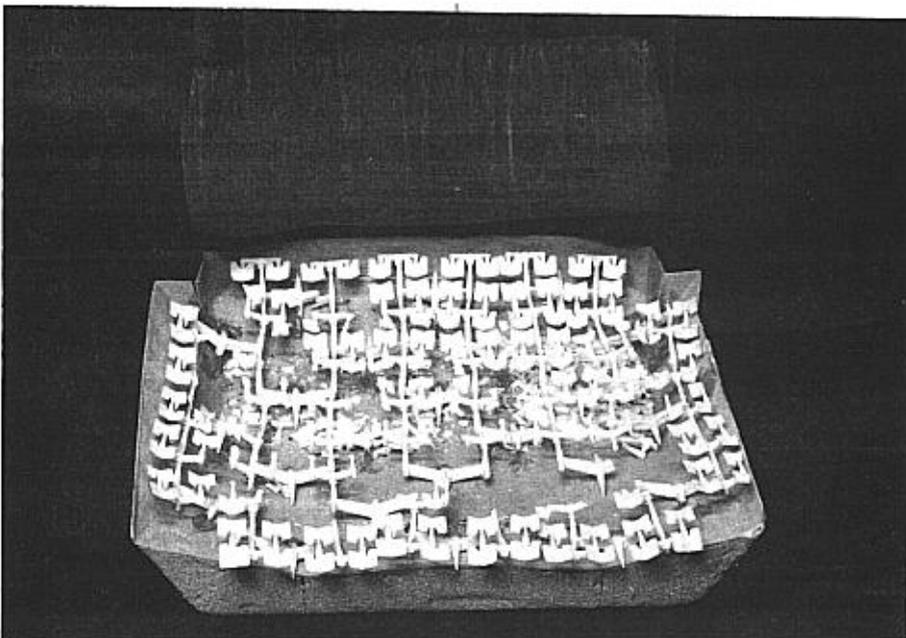
Figure 36b. Copilot (left) seat bottom and back cushions (note disintegrated plastic lever supports).
