USAARL Report No. 95-9

**Evaluation of a Retrofit OH-58
Pilot's Seat to Prevent Back Injury**

**United States Army Aeromedical Research Laboratory
Fort Rucker, Alabama 36362-0577**

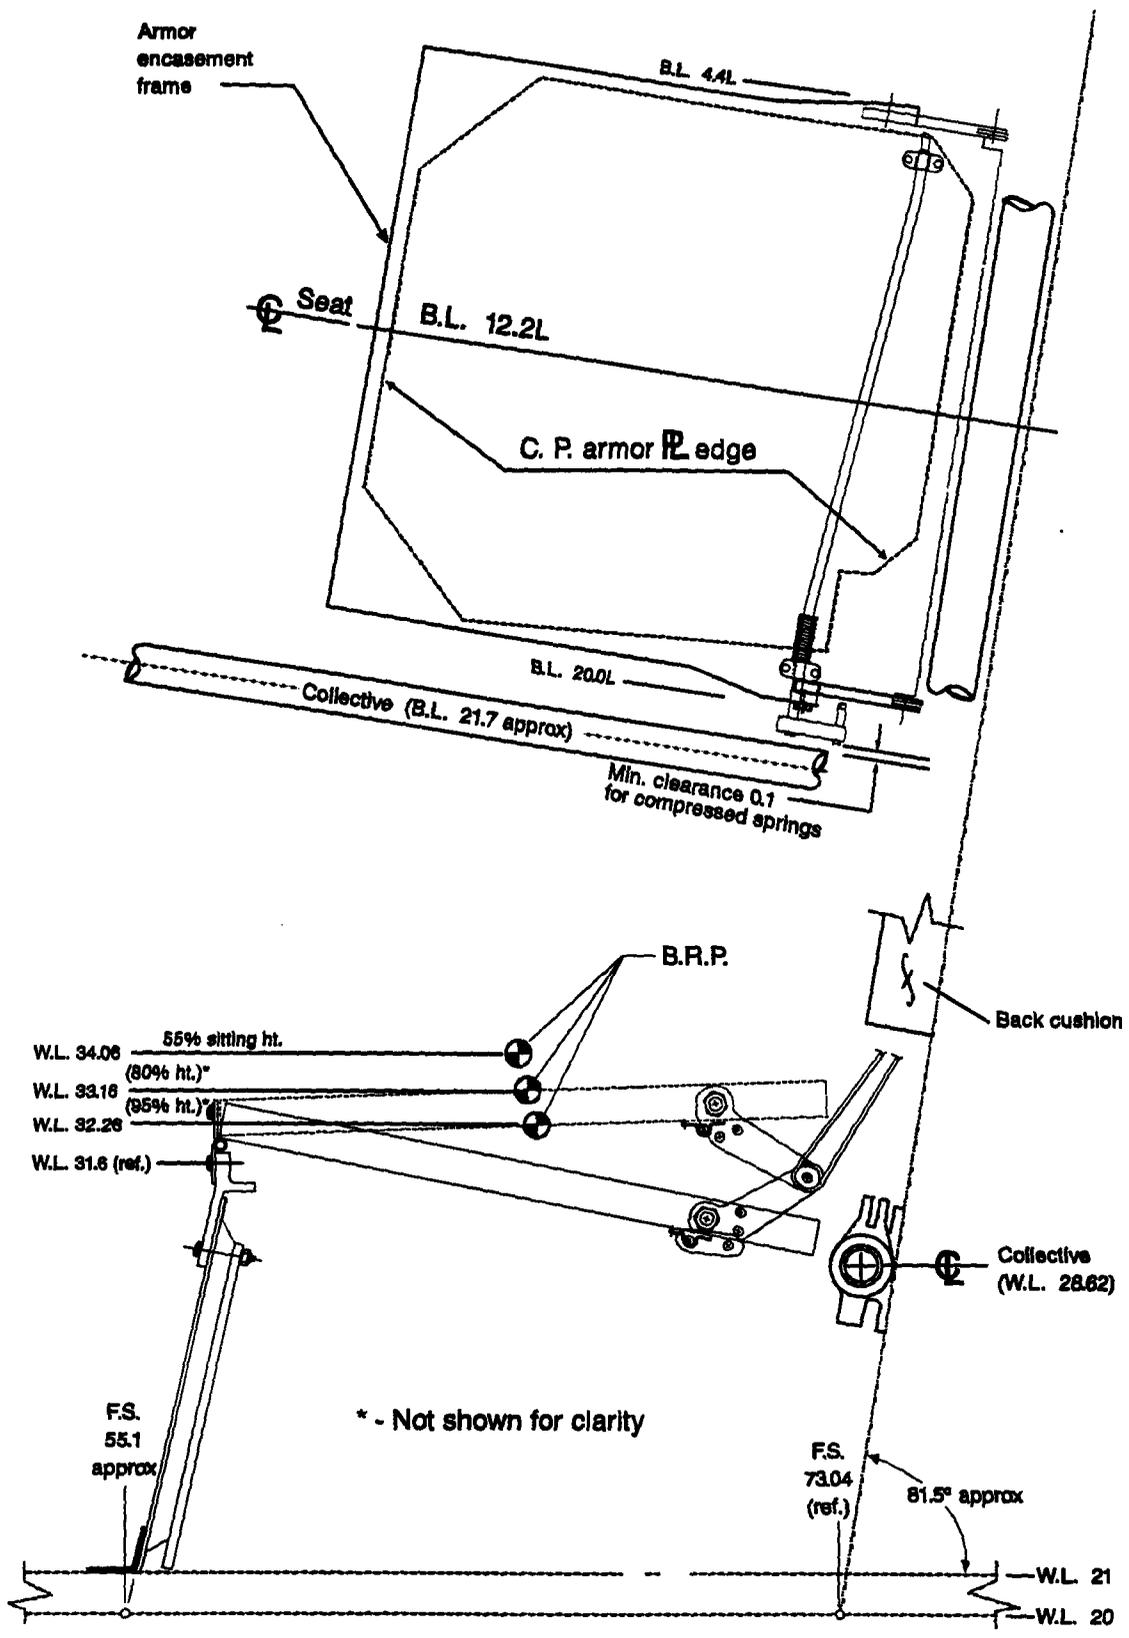
Figure 37a. Vertical seat adjustment concept to provide 1.8-inch BRP movement.

* Exact weight increase awaits a detailed design, but a simple device (as shown in Fig. 37) will add approximately 2 lb (i.e., 1 lb per seat).

The seat adjustment feature would add 2 lb, but the weight penalty is considered negligible considering the improved comfort for the OH-58, the only Army helicopter without this feature in the active Army inventory. The seat adjustment design idea shown in Figure 37 assumes a preflight seat adjustment to three positions.

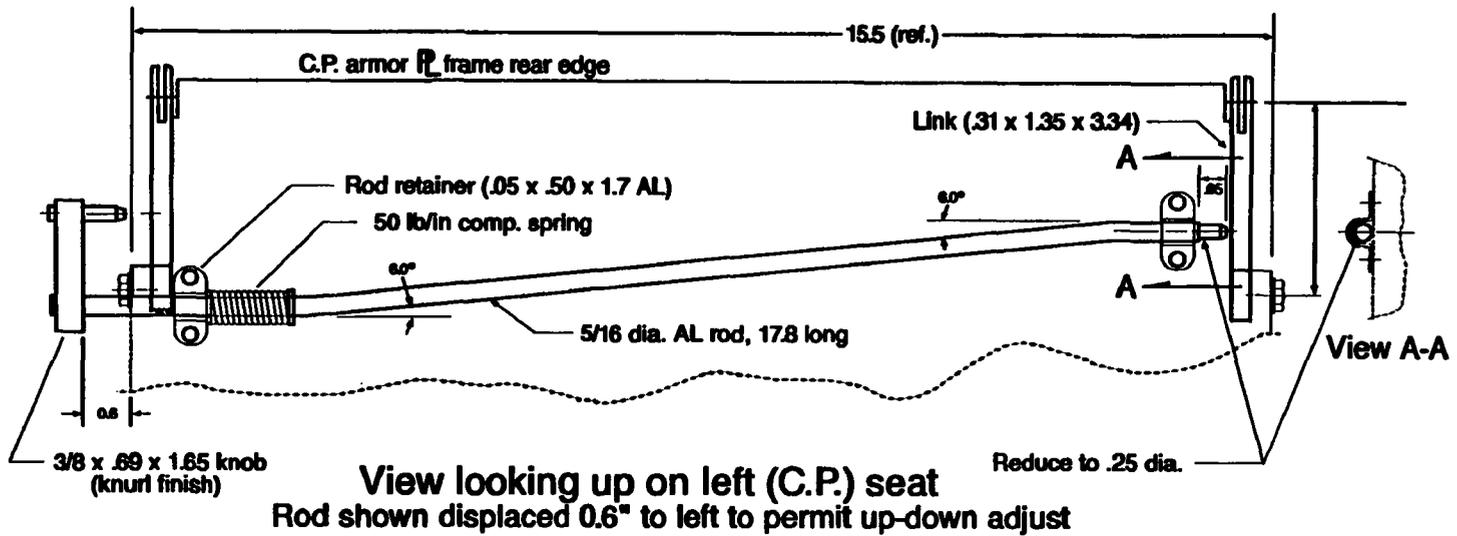
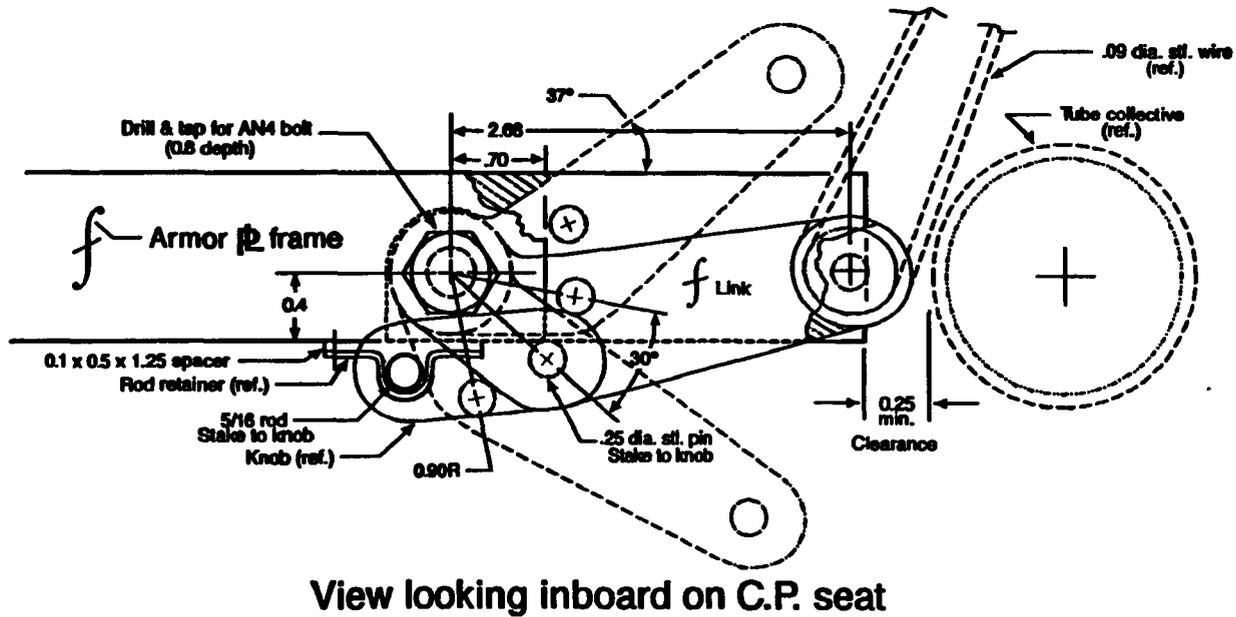
Figure 37b. Seat adjustment concept details.

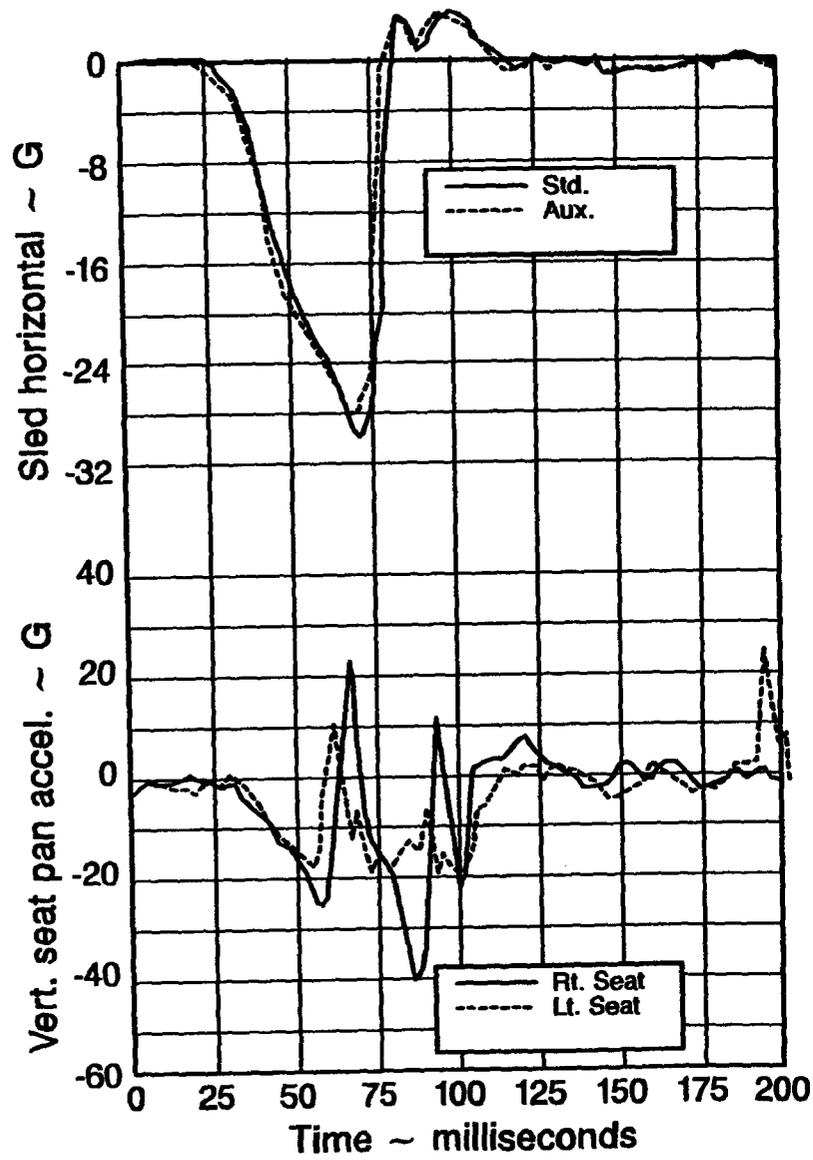
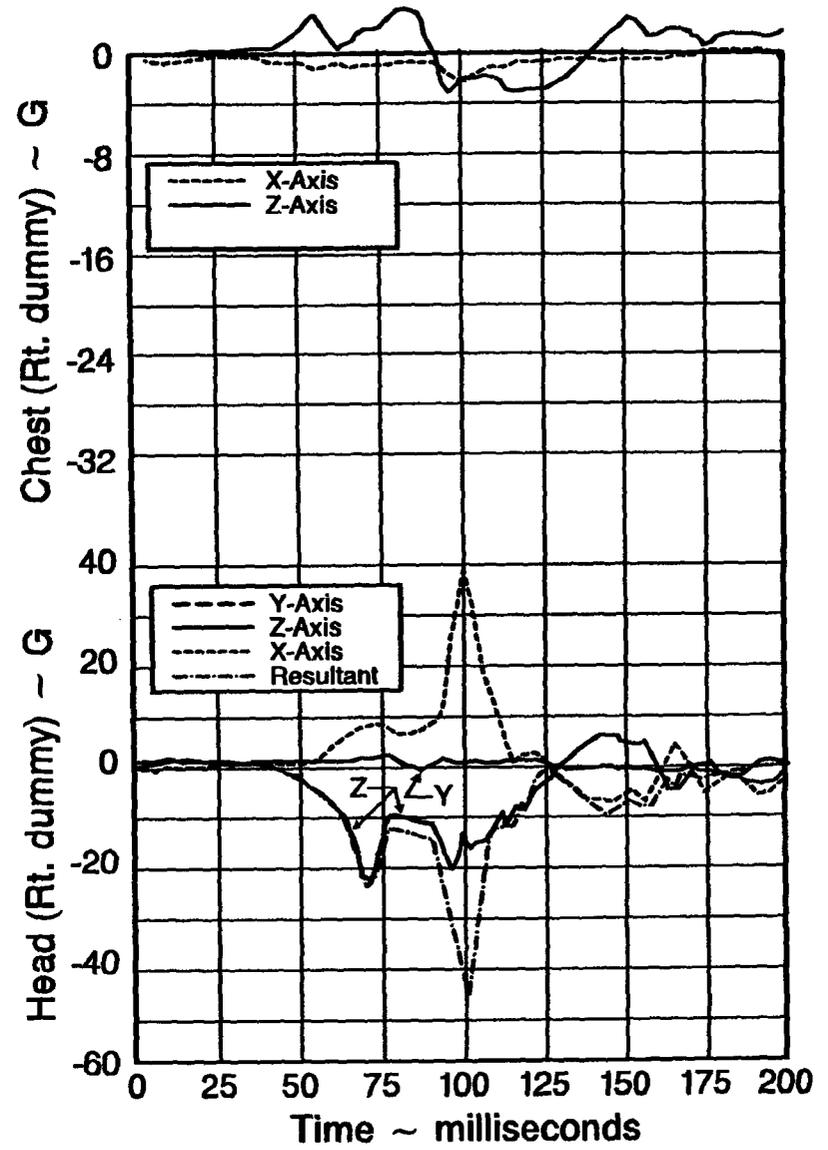
Figure A-1. Sled, seat, and dummy acceleration traces from test 88057.

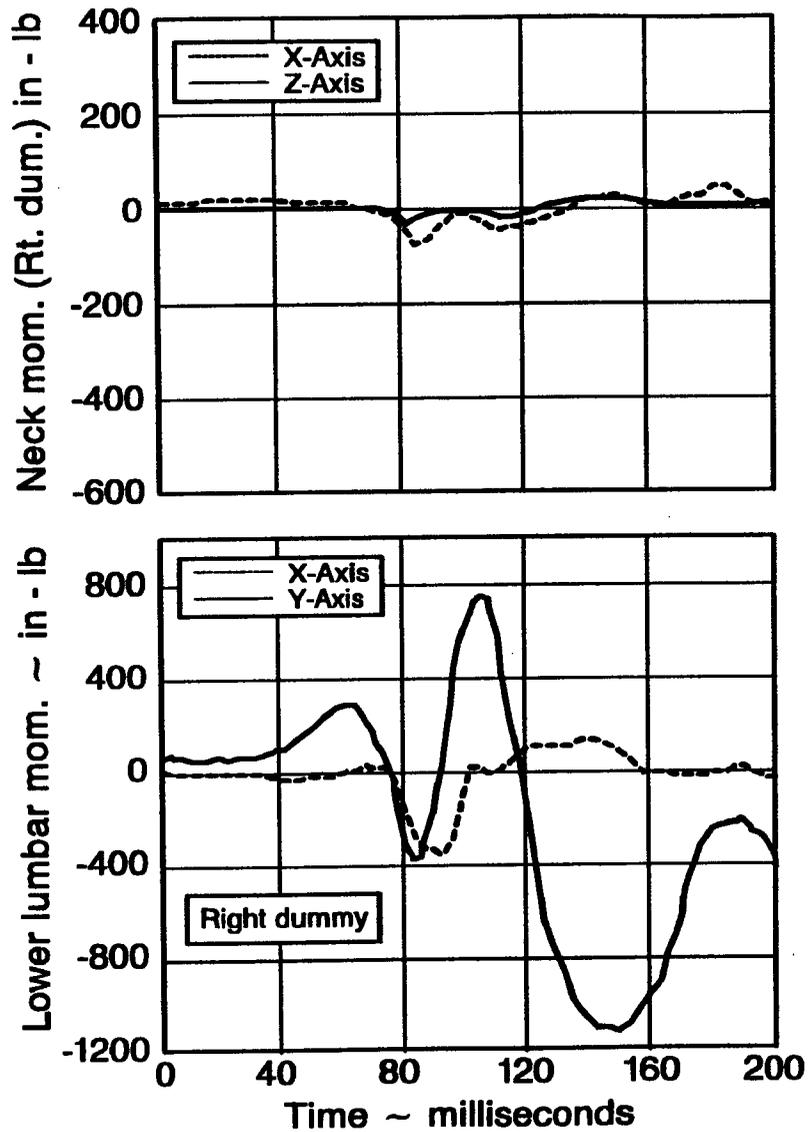
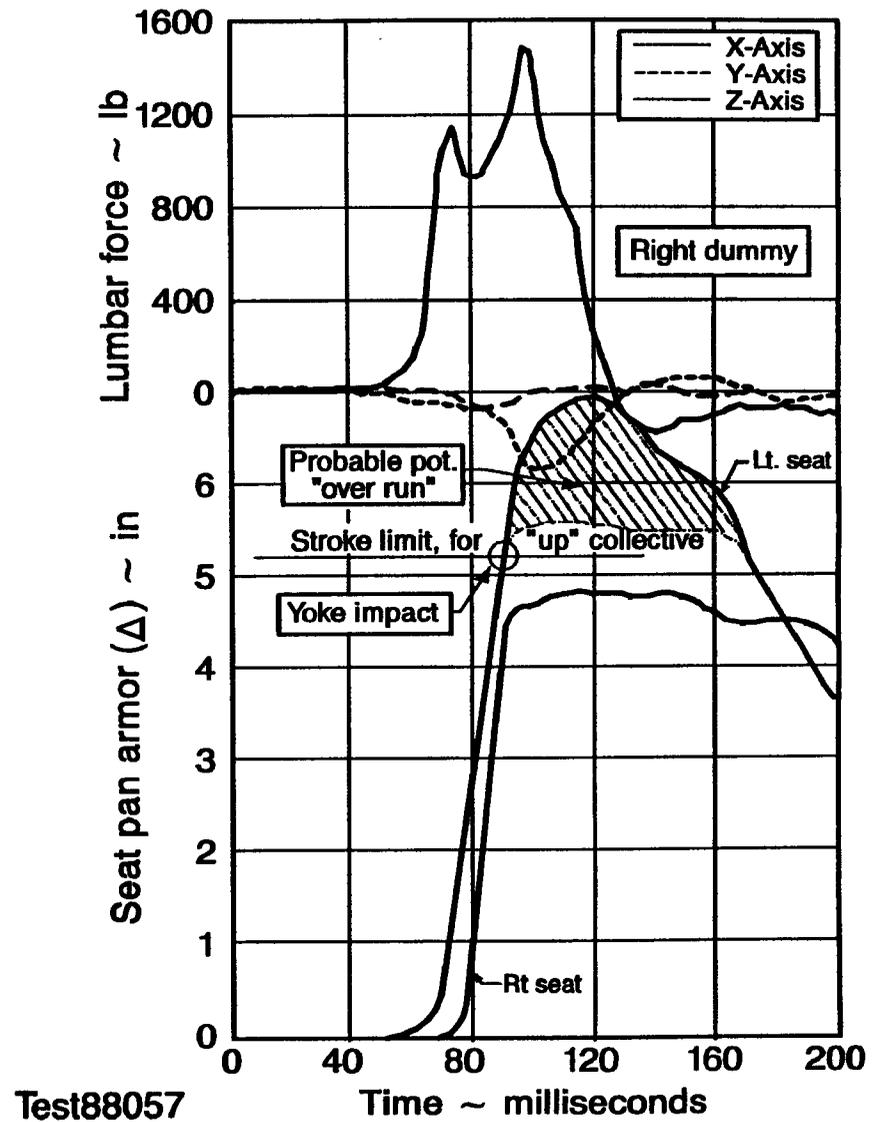
Figure A-2. Seat pan deflection and right dummy neck and lumbar force/moment from test 88057.

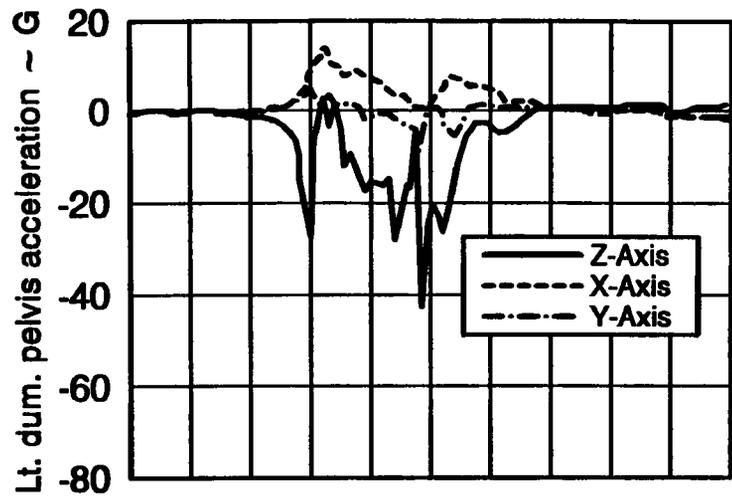
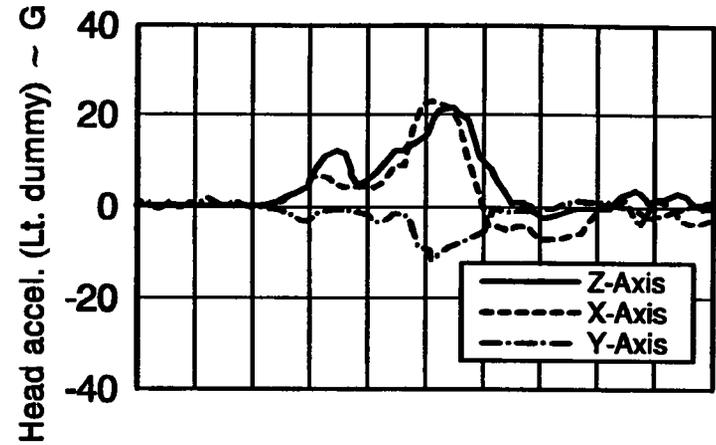
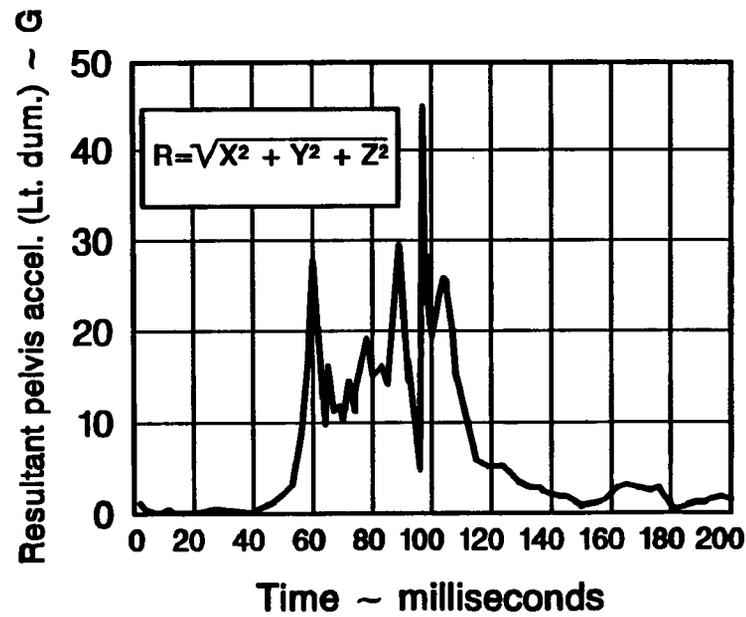
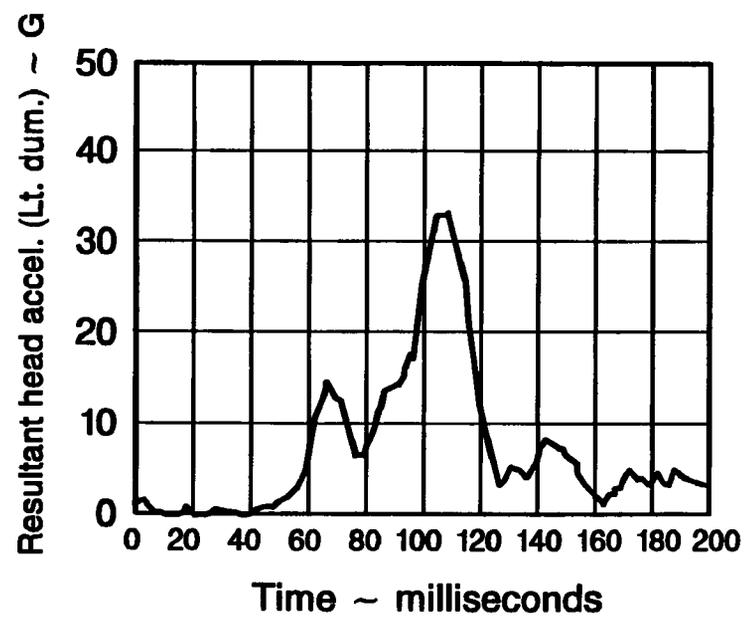
Figure A-3. Head and pelvis accelerations of left dummy in test 88057.

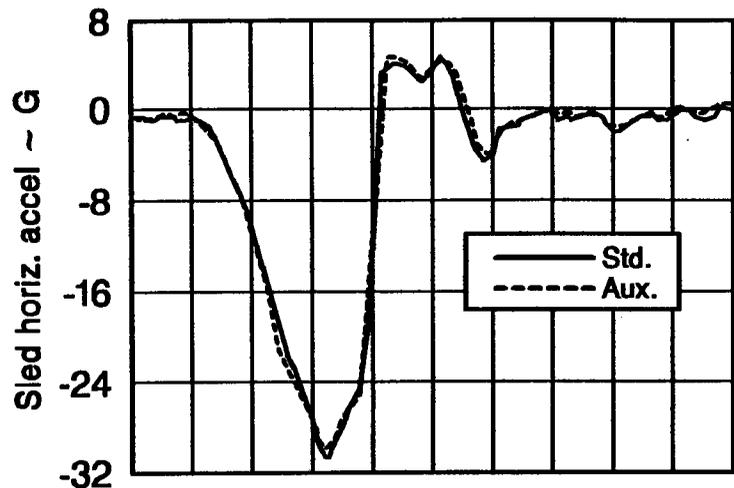
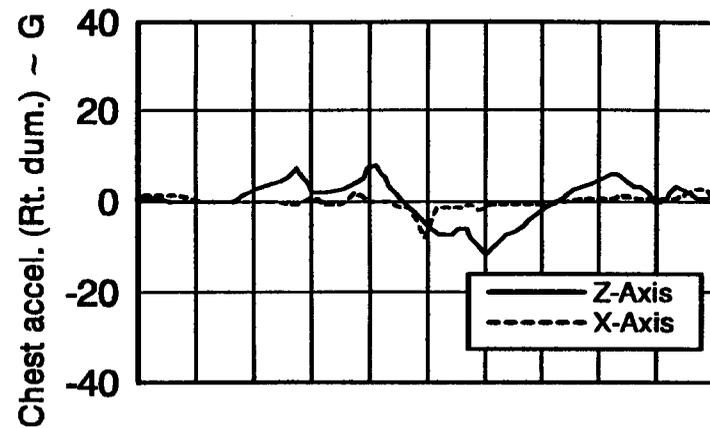
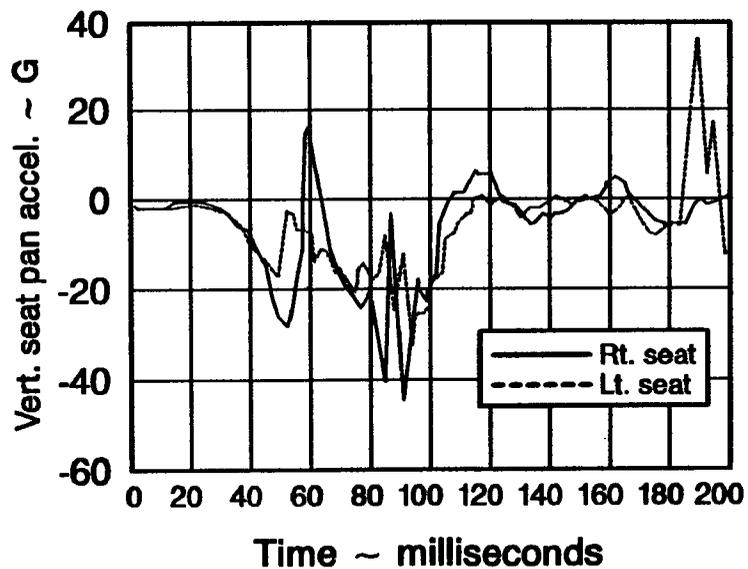
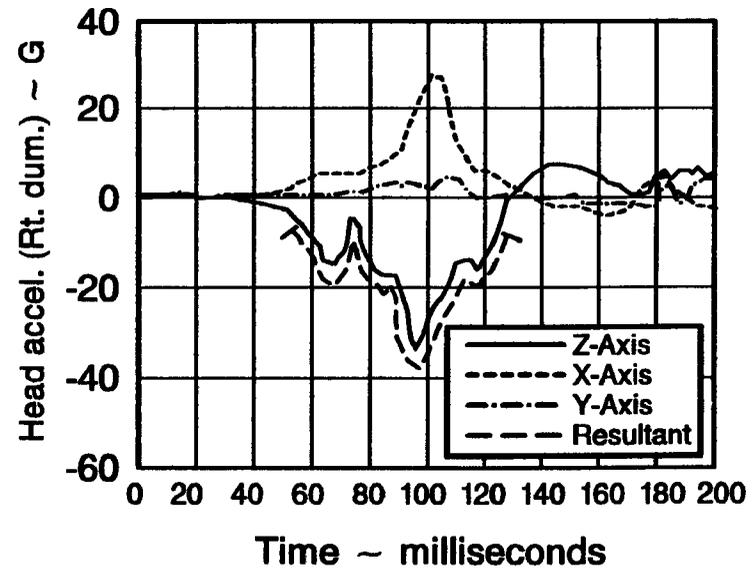
Figure A-4. Sled, seat, and dummy acceleration traces from test 88058.

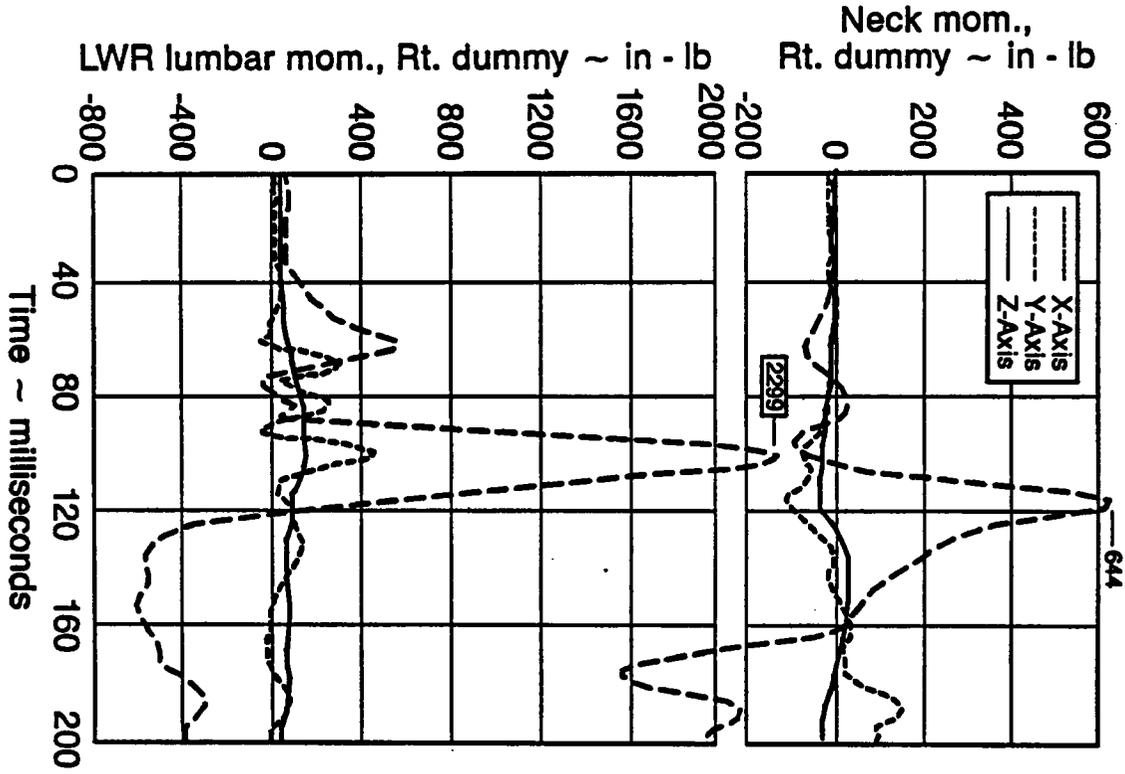
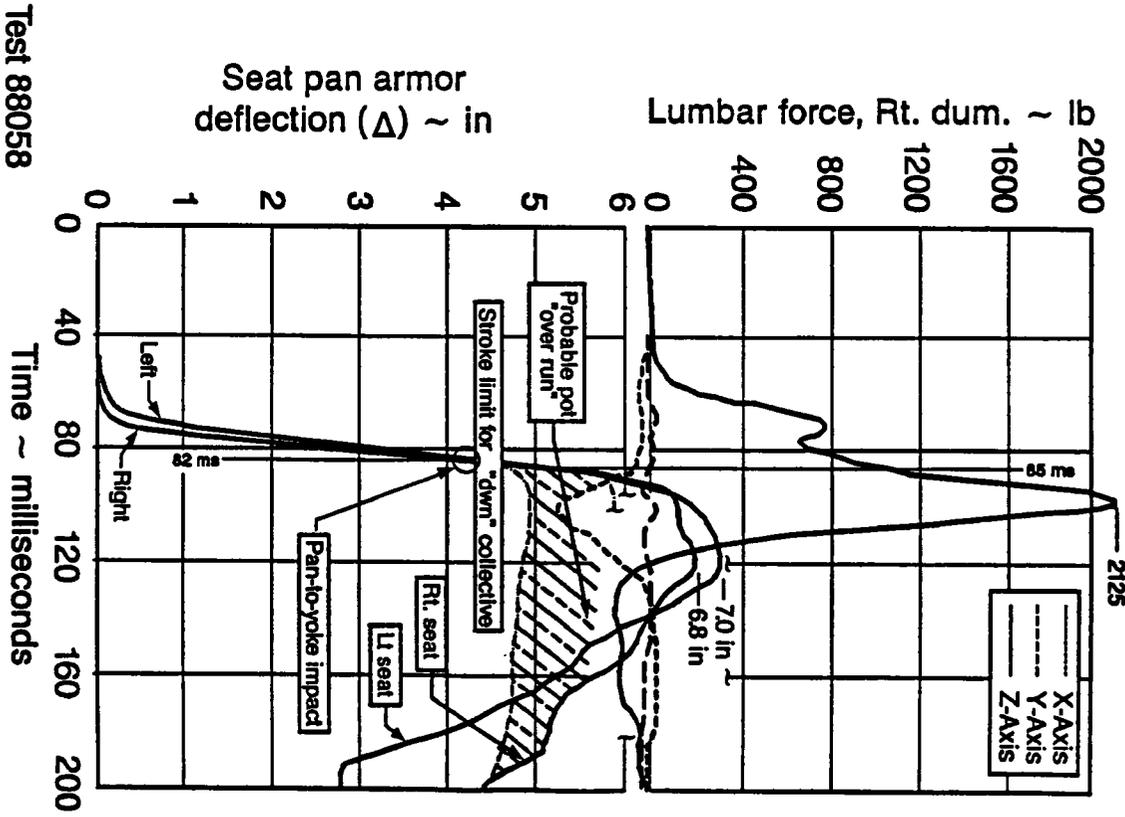
Figure A-5. Seat pan deflection and right dummy neck and lumbar force/moment from test 88058.

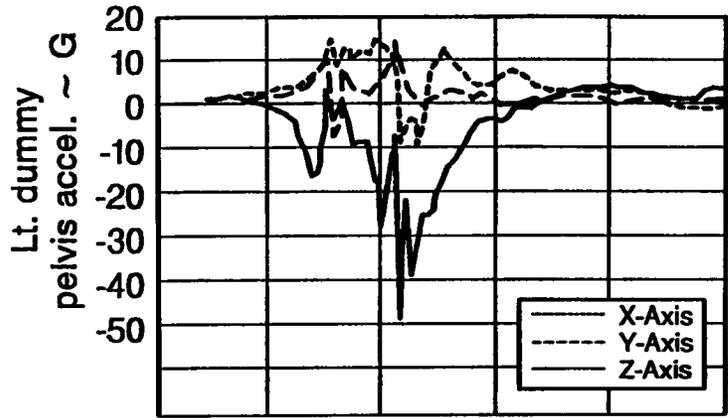
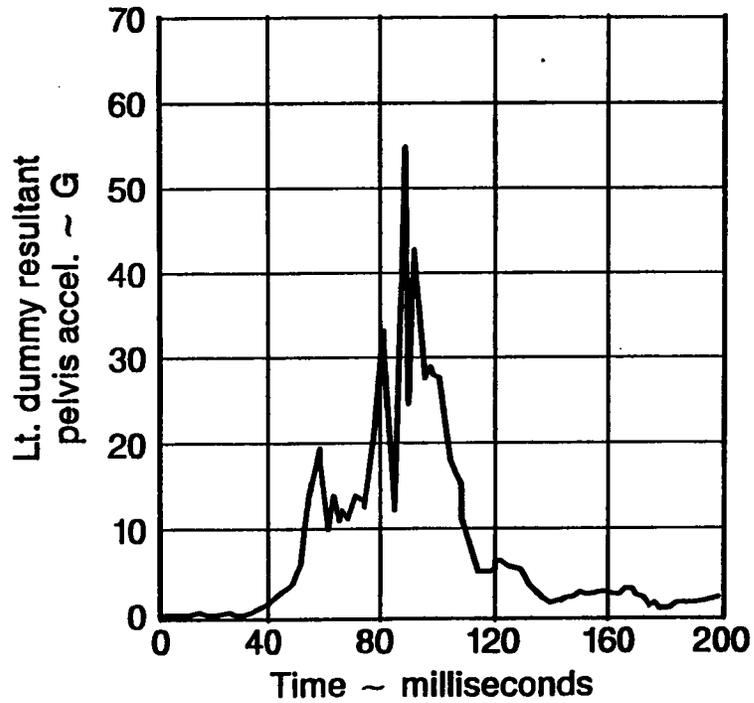
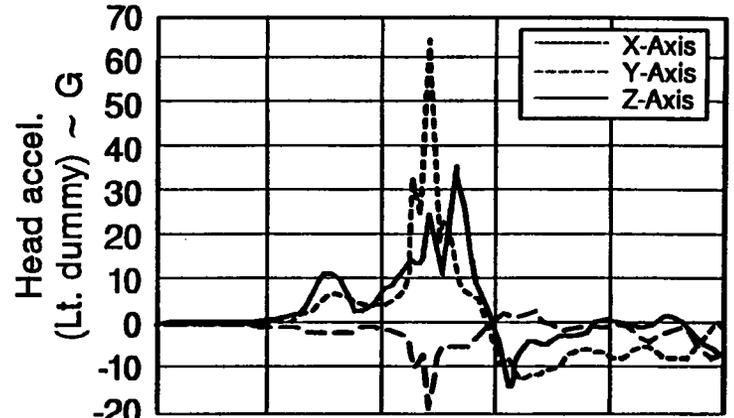
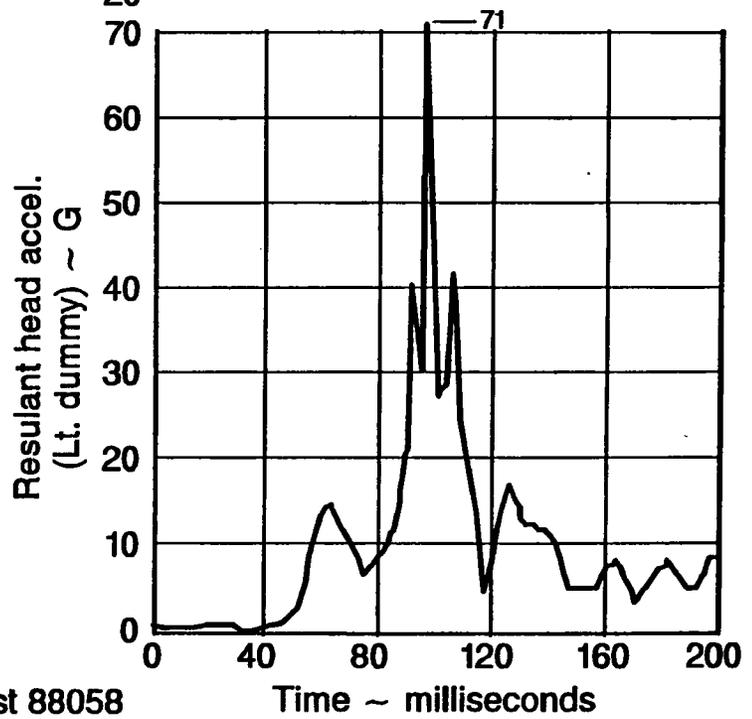
Test 88058

Figure A-6. Head and pelvis accelerations of left dummy in test 88058.

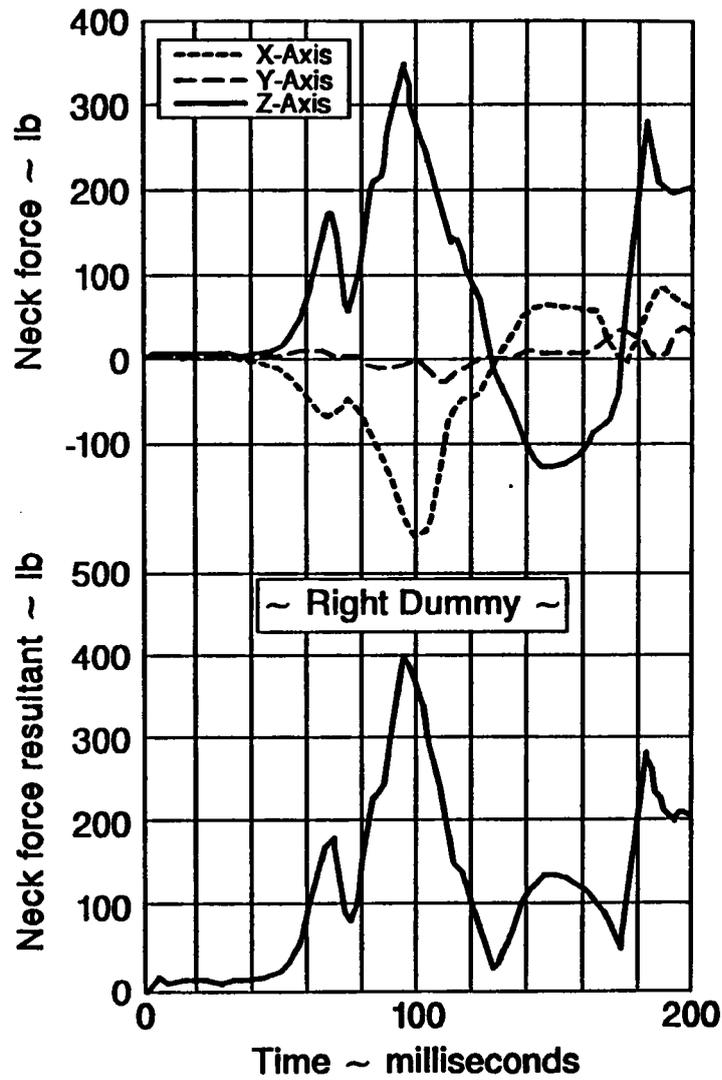
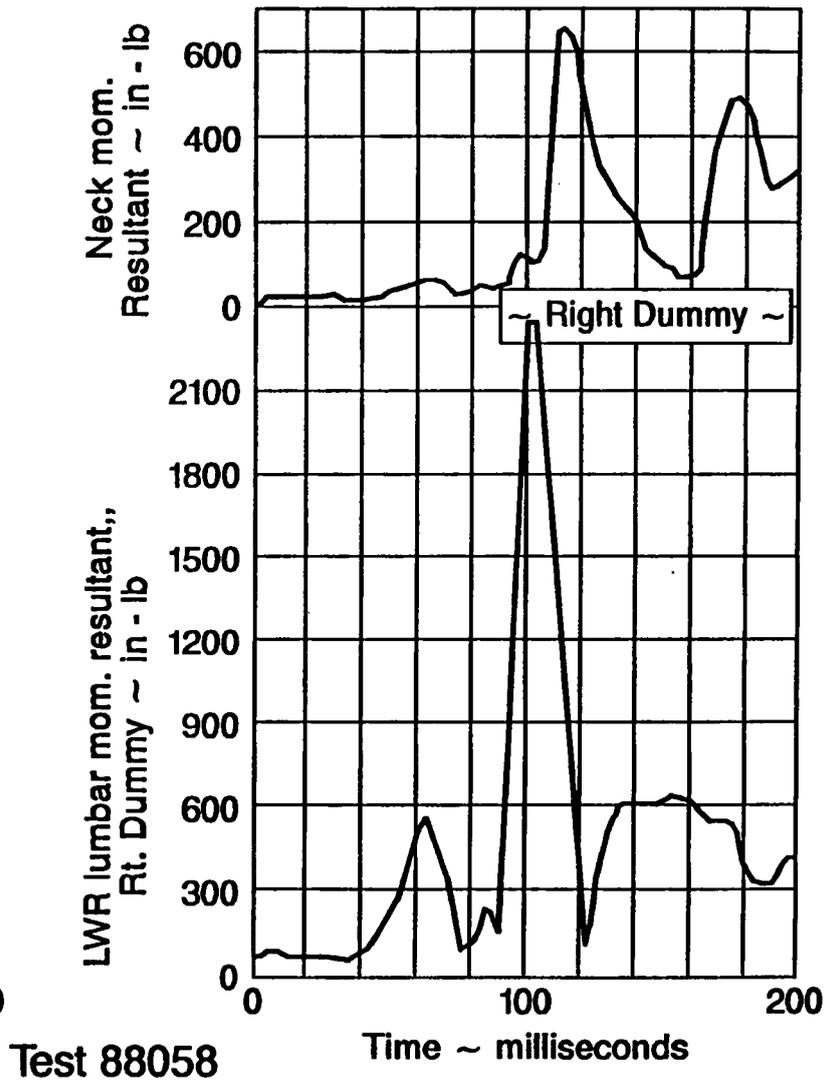
Figure A-7. Neck forces and moments and lower lumbar resultant moment, right dummy, test 88058.

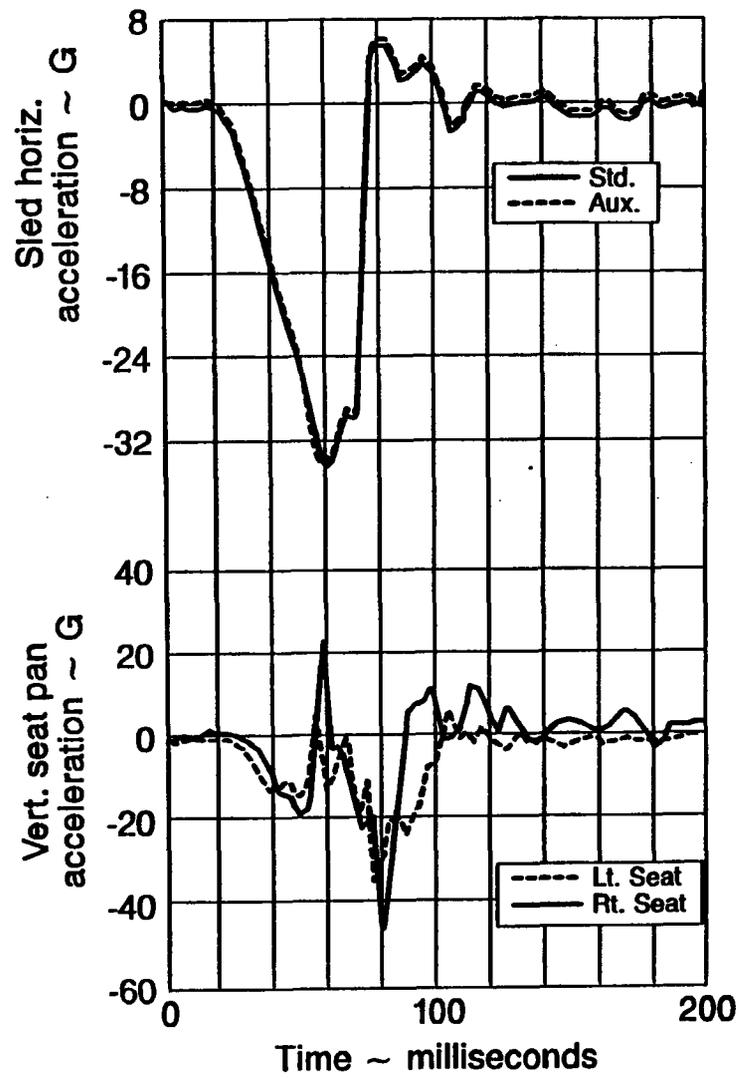
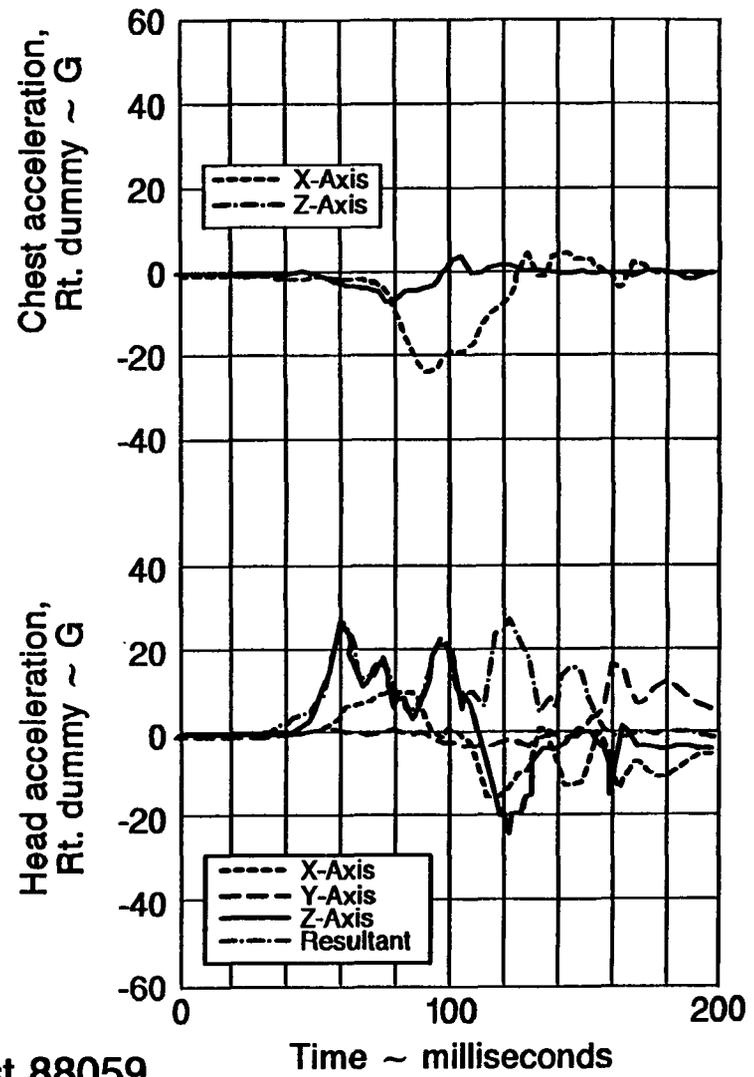
Test 88059

Figure A-8. Sled, seat, and right dummy acceleration traces.

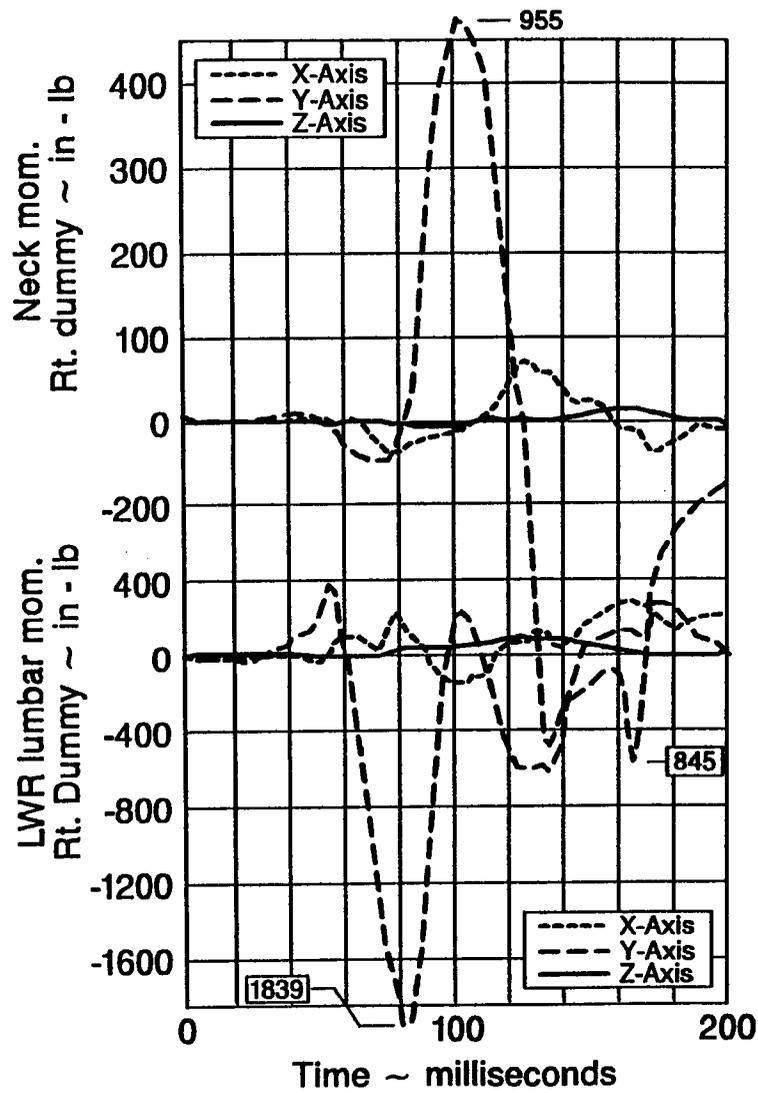
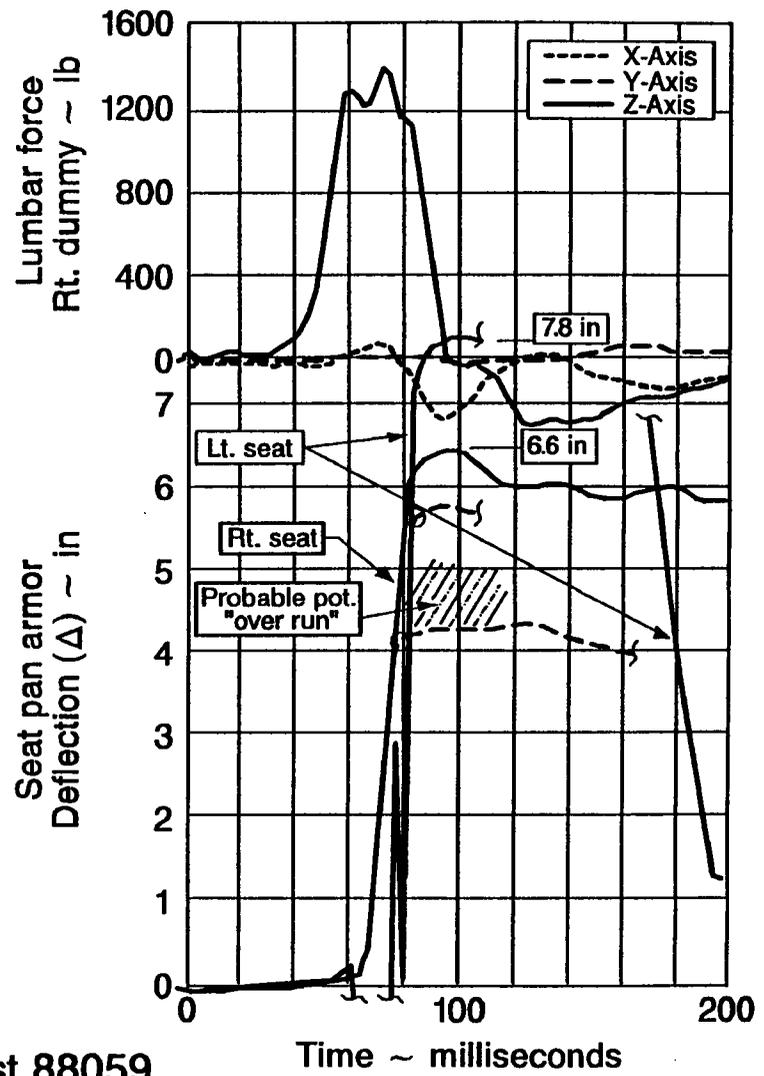
Test 88059

Figure A-9. Seat pan deflection and right dummy neck and lumbar force/moment.

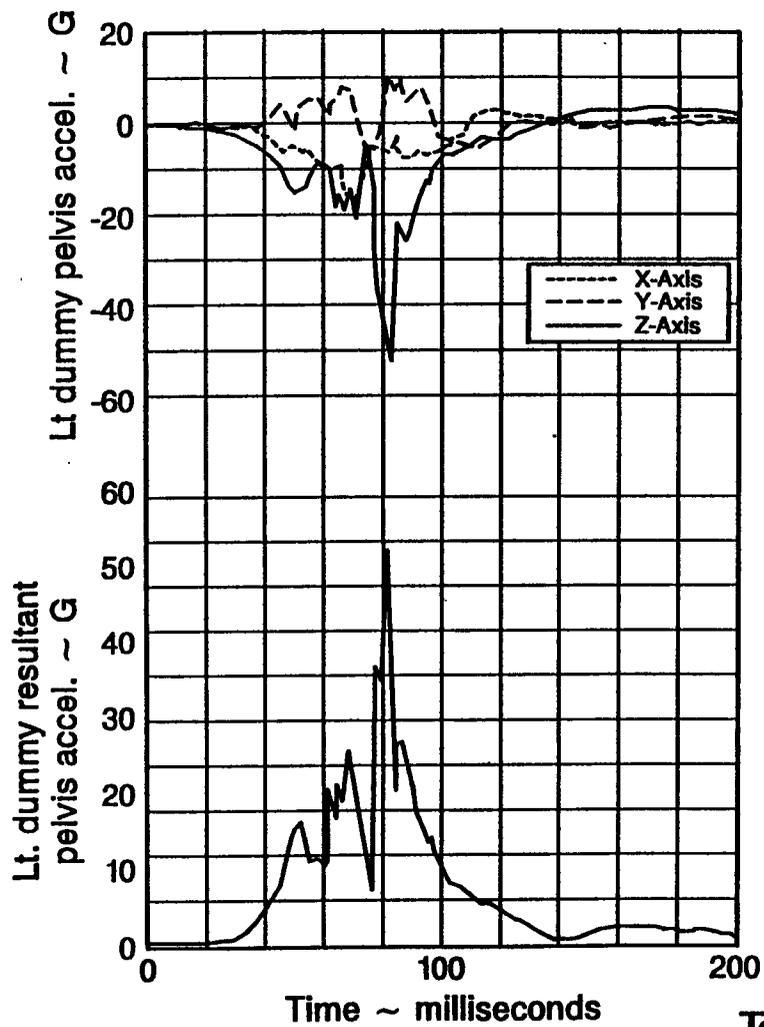
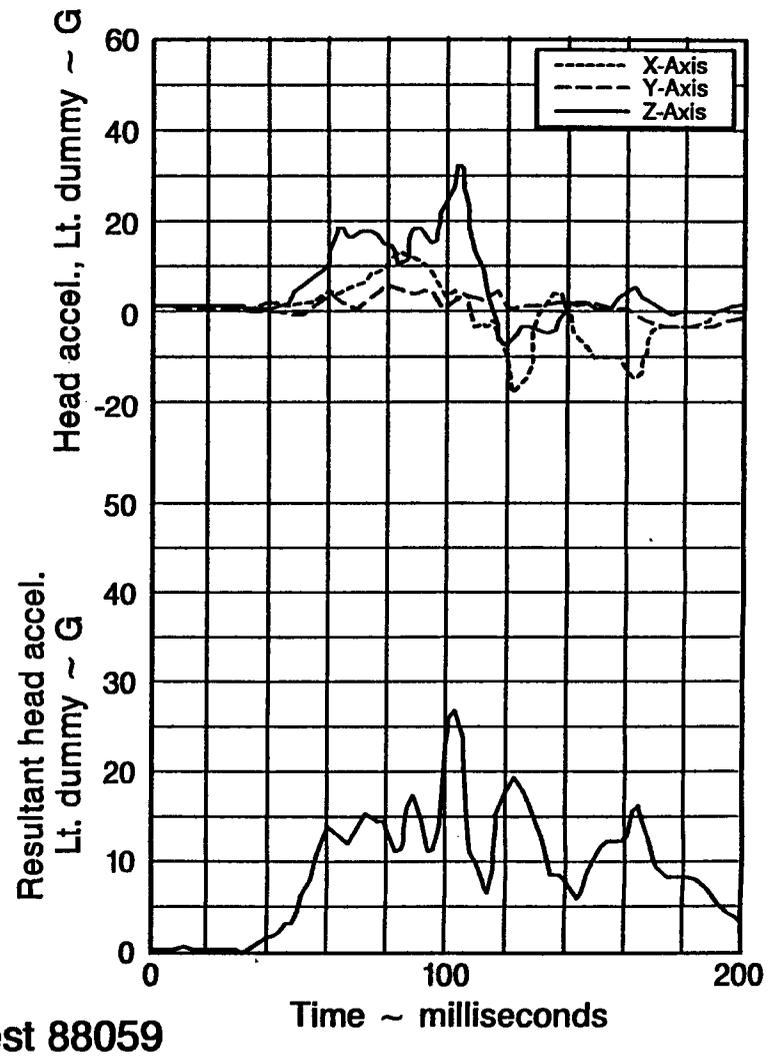
Figure A-10. Head and pelvis accelerations of left dummy.

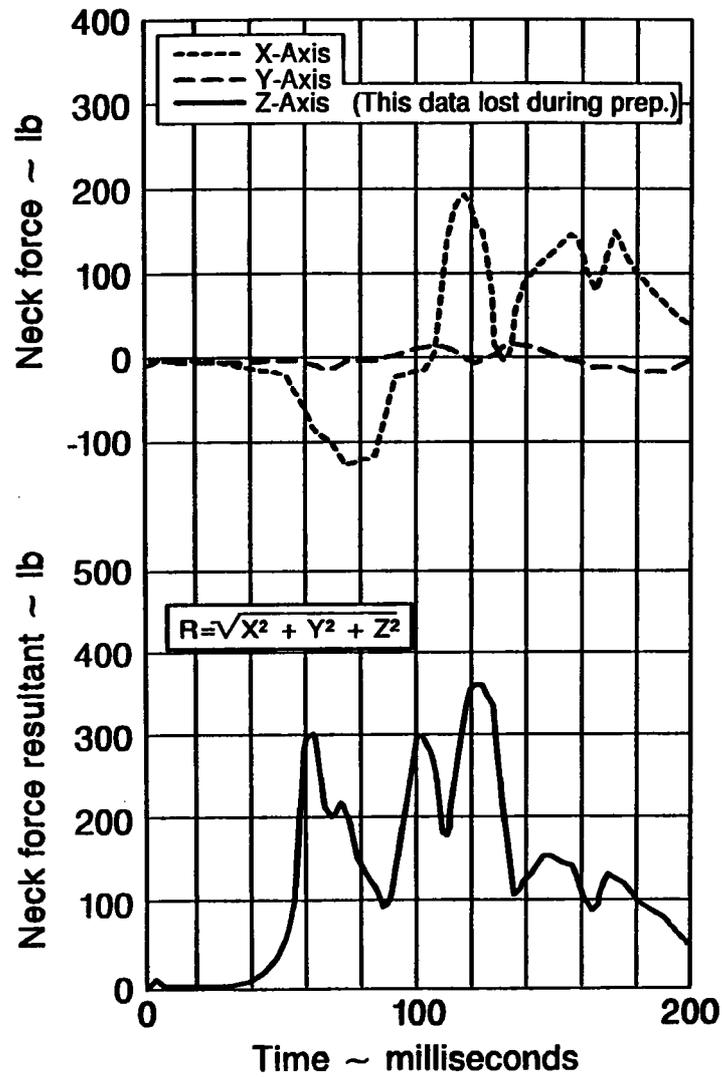
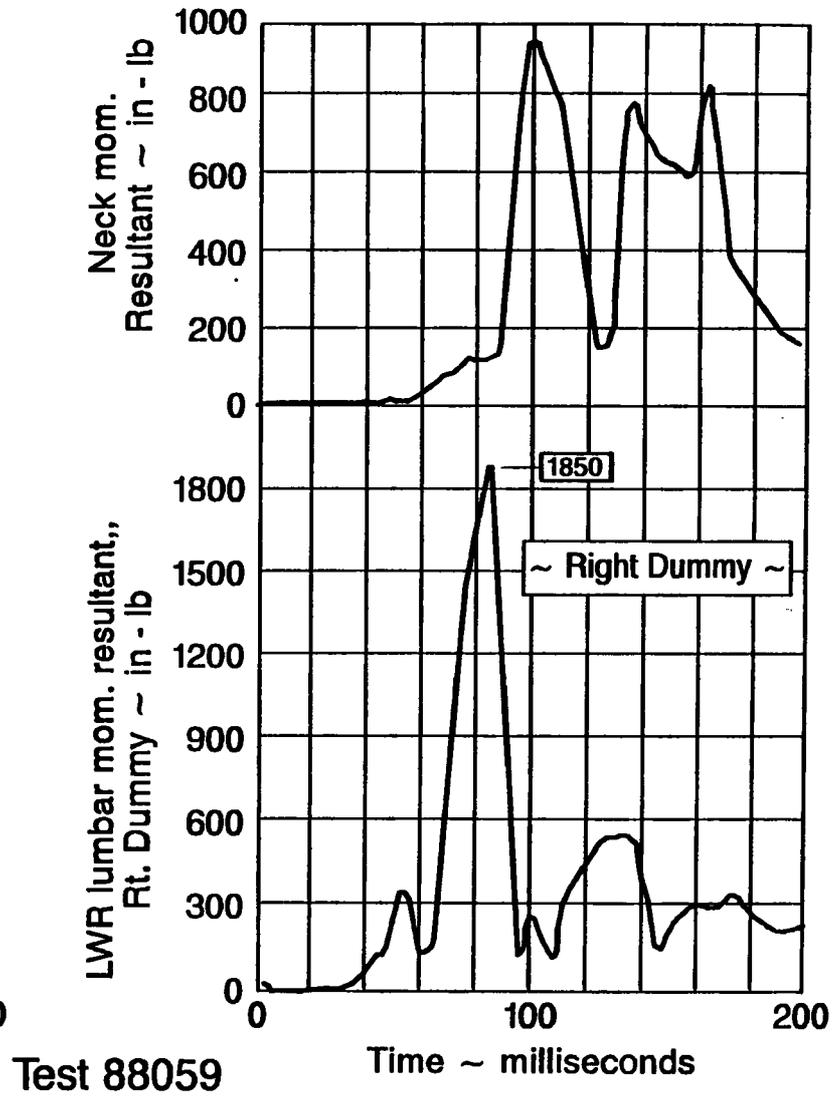
Figure A-11. Neck forces and moments and lower lumbar resultant moment for right dummy.
