USAARL Report No. 95-9

**Evaluation of a Retrofit OH-58
Pilot's Seat to Prevent Back Injury**

**United States Army Aeromedical Research Laboratory
Fort Rucker, Alabama 36362-0577**

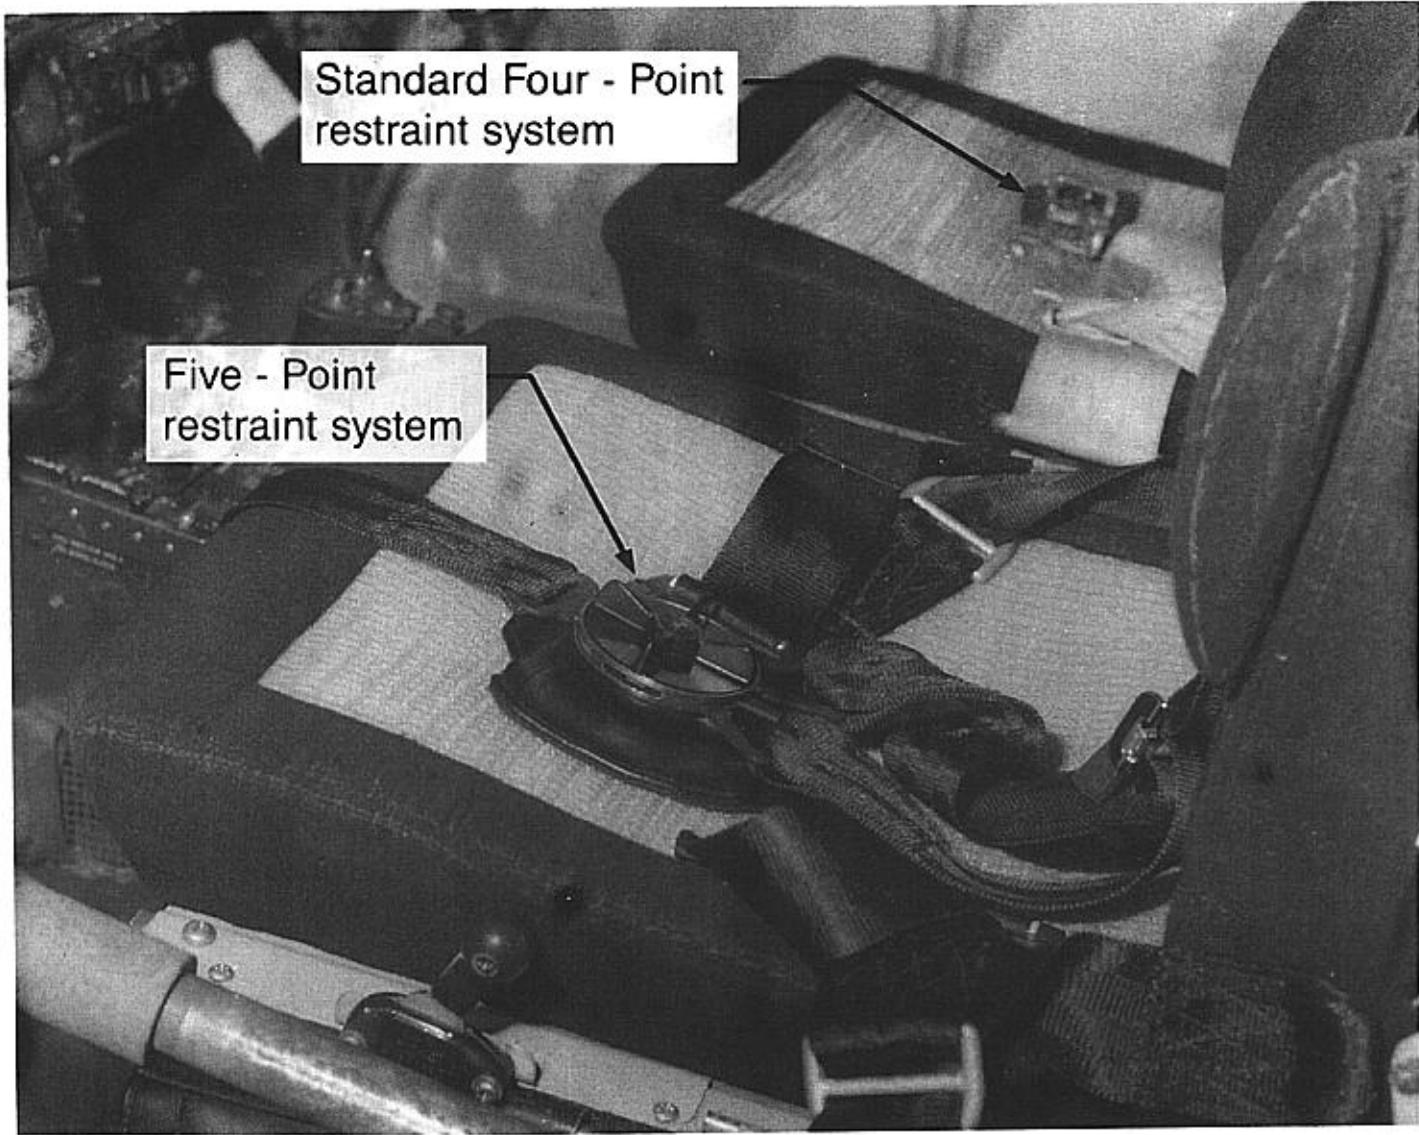
Figure C-1. The crashworthy seat and five-point restraint system (from TECOM #4AI-130-58A-023).

(5) No compatibility problems were found or reported after changes to the seat/restraint system were implemented. Changes included shortening the shoulder harness, moving the crotch harness inboard, decreasing the width of the seat pad, and raising the inertia reel control 3/4 inch.
