USAARL Report No. 2003-08

# The Role of the Pilots Night Vision System (PNVS) and Integrated Helmet and Display Sighting System (IHADSS) in AH-64 Apache Accidents

U.S. Army  
Aeromedical Research  
Laboratory

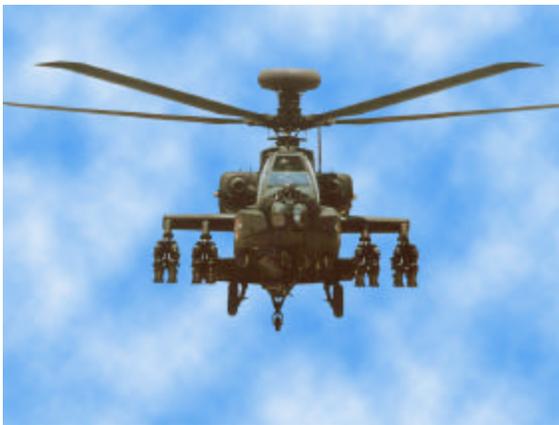
Figure 1. The AH-64D Apache helicopter.

The AH-64 Apache is the U.S. Army's most advanced rotary-wing attack aircraft (Figure 1). It exists in two model configurations, the AH-64A and AH-64D. The AH-64D is referred to as having a "glass cockpit." This reference is made to the modified crewstation design employed in the AH-64D that replaces most of the traditional dedicated instruments with multifunction displays (MFDs). The D-model also has an expanded mission capability and may present a higher workload cockpit.

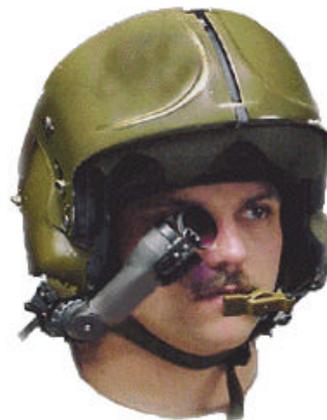
Figure 2. The Integrated Helmet and Display Sighting System (IHADSS).

The AH-64 is flown using a helmet-mounted display (HMD) known as the Integrated Helmet and Display Sighting System (IHADSS) (Figure 2). This HMD presents pilotage imagery and flight symbology. Pilotage imagery originates from a nose-mounted forward-looking infrared (FLIR) sensor known as the Pilot's Night Vision System (PNVS). Several studies (Behar et al., 1990; Hale and Piccione, 1990; Crowley, 1991; Stewart, 1997; and Rash et al., 2002) have identified a number of visual problems and illusions that may be contributing factors to AH-64 accidents.

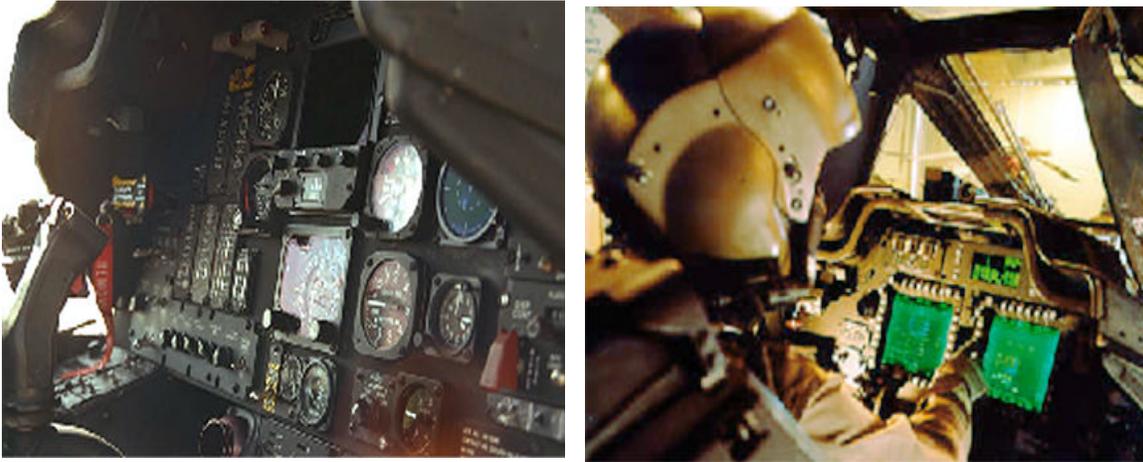
Figure 3. Cockpit views of the AH-64A (left) and AH-64D (right).  
(Pictures printed with permission from Boeing)

The Army's AH-64 Apache attack helicopter uses a tandem-seating configuration. The dedicated instrument A-model was fielded in 1985. The glass cockpit D-model was introduced in 1997. The two cockpit designs are presented in Figure 3. The total flight hours for the AH-64A and AH-64D models (as of 31 March 2002) were 1,341,397 and 81,433, respectively.
