**Transmittance Characteristics
of U.S. Army Rotary-Wing Aircraft Transparencies**

March 1995

**United States Army Aeromedical Research Laboratory
Fort Rucker, Alabama 36362-0577**

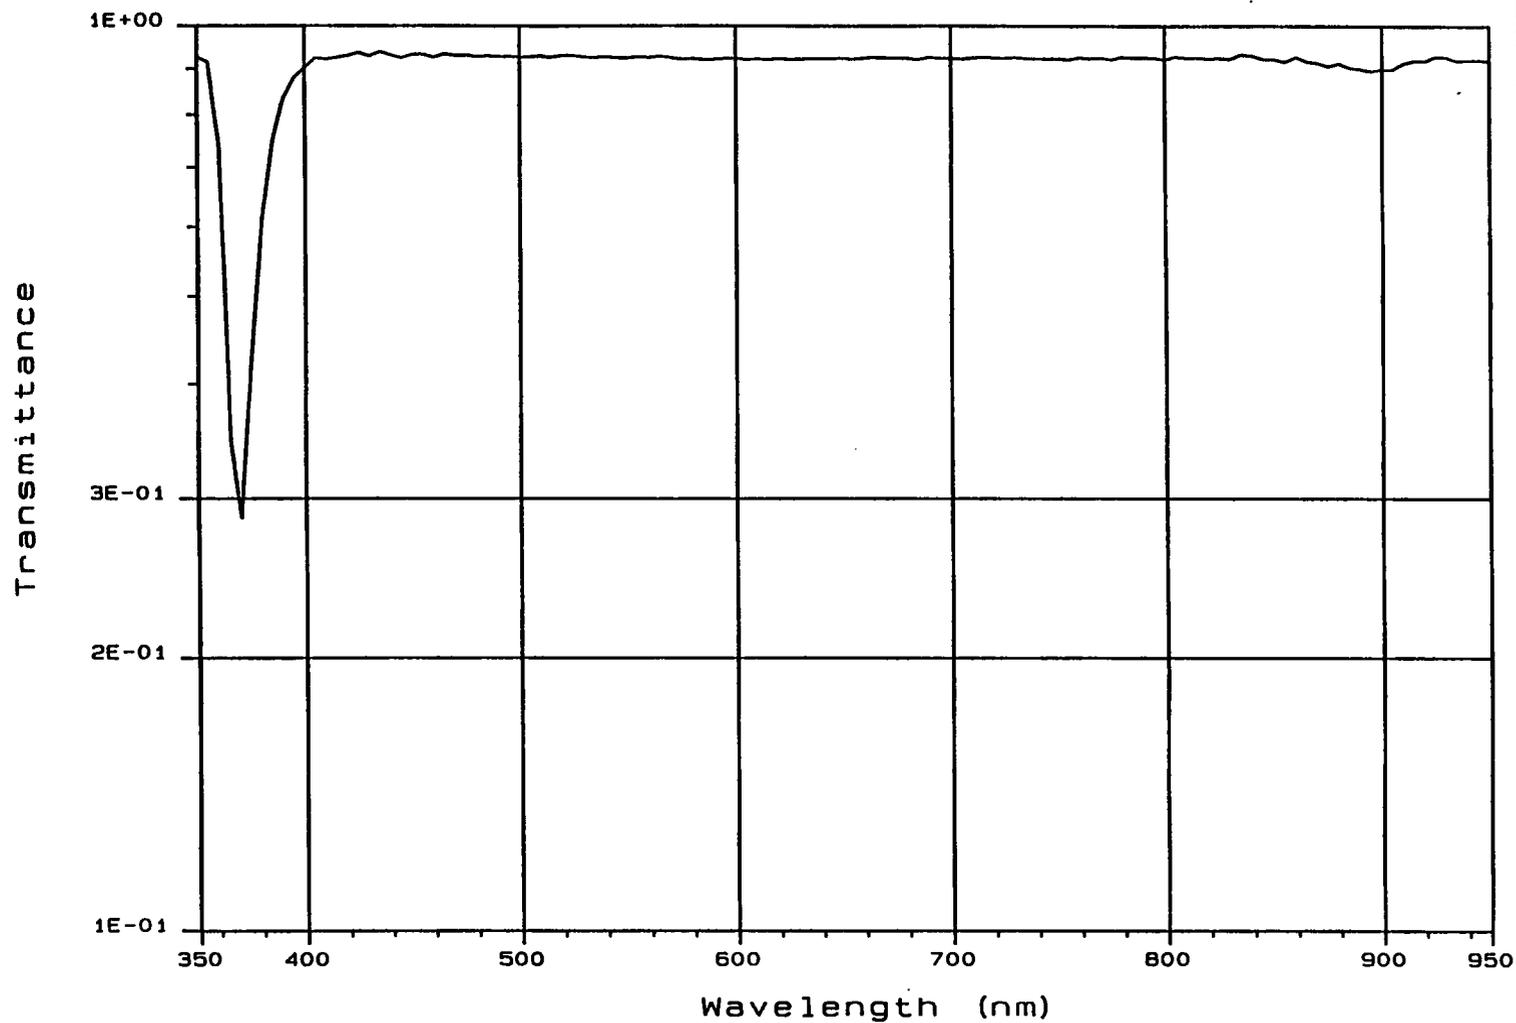
Figure 11. Spectral transmittance curve for AH-1 Cobra.

TITLE: AH-1 Cobra
DEVICE: Cobra #0476/

DATE: 07-11-1994
MAX: .93869
MIN: .28553

The spectral curves in Figures 11-18 correspond to the descriptions above. The curves for the AH-1, OH-58, and TH-67 samples demonstrate the spectral transmittance characteristics of acrylic materials. These include an ultraviolet cut-off between 350-380 nm and excellent spectral neutrality (flatness of transmittance) over the visible spectral range 400-780 nm. These acrylic windscreens also provide high, relatively flat, transmittance over the spectral response range of the ANVIS, 450-930 nm. The TH-67 sample has a deviation from neutrality over the range 560-780 nm (Figure 16). This decrease in transmittance of the red wavelengths produces the bluish color of the tint.

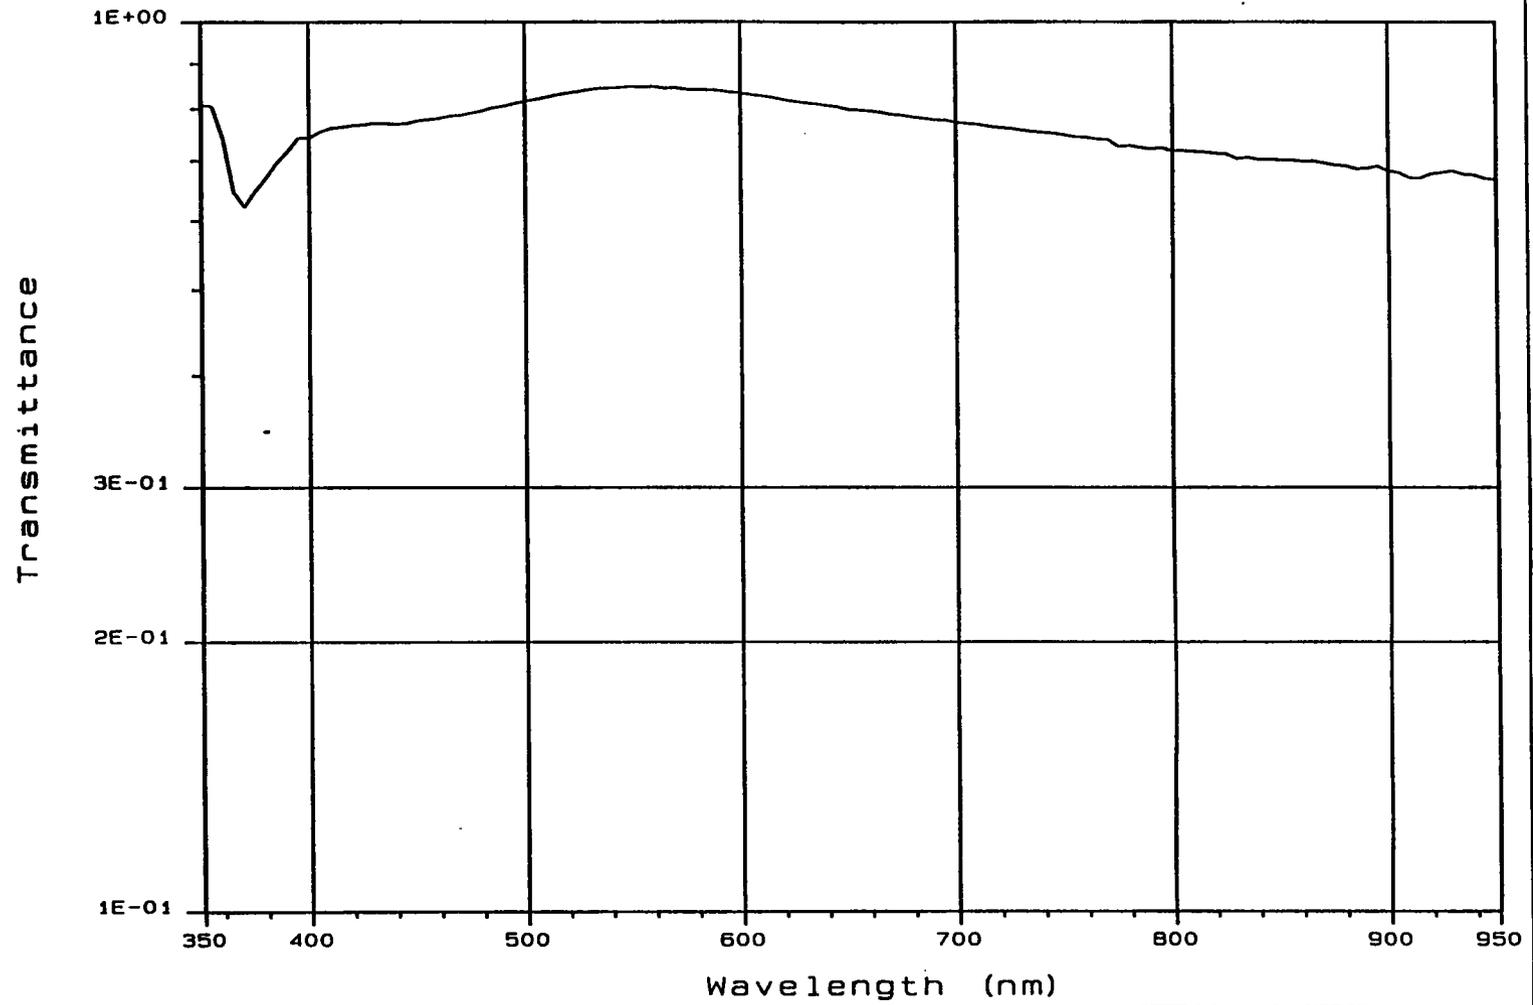
Figure 12. Spectral transmittance curve for AH-64 Apache.

TITLE: AH-64 Apache
DEVICE: AH-64 (frwd) #7475/

DATE: 07-14-1994
MAX: .84769
MIN: .62242

The glass samples of the AH-64, CH-47, UH-1, and UH-60 also provide a relatively neutral transmittance over the measured spectral range with a similar UV cutoff around 360 nm, but present some relative falloff in transmittance beyond 600 nm. This is of little significance to naked eye vision, which peaks at 550 nm. It also has little effect on ANVIS performance, which has enhanced sensitivity over the spectral range of 625-900 nm.

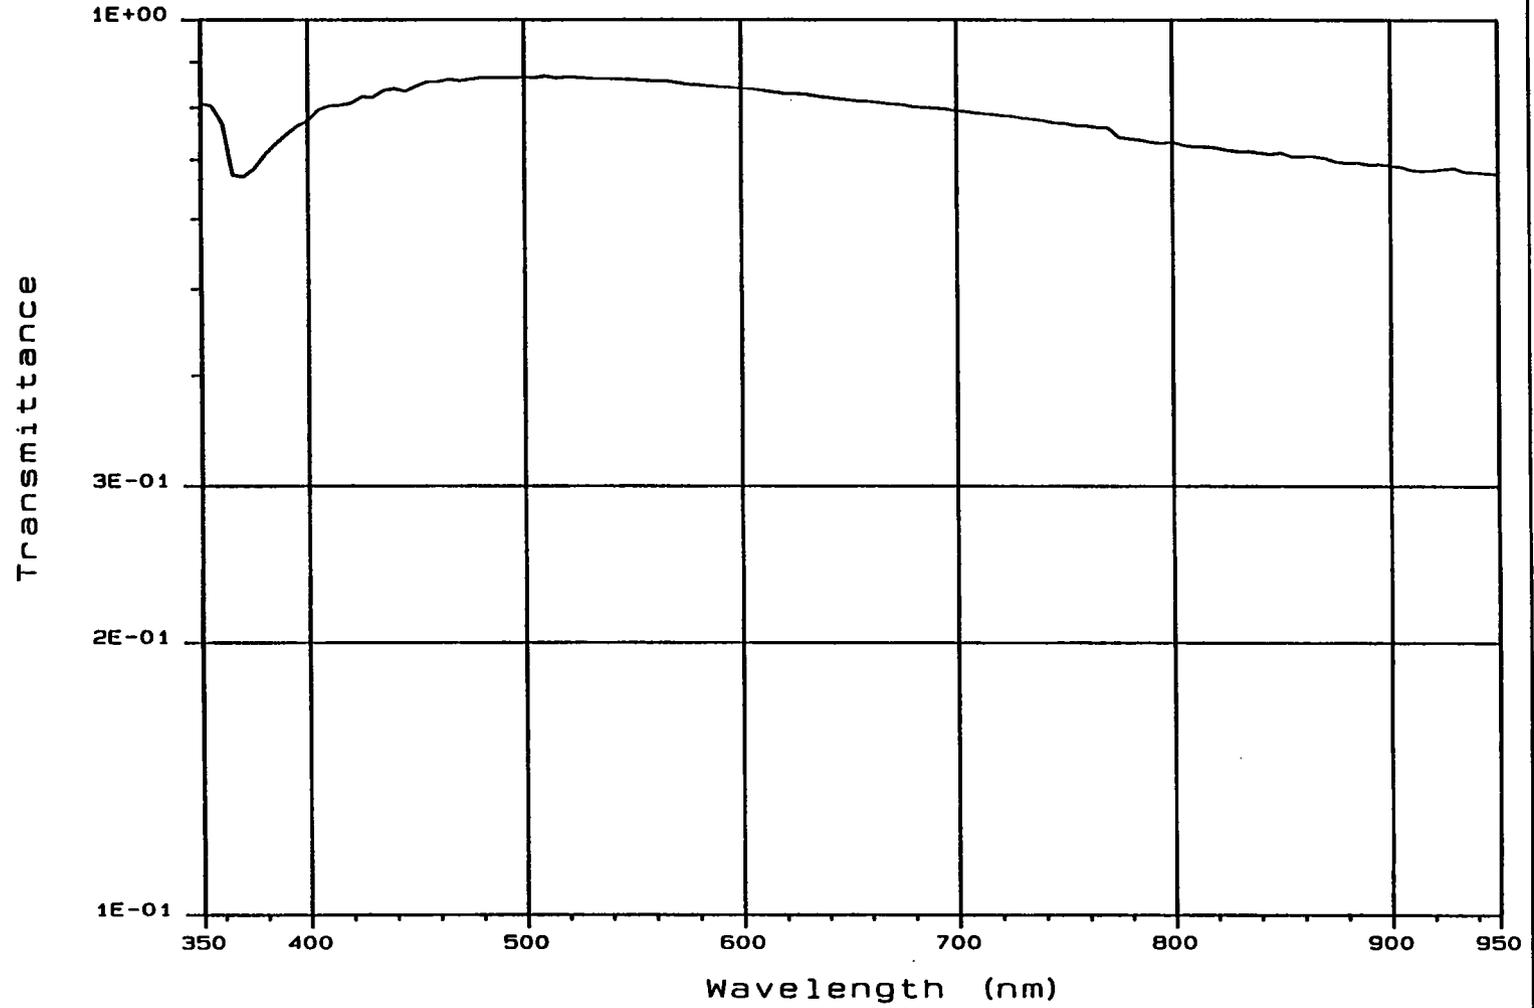
Figure 13. Spectral transmittance curve for CH-47D Chinook.

TITLE: CH-47 Chinook
DEVICE: CH-47 #7857/

DATE: 07-11-1994
MAX: .86792
MIN: .66991

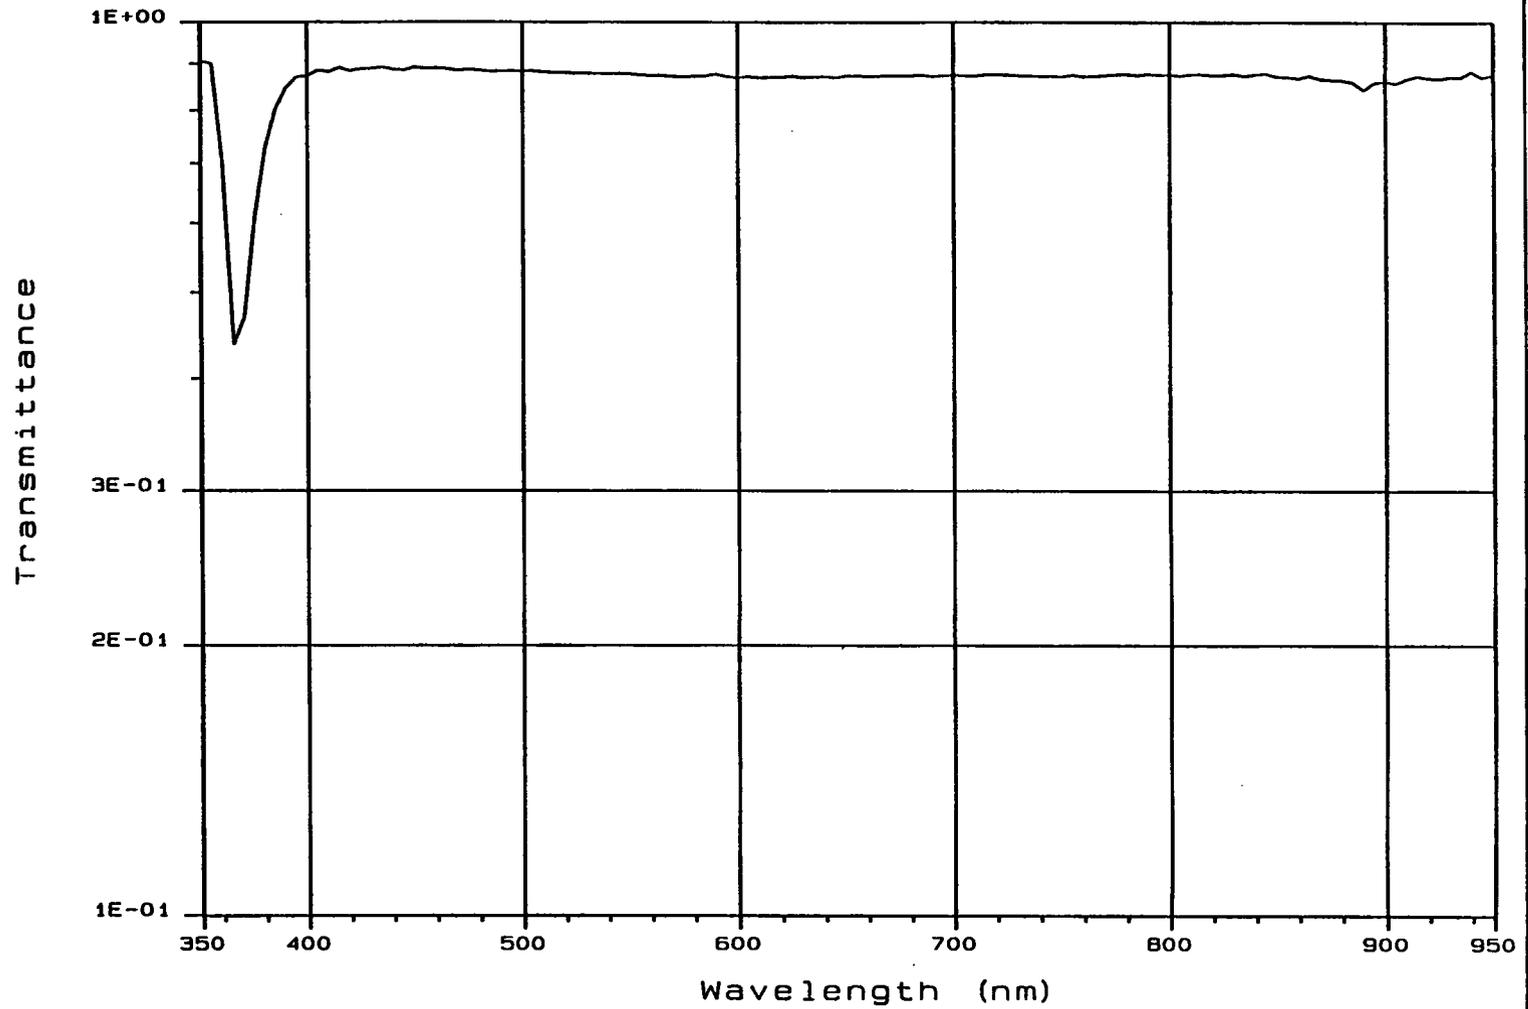
Figure 14. Spectral transmittance curve for OH-58A/D Kiowa.

TITLE: OH-58 A&D Kiowa
DEVICE: OH-58 A&D (1&r) #3181/

DATE: 07-15-1994
MAX: .9059
MIN: .4368

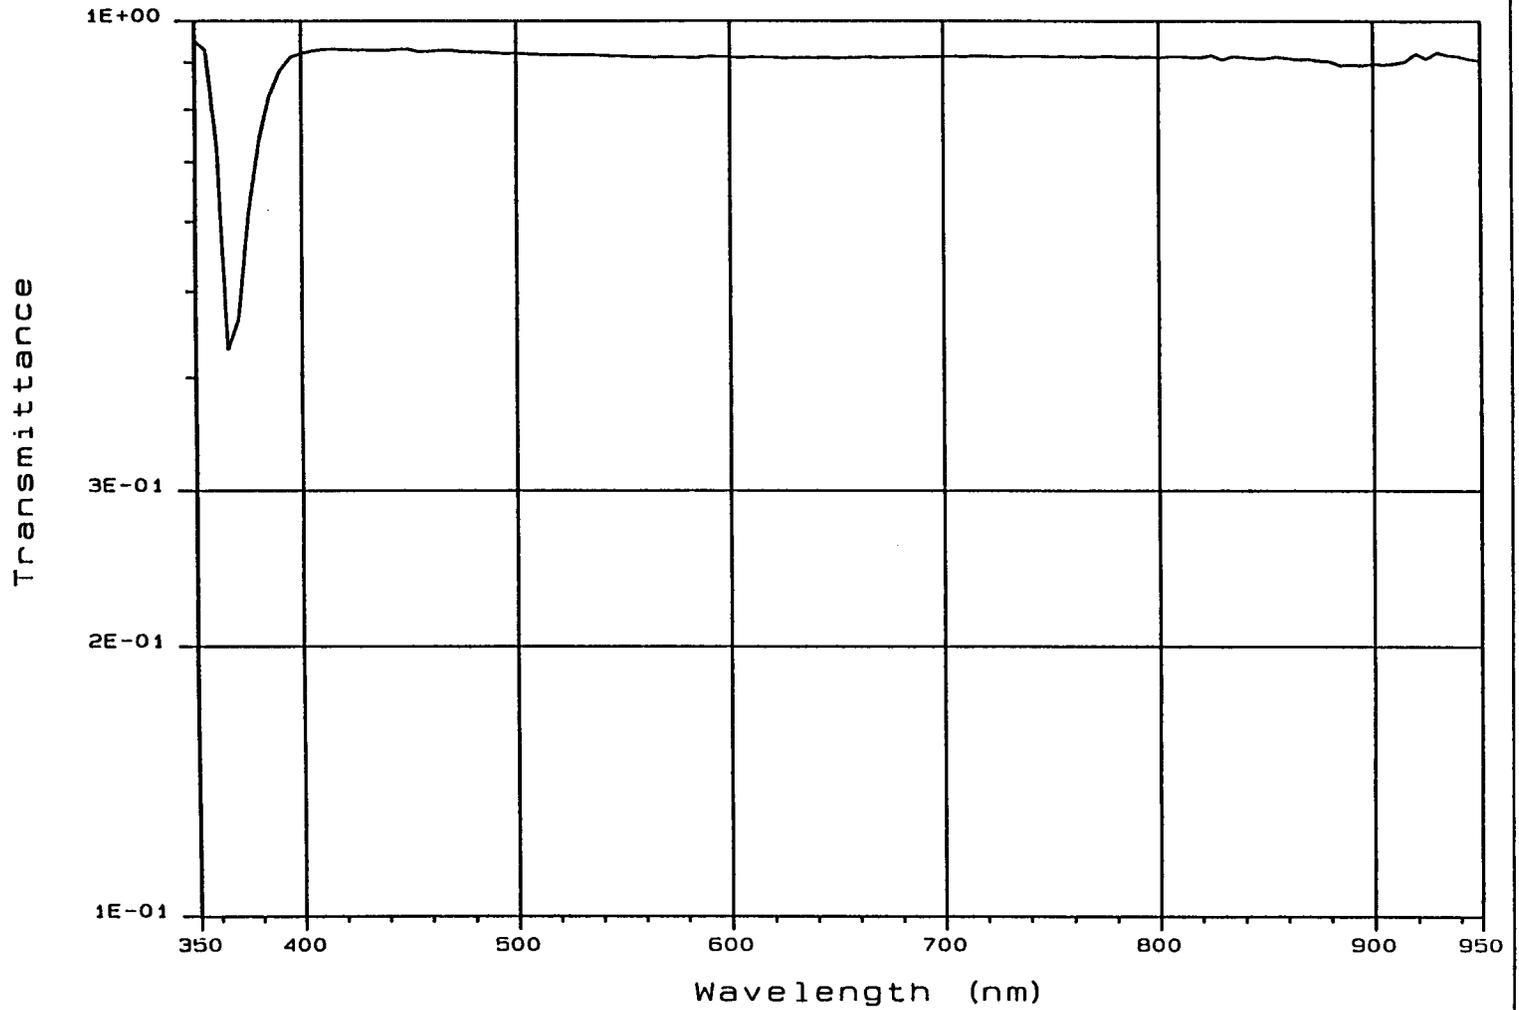
Figure 15. Spectral transmittance curve for OH-58C Kiowa.

TITLE: OH-58 C Kiowa
DEVICE: OH-58C (left) #5359/

DATE: 07-14-1994
MAX: .94996
MIN: .43017

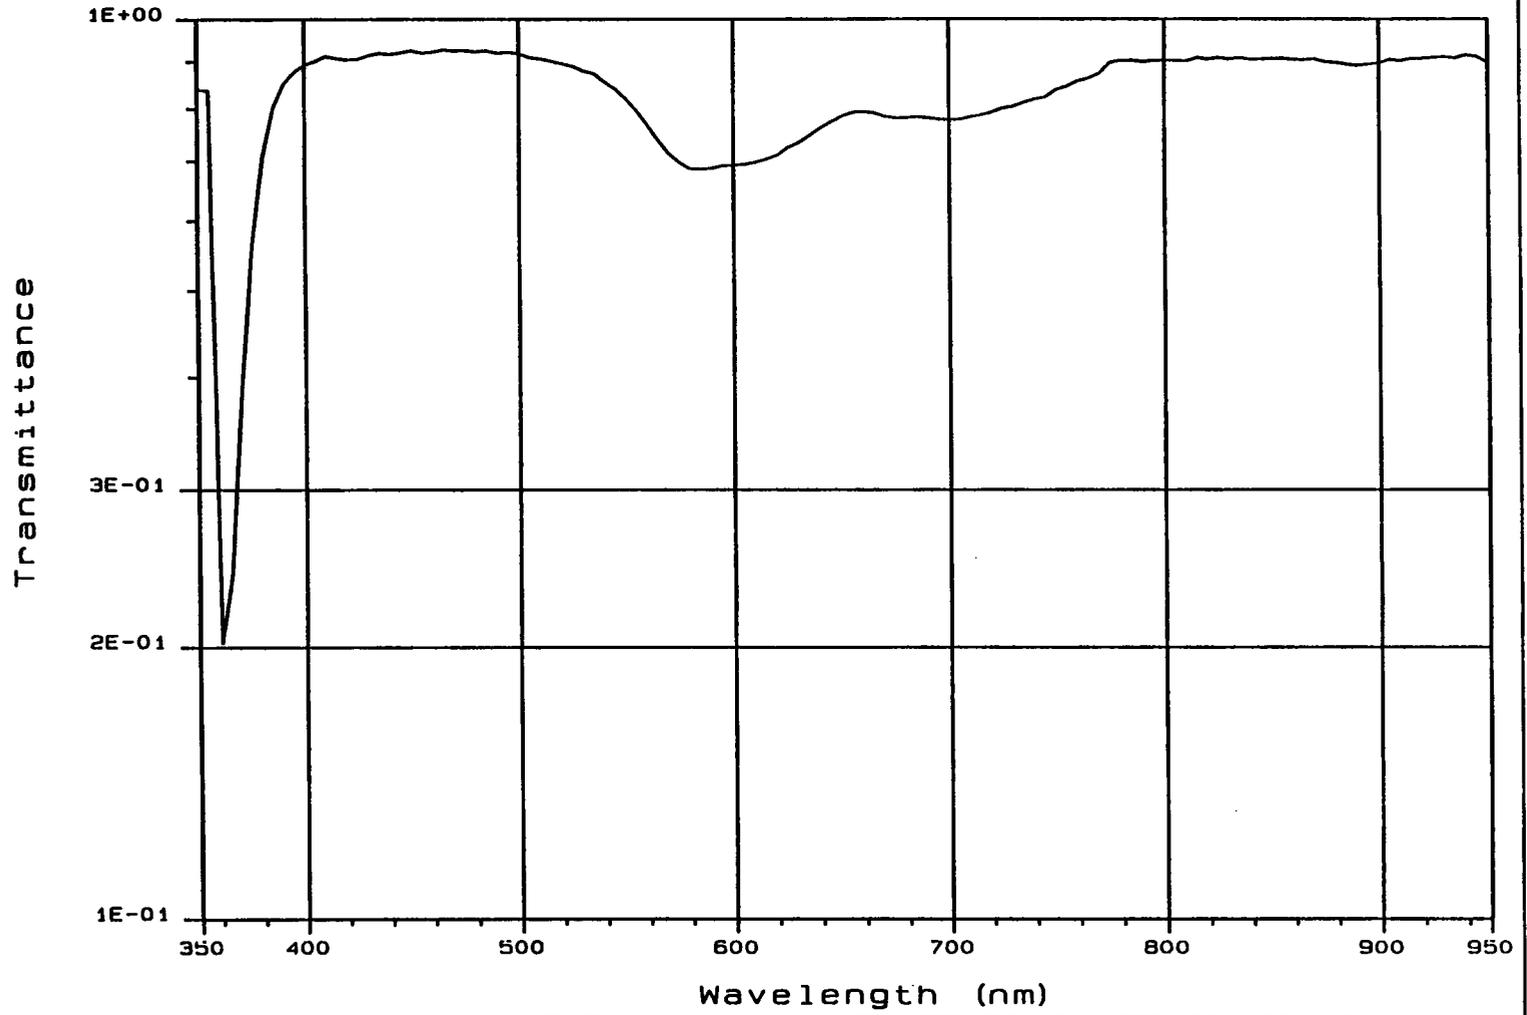
Figure 16. Spectral transmittance curve for TH-67 Creek.

TITLE: TH-67 Creek
DEVICE: TH-67 Front Left/

DATE: 08-04-1994
MAX: .92585
MIN: .202

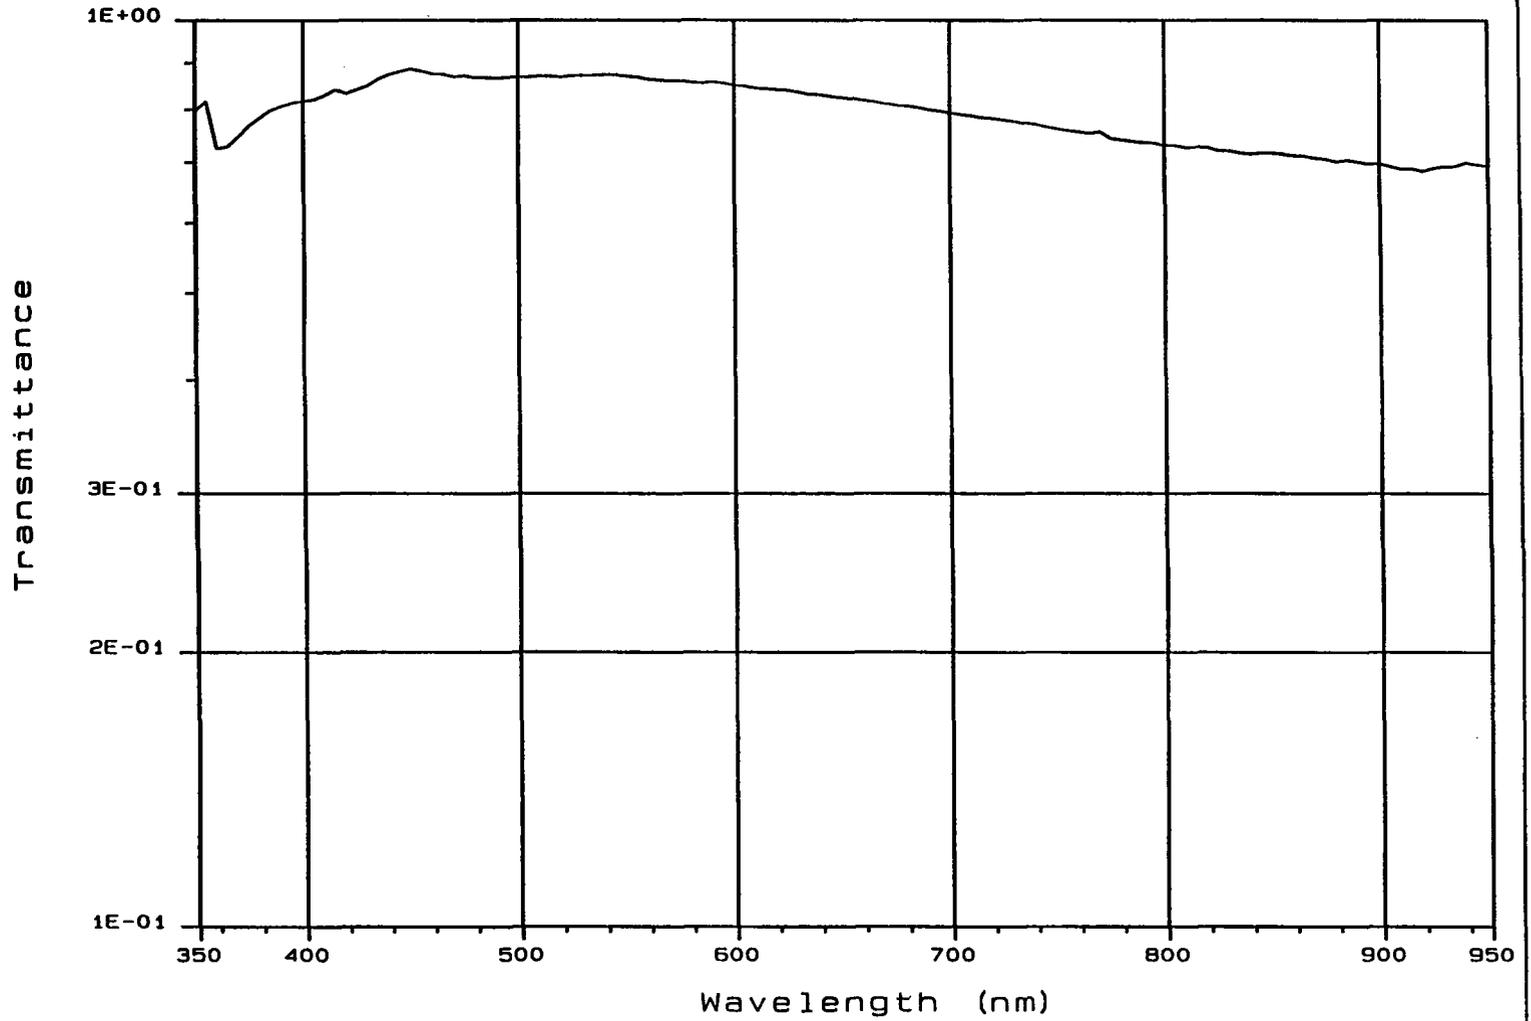
Figure 17. Spectral transmittance curve for UH-1 Iroquois.

TITLE: UH-1 Iroquois
DEVICE: UH-1 Front Left/

DATE: 08-04-1994
MAX: .88593
MIN: .68467

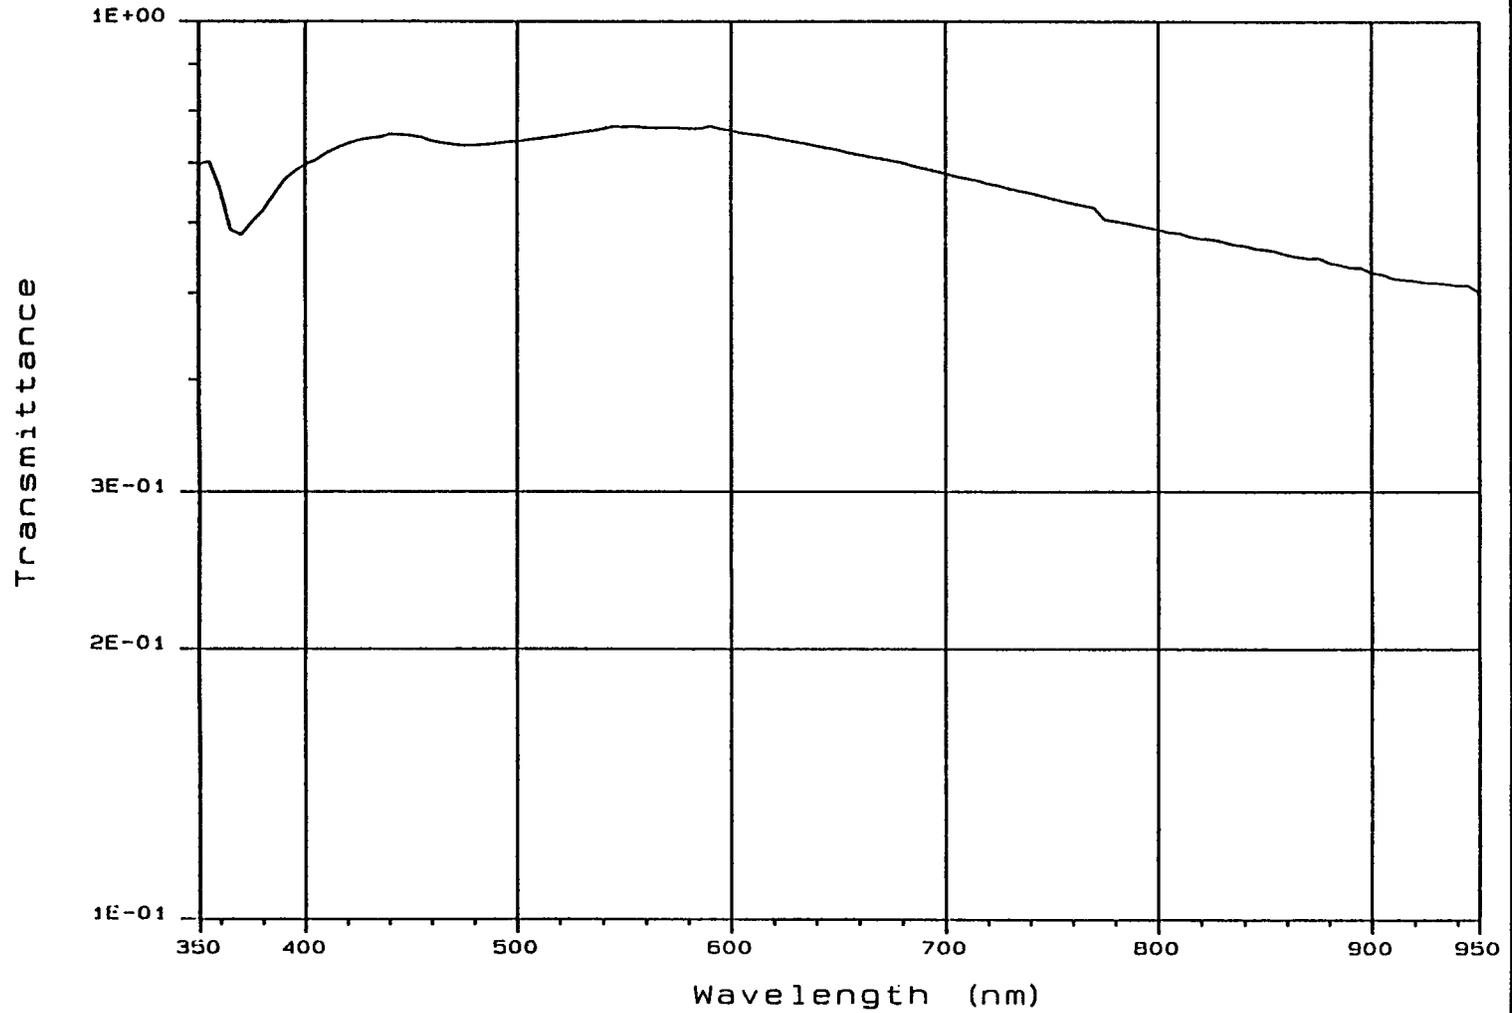
Figure 18. Spectral transmittance curve for UH-60 Black Hawk.

TITLE: UH-60 Black Hawk
DEVICE: UH-60 (left) #2249/

DATE: 07-13-1994
MAX: .7692
MIN: .50154
