**Helmet-Mounted Displays and Facial
Injury in U.S. Army AH-64A
Apache Accidents
(Reprint)**

January 1999

**U.S. Army Aeromedical Research Laboratory
Fort Rucker, Alabama 36362-0577**

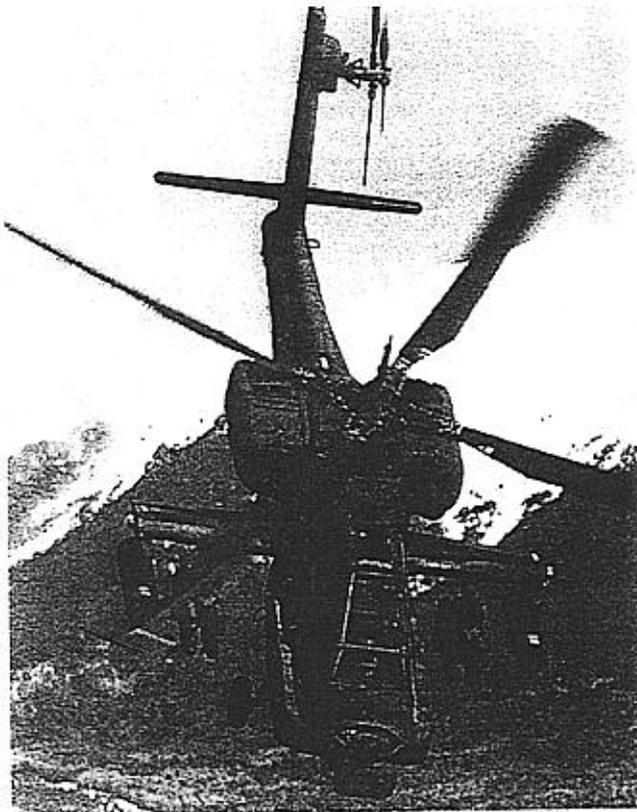
Fig 1. The US Army AH-64A helicopter (US Army photograph).

The AH-64A Apache is a tandem seat, dual engine attack helicopter (Fig 1) that is equipped with an integrated helmet and display sighting system (IHADSS) (Figs 2, 3, 4). This

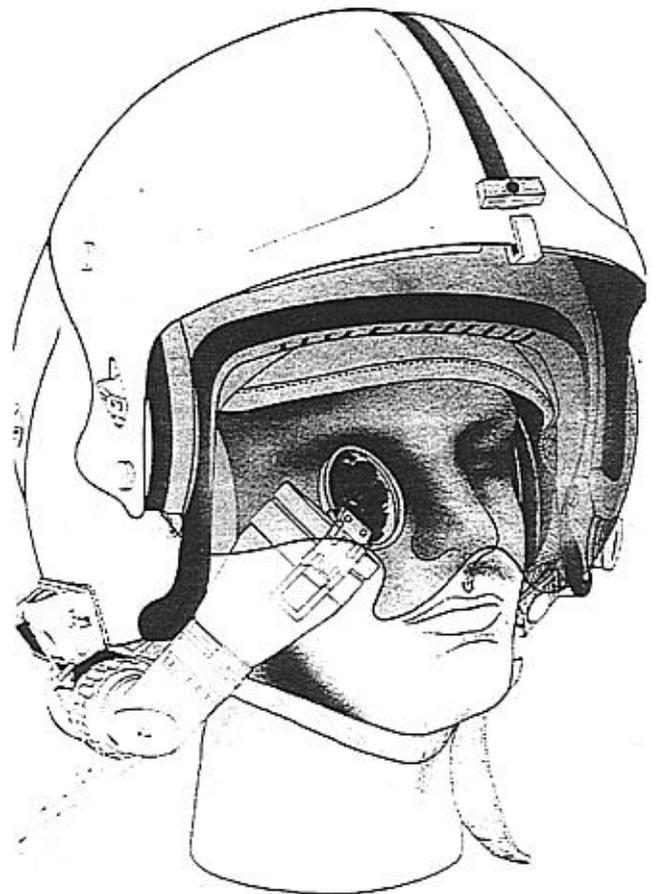
Fig 2. The AH-64 integrated helmet and display sighting system (IHADSS) helmet. Note the proximity of the HDU to the right side of the aviator's face.

These visual aids must be worn extremely close to the aviator's eye(s) and face, constituting a potential injury hazard. The rationale for concern is not that the HDU or NVG will independently cause injury, but rather that in a crash an otherwise blunt impact from a cockpit surface could be focused on critical structures such as the eye or orbit. The HDU combiner lens is made of polycarbonate, so fragmentation is unlikely, but it is positioned at such an angle that orbital injury remains a hazard (Fig. 2). To date no HDU injury analysis has been published.

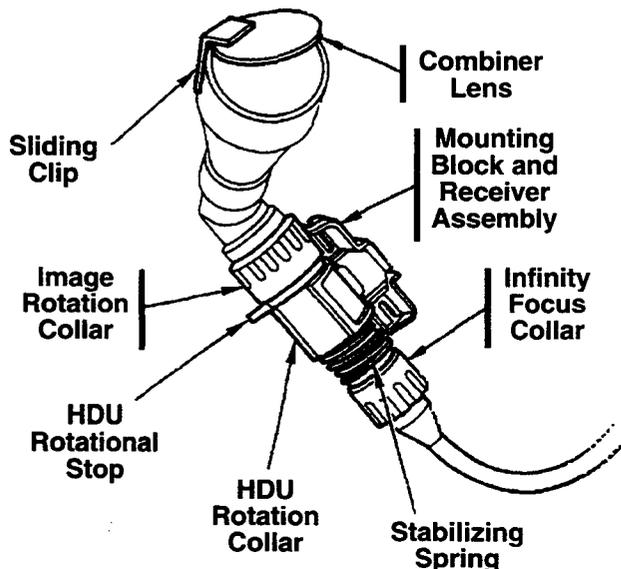
system provides sensor video and/or symbology to each crewmember via a HDU (Fig 3). The HDU contains a 1-inch cathode ray tube (CRT) and attaches to the right side of the helmet, positioning a polycarbonate combiner lens directly in front of the pilot's eye. When in use, the HDU usually rests on the pilot's right cheek; when not needed, it can be rotated away from the face.

Fig. 3. The AH-64 helmet display unit (HDU) (5).
