**USAARL Report No. 93-15**

**Basic Principles  
of Helicopter Crashworthiness**

**Dennis F. Shanahan**

**February 1993**

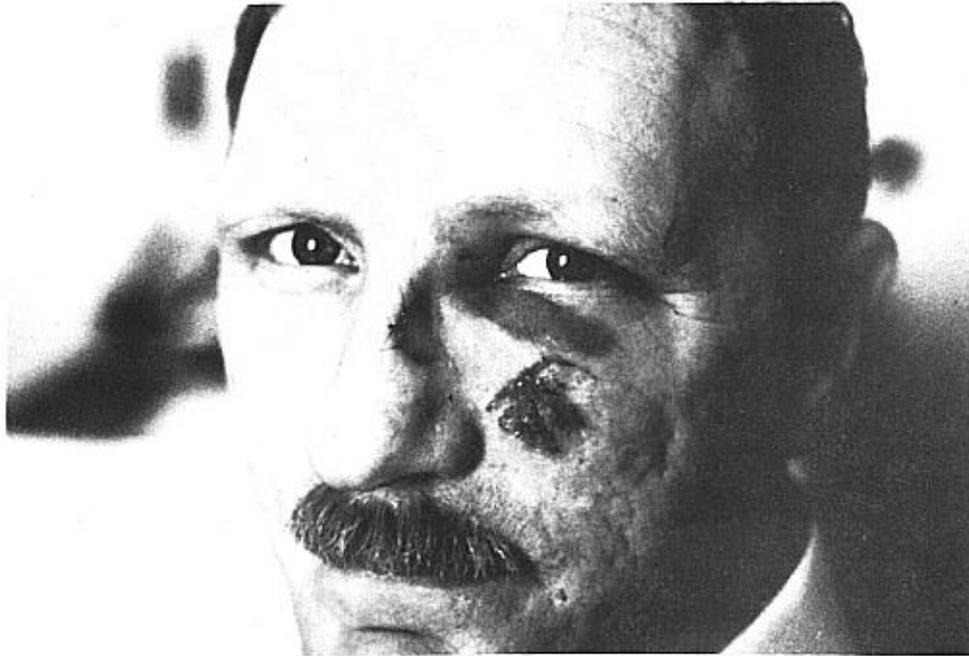
Figure 7a. Note the shapes and location of the abrasions and lacerations on the left side of the face of the pilot.

may be considered an injury hazard (Figures 7 and 8). As an example, the cyclic and collective controls can pose a significant injury hazard to pilots during a crash, particularly when the visor on the flight helmet is not worn in the down position. The volume of that space will vary depending on the type restraint system anticipated and, to a lesser extent, on the anthropometry of the expected occupants. The maximum head strike distance is reduced by about 50 percent when upper torso restraint is utilized. Clearly, the primary concern must be for hazards within the strike zone of the head and upper torso, but objects within the strike zone of the extremities also should be considered.

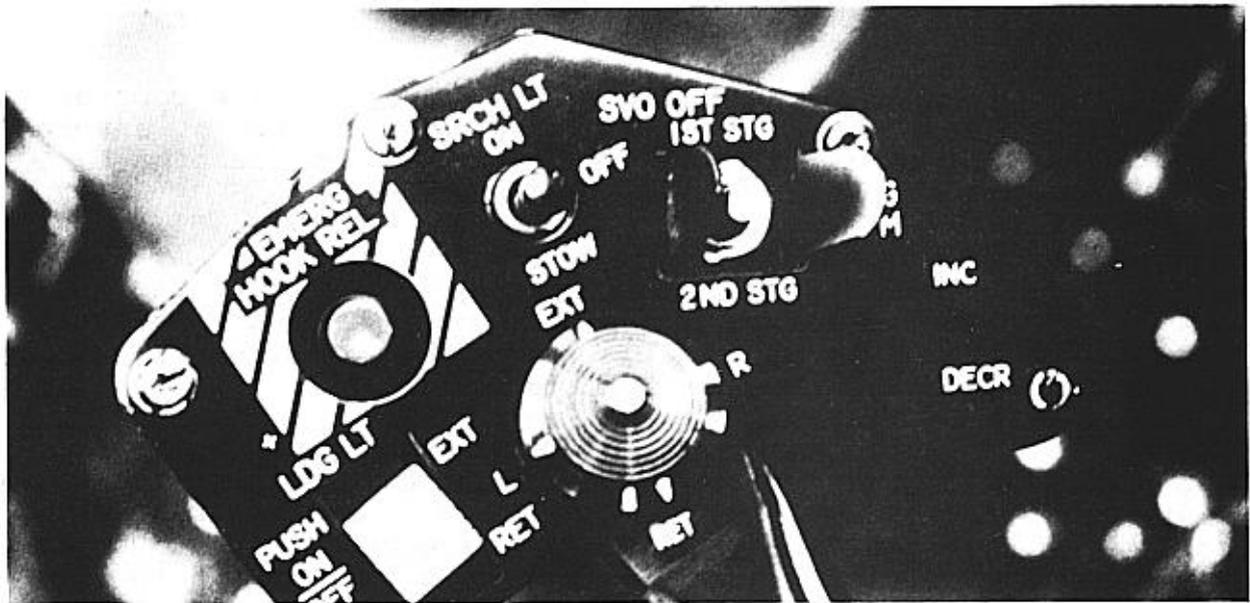
Figure 7b. A comparison of the pilot's injuries with the collective control demonstrates a concordance between his injuries and the metal guard around the "SVO OFF" switch and the "Chinaman's hat" switch. Minute particles of human tissue also were recovered from the switch guard.

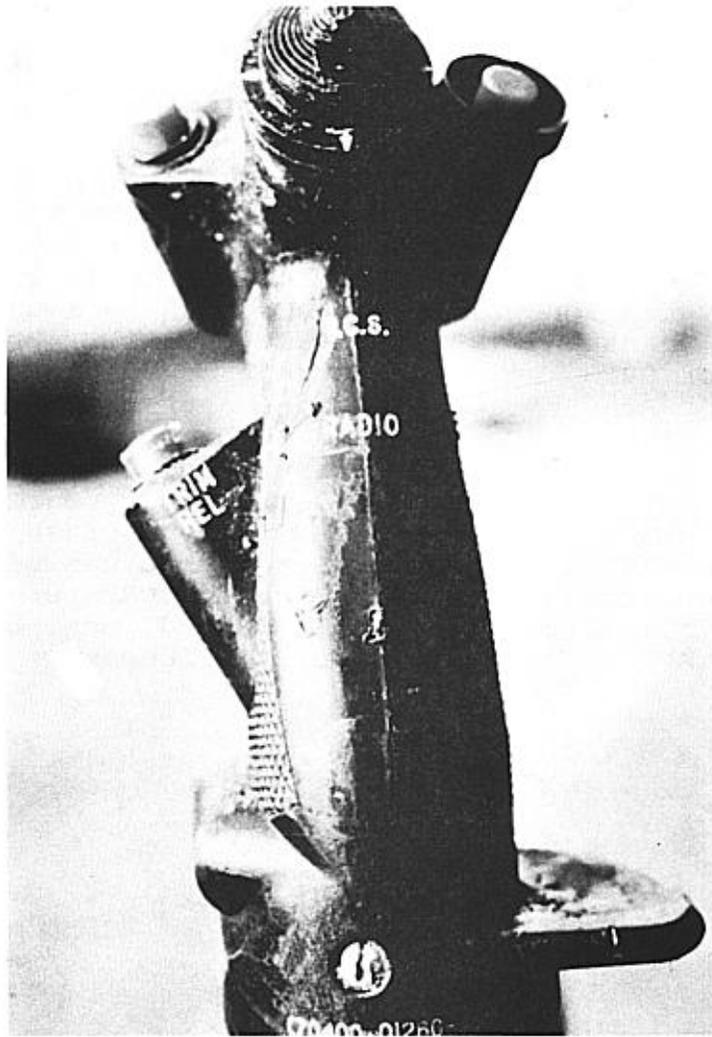
**Figure 8. Cyclic control recovered from a UH-60 crash shows longitudinal gouges made by the pilot's teeth. The pilot lost several anterior teeth in the crash, but received no other serious injury.**

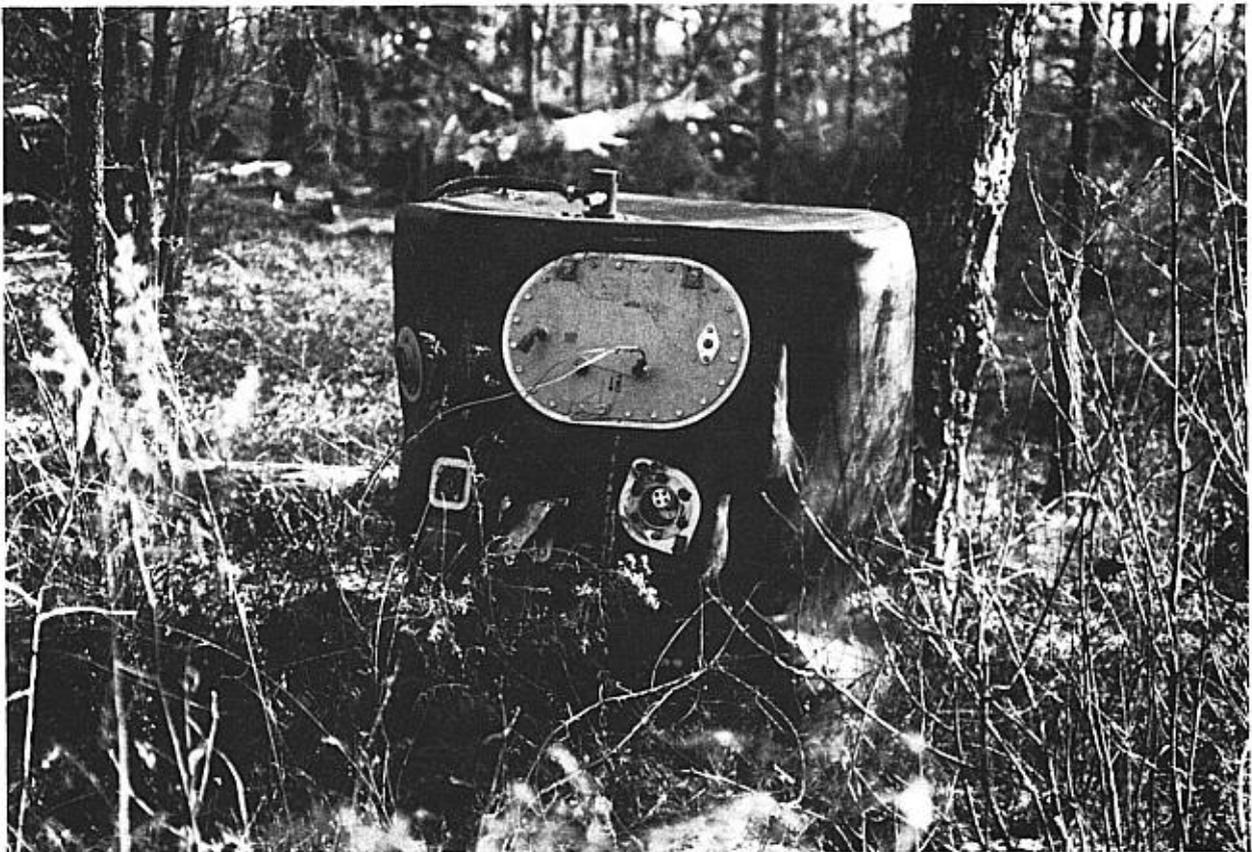
Figure 9. Fuel cell torn loose from Apache helicopter during a nonsurvivable crash. Fuel was completely contained; there was no postcrash fire.

In the case of postcrash fire, controlling the hazard at the source has proven to be an extremely effective strategy for helicopters (Figure 9). Since the U.S. Army introduced crash resistant fuel systems (CRFS) into its helicopter fleet in the 1970s, there has only been one fire related death in a survivable crash (Shanahan and Shanahan, 1989b; Singley, 1981). Prior to the introduction of CRFS, up to 42 percent of deaths in survivable crashes of U.S. Army helicopters were attributed to fire (Haley, 1971; Singley, 1981). Considering the magnitude of the problem of postcrash fire in non-CRFS equipped helicopters and the incredible effectiveness of CRFS, it is most regrettable that helicopters continue to be produced without crash resistant fuel systems. This situation continues more because of the persistent failure of regulatory agencies to require CRFS use than that of the manufacturers to provide them. Indeed, many manufacturers have offered CRFS as an option, but few operators have opted to

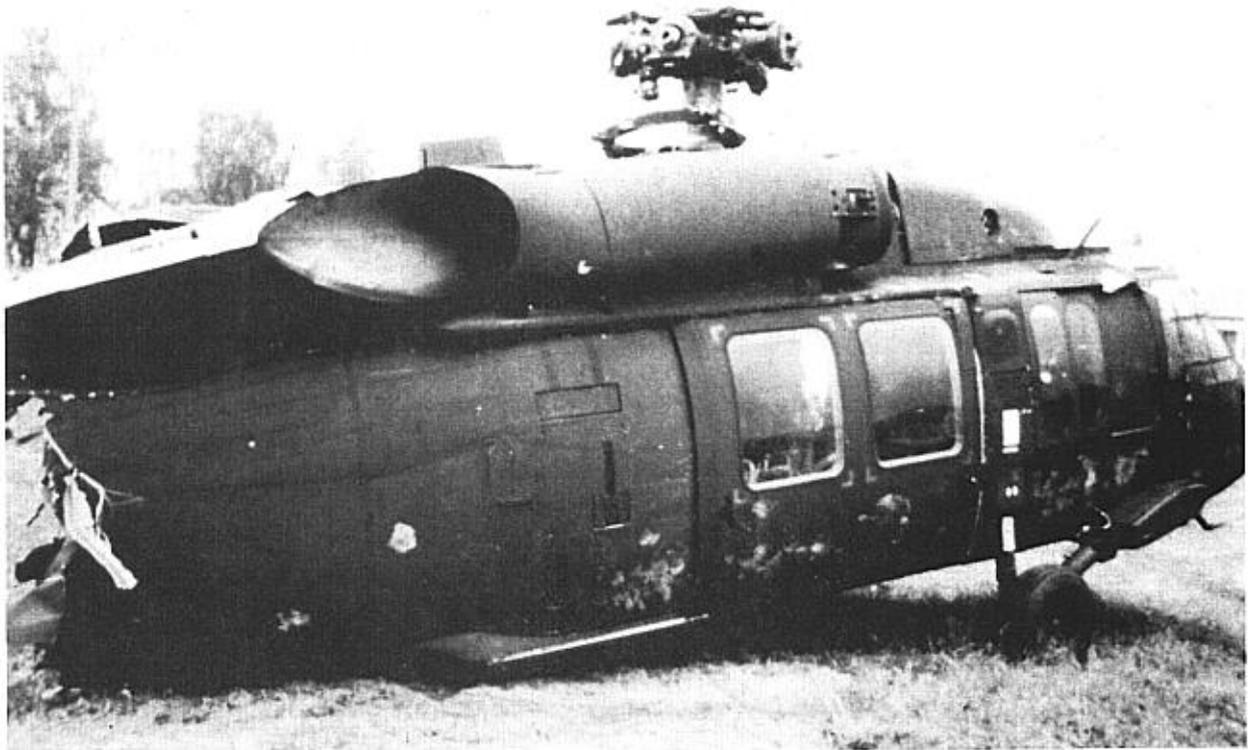
Figure 11b. Crashworthy design of UH-60 prevented dislodgement of the transmission during a crash. The blades broke away rather than flexing into occupied spaces.

spaces frequently has tragic consequences. The results are particularly vivid when rotor systems penetrate the cockpit (Figures 11a and 11b). When appropriate consideration is given to the placement of these items with respect to occupied spaces and to their tie-down strength to the airframe, intrusion of these items can be practically eliminated as a hazard in survivable crashes (Shanahan and Shanahan, 1989b; Singley, 1981). Current FAA retention standards should be increased by a factor of at least 2.0.
